Petroglyph Energy, Inc.
Well Pad Final Reclamation Evaluation

Well Name: Anselmo 18-03

Evaluation Date: July 14, 2015

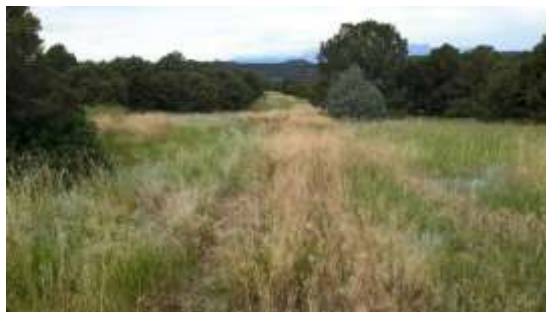
A small area at the northern tip of the pad is dominated by the weedy annual tall tumbled mustard (*Sisymbrium altissimum*), while the access road has several patches of the weedy annual western tansymustard (*Descurainia pinnata*.)

Annuals on access road

These northern tip of the access road should be mowed and reseeded. Mulching is optional.

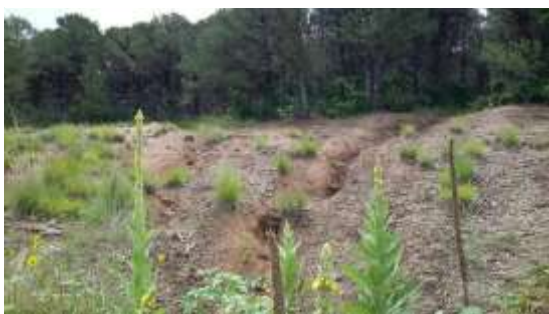
The cut slope on the edge of the pad has some established vegetation but it is quite sparse. There are gullies in the eastern corner of the pad due to drainage onto the cut slope. Also, drainage onto the access road is causing major movement and deposition of sediment.

Erosion

The cut slope should be furrowed on the contour and reseeded with the approved seed mix. Erosion fabric or WoodStraw mulch applied at a target rate of 70% cover may facilitate establishment. Stormwater conveyance structures and BMPs should be installed to control gulley erosion on the eastern corner of the well pad and handle water running onto the site from the access road.

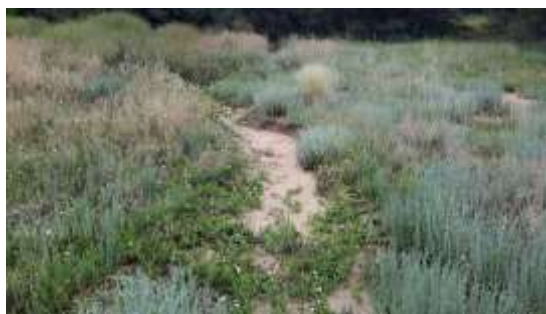
Flow onto access road.

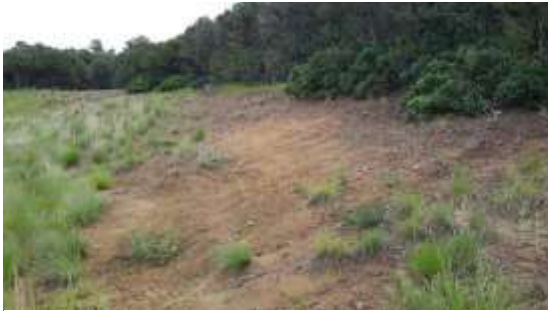
Low vegetation density

Areas of poor vegetation establishment indicated on the attached map should be re-seeded using a no-till drill or harrow and broadcast method. The approved seed mix should be used at the approved target rate. Seeding can occur any time from late fall to early spring, as ground conditions allow.

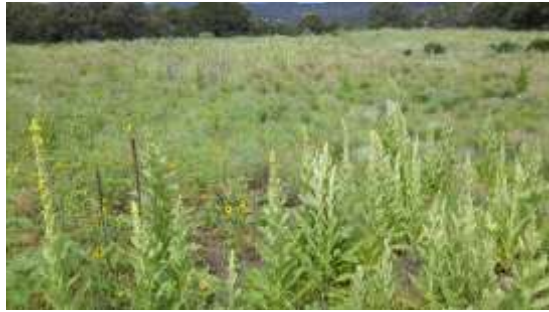
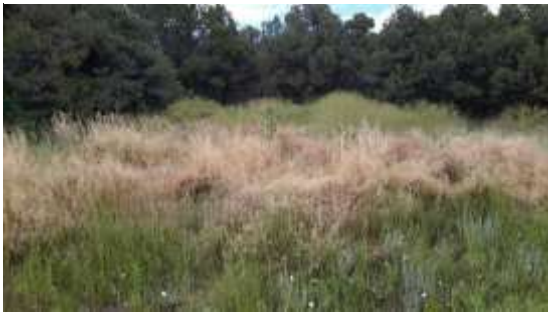
The noxious weed common mullein (*Verbascum thapsus*) is abundant on the pad, as well as scattered redstem stork's bill (*Erodium cicutarium*.) While no cheatgrass (*Bromus tectorum*) occurs on the pad itself, cheatgrass does occur on and adjacent to the long access road. Field bindweed (*Convolvulus arvensis*) is also abundant on the access road.

Noxious weeds

The entire well pad should be treated in the fall of 2015 to minimize the cheatgrass infestation. Prior to herbicide application the site should be mowed to remove the standing dead annual vegetation and allow for effective soil contact of herbicides. A pre-emergent herbicide should be applied to prevent germination of this winter annual. Mullein and bindweed should be spot-sprayed with appropriate herbicides to prevent their continued spread.

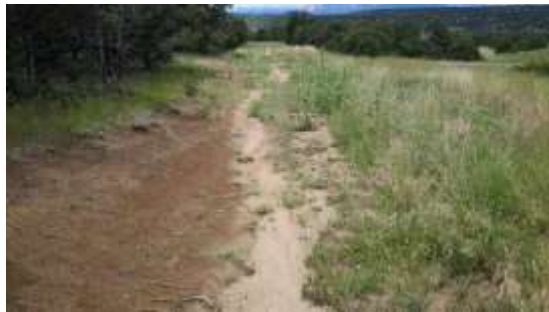
Sediment deposition on road

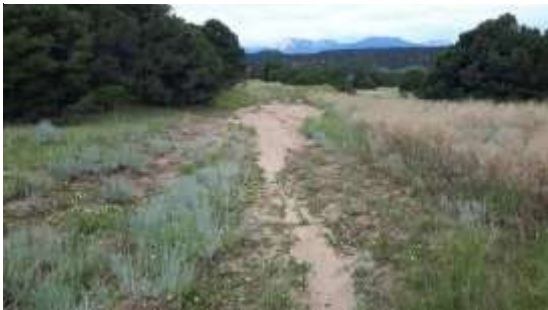
Sediment deposition onto access road

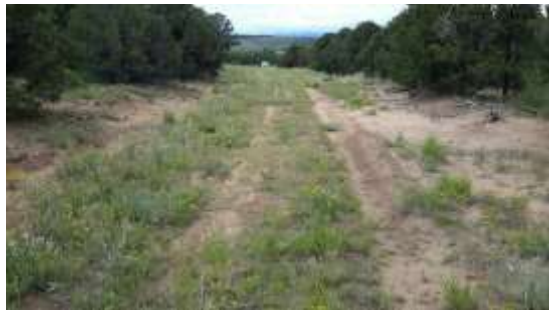
Vehicle tracks/ruts

Vehicle traffic on this pad is affecting establishment of the vegetation on the access road and should be prevented or minimized.

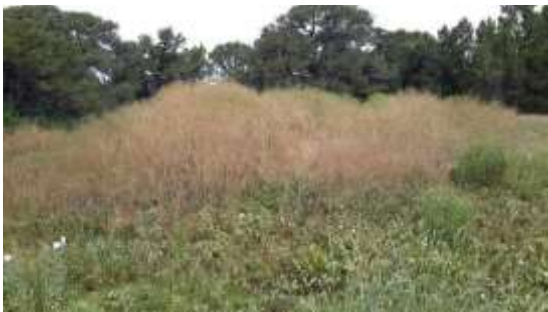
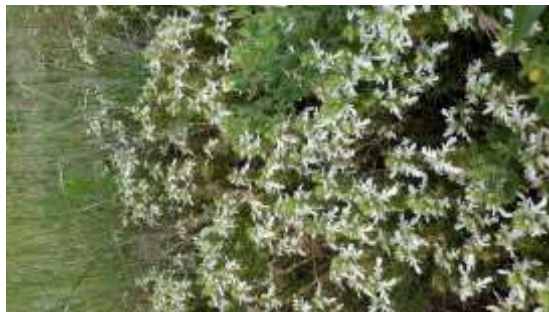
Weedy annual vegetation
