Lopez Salt Water Disposal Well API# 05-071-09733

Date: June 08, 2017

COGCC FIR Document # 673504275 (2) Corrective Actions are complete.

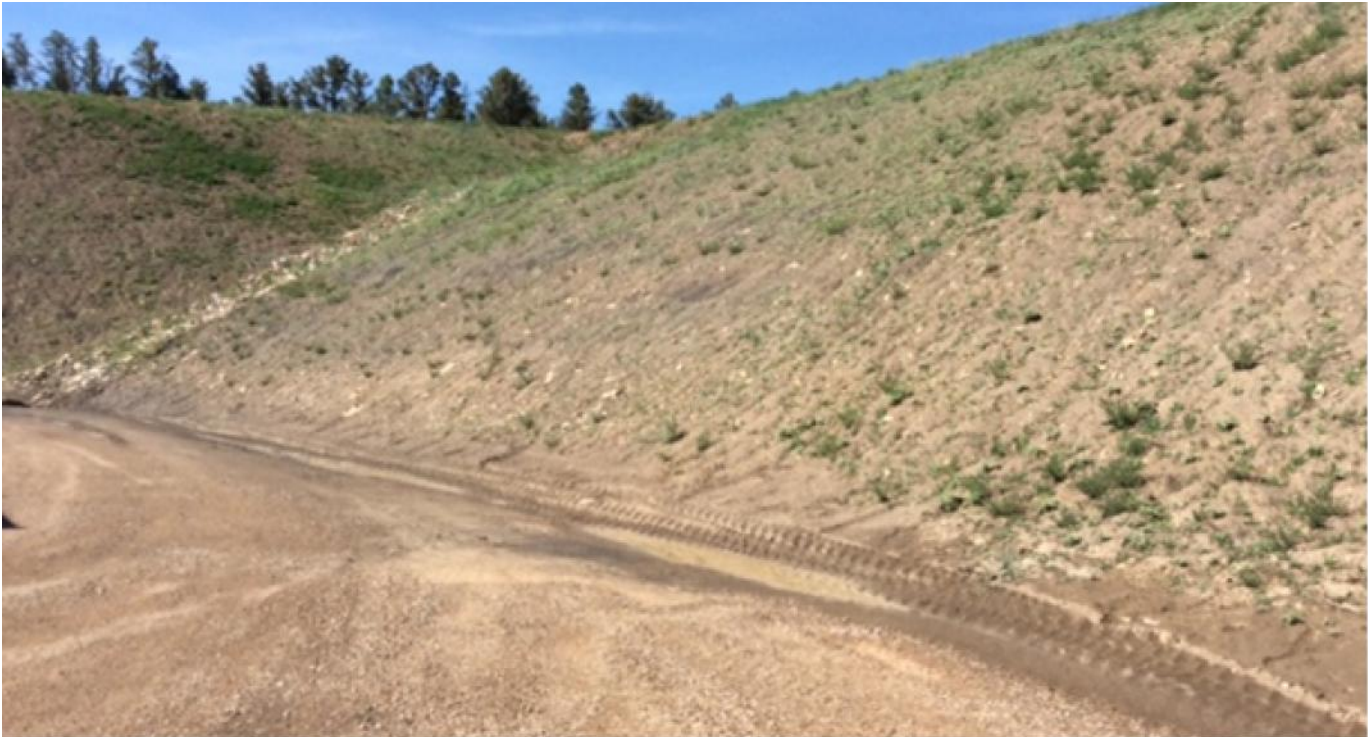
Photo 3: Facing southwest corner of the well pad cut slope. The sediment was removed from the pad.

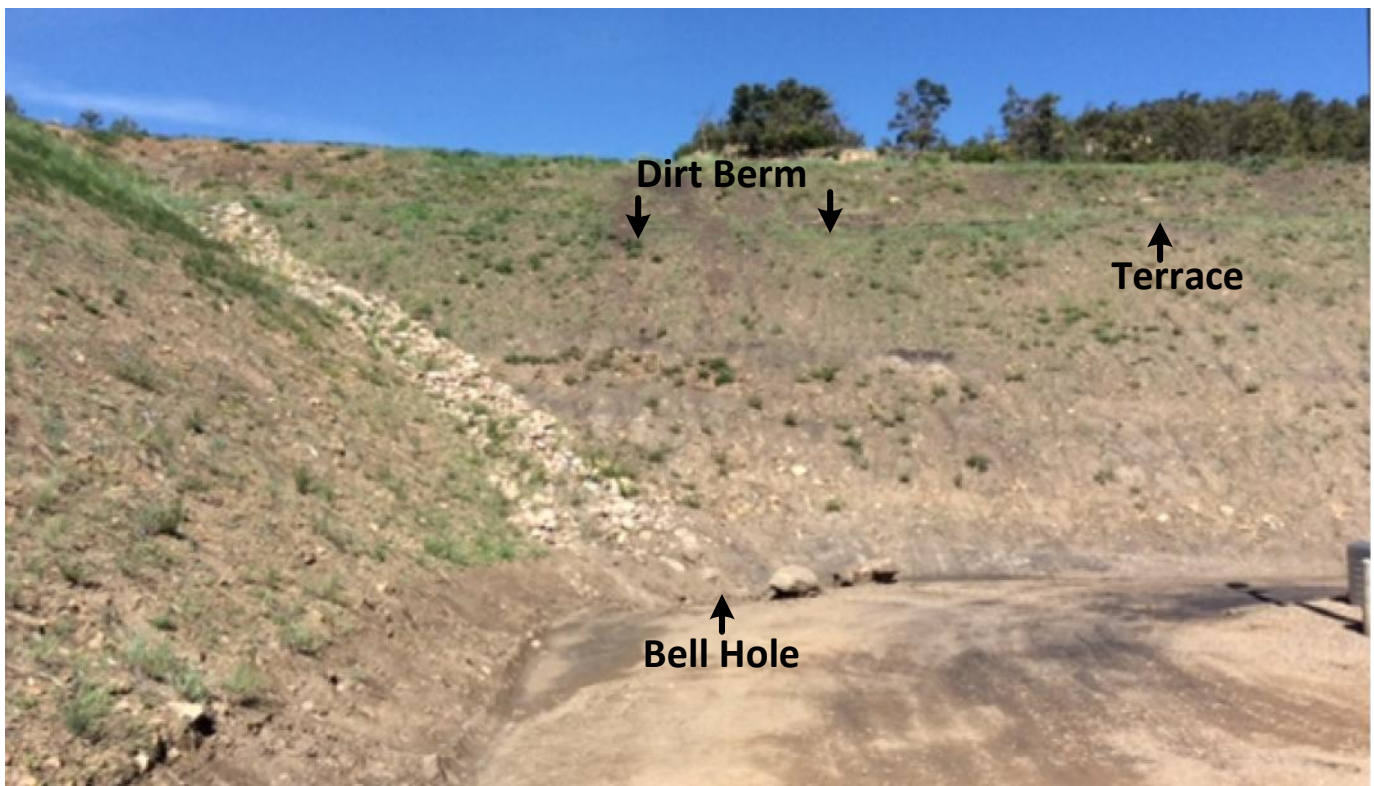
Photo 4: Established a bell hole at the toe of the rock run down to retain sediment. Installed a dirt berm on the terraced cut slope to direct run off away from the cut slope.

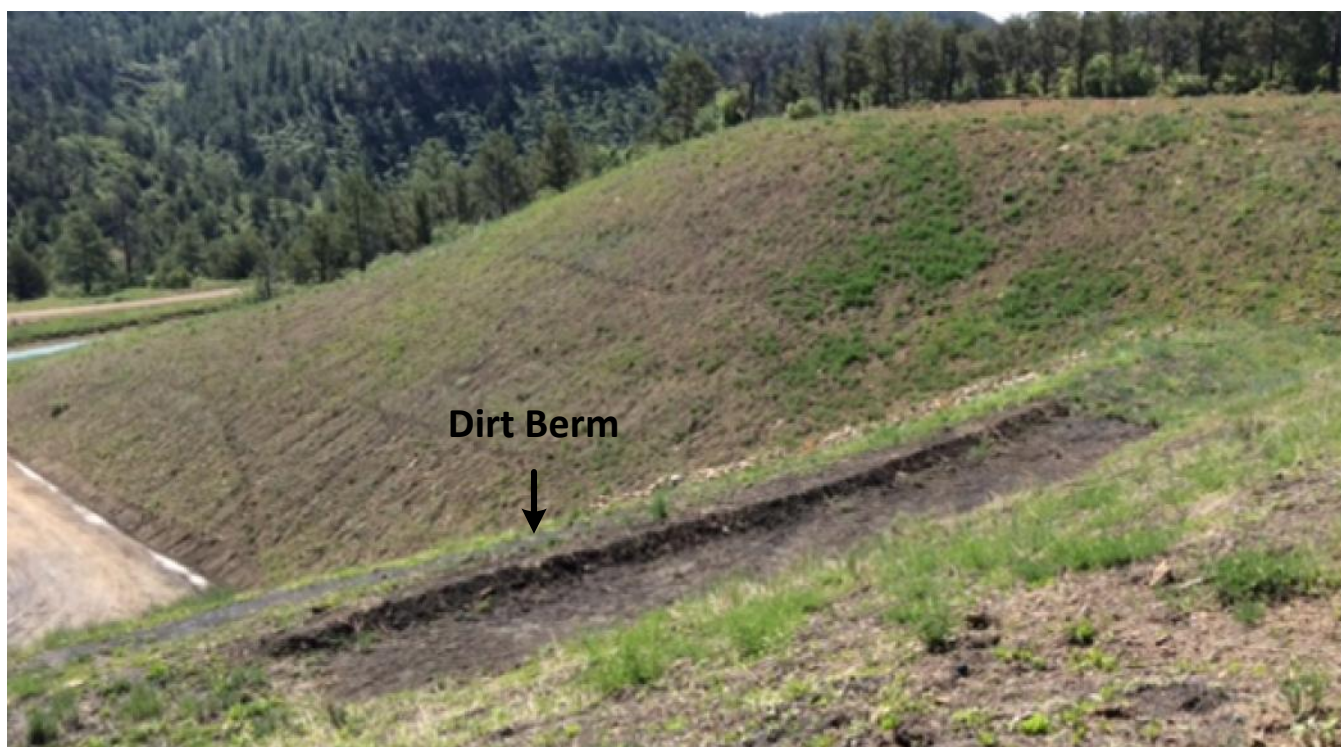
Photo 5: Installed a dirt berm on the terraced cut slope to direct run off away from the cut slope of the well pad.

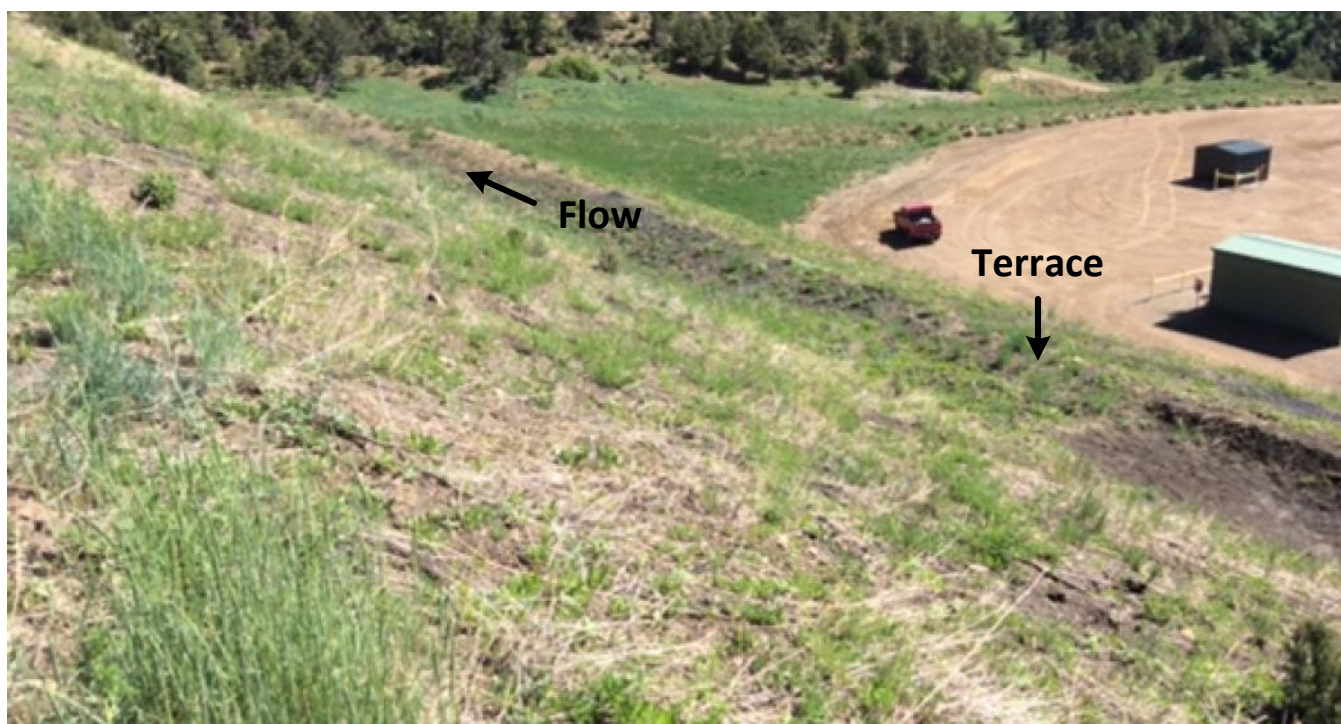
Photo 6: Run off was re-directed to flow down the terrace toward a culvert with an armored outlet.

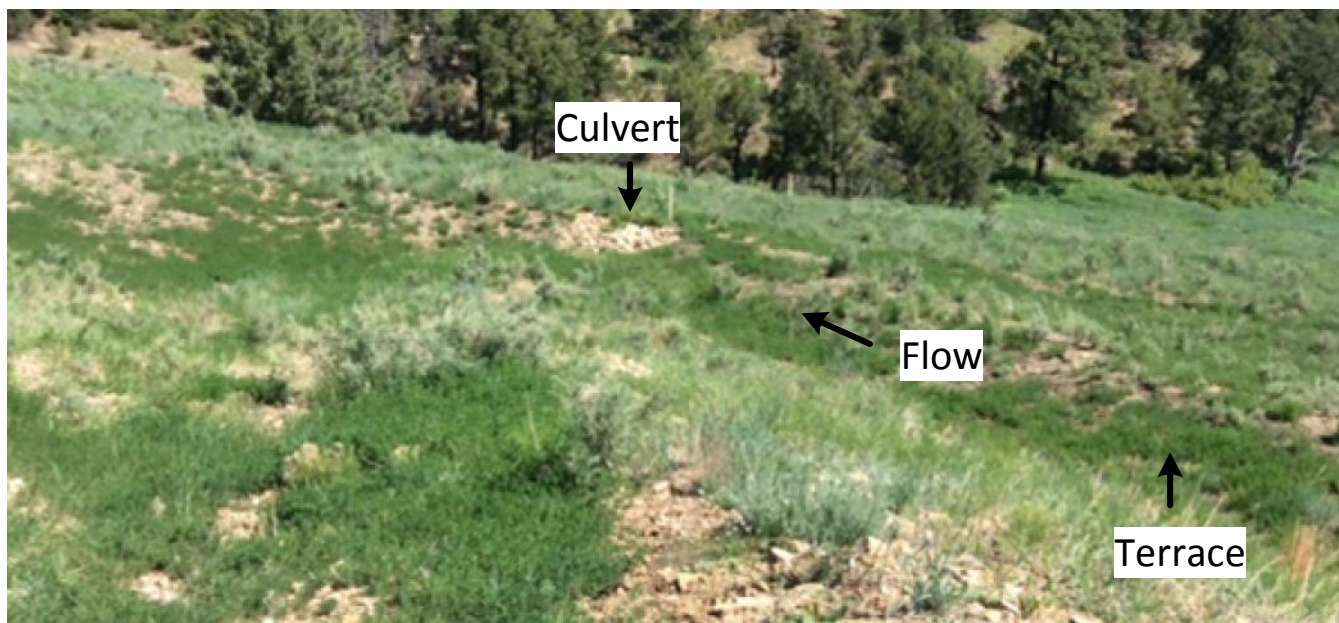
Photo 7: Run off from the terrace flows north to a culvert inlet. This will reduce the flow on the well pad cut slope.

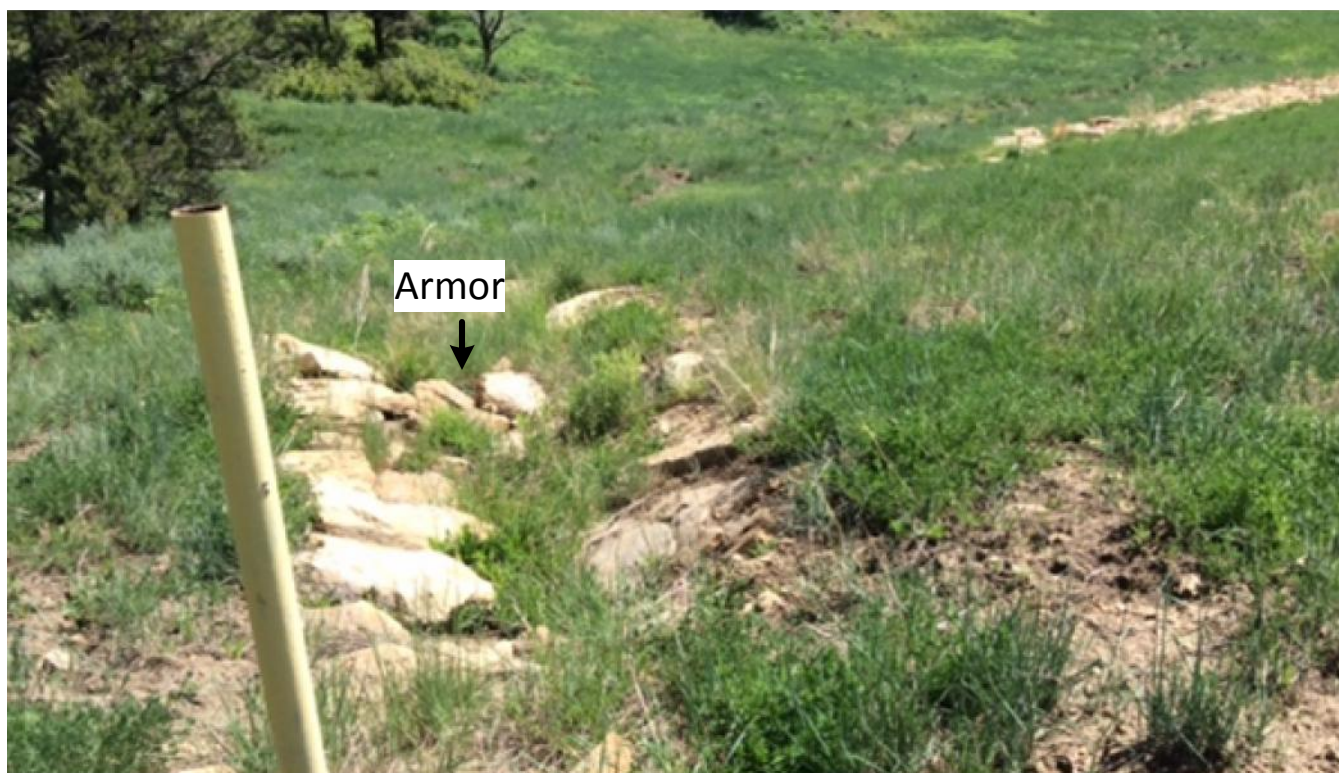
Photo 8: Culvert outlet is armored to prevent erosion from run off.

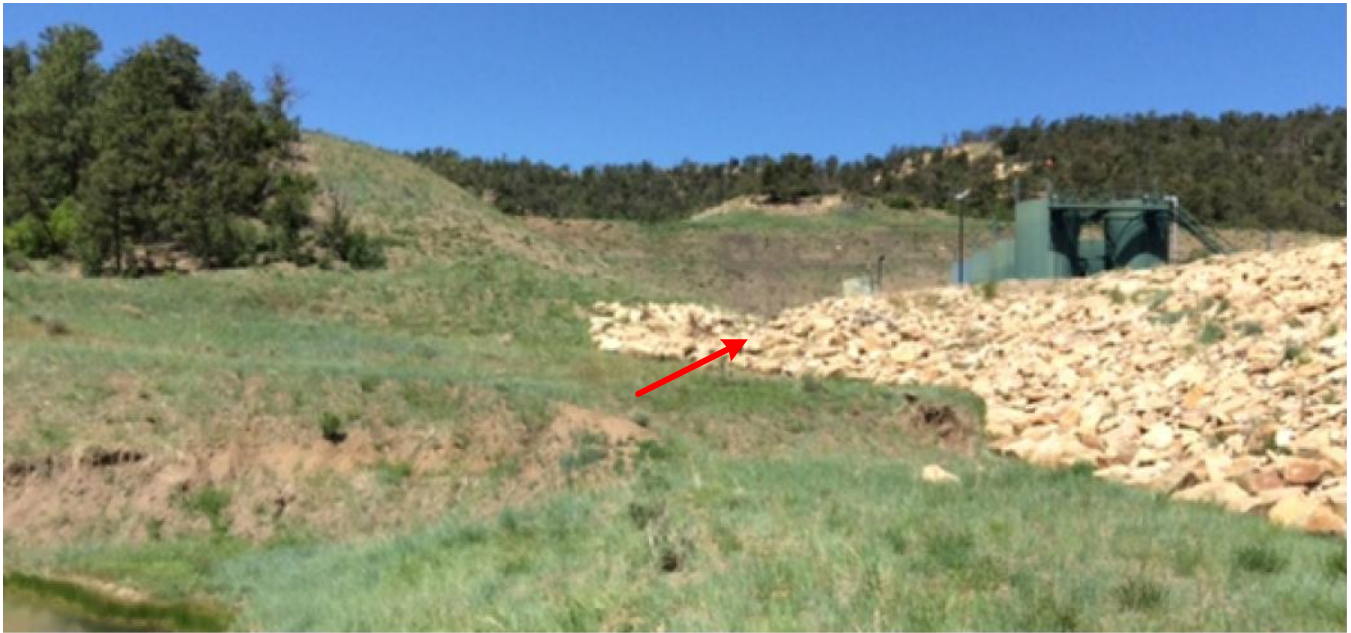
Photo 9: Southeast side of the location facing west. The red arrow points to where noxious weeds were treated on 05/18/17.

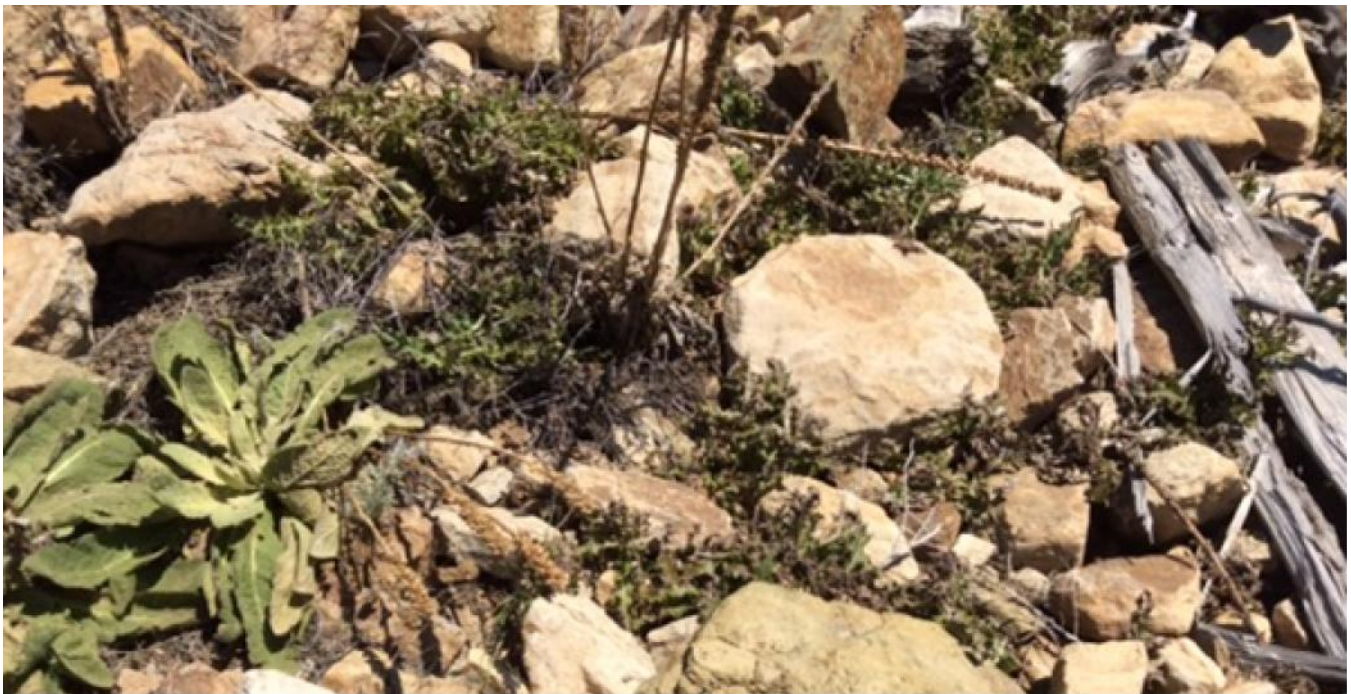
Photo 10: The Canada thistle and Common mullein that were growing in the rock rip rap on the south side of location were treated on 05/18/17.
