Inspection Photos

Operator: PDC ENERGY INC - 69175

Location ID: 323261

Inspection Doc. Number: 682502354

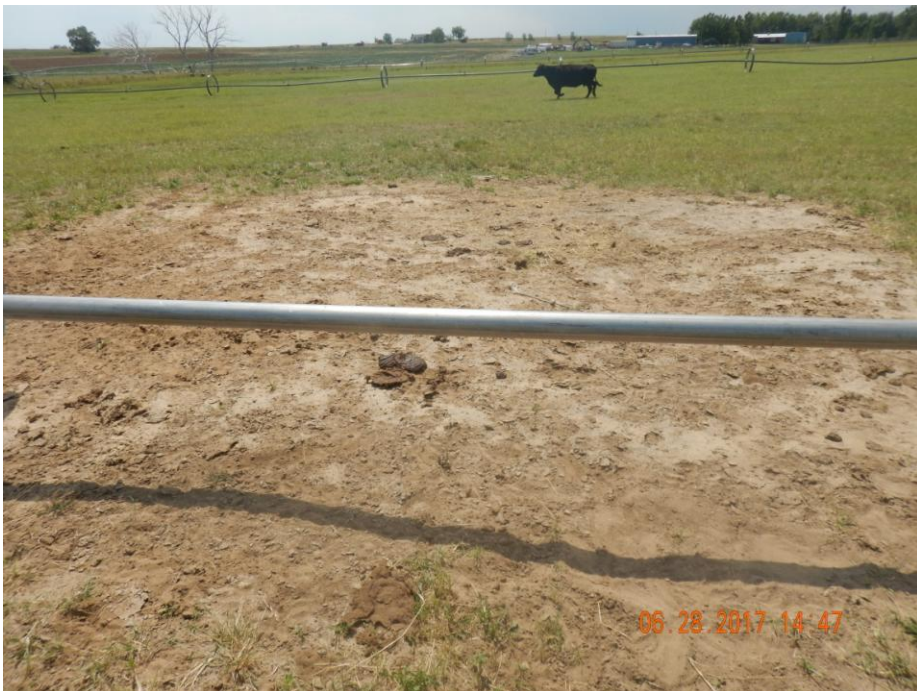
Photo 1: Photo taken from well location, facing west. Photo shows well site remains bare and exposed soil.

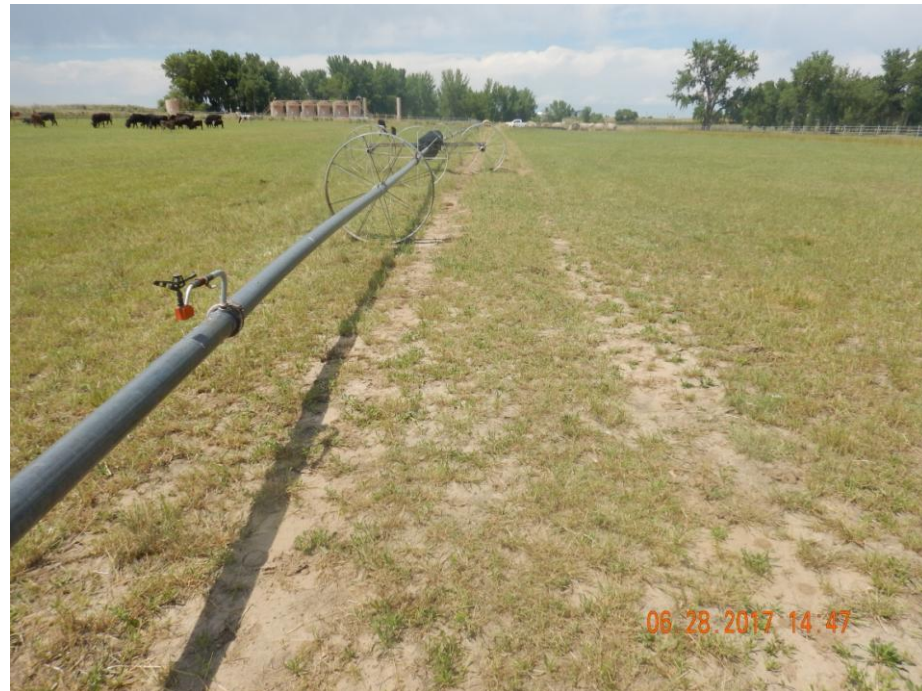
Photo 2: Photo taken the well site, facing north. Photo shows access road has not been reclaimed. Gravel and ruts remain, road has not been revegetated. Access road ends at well location.

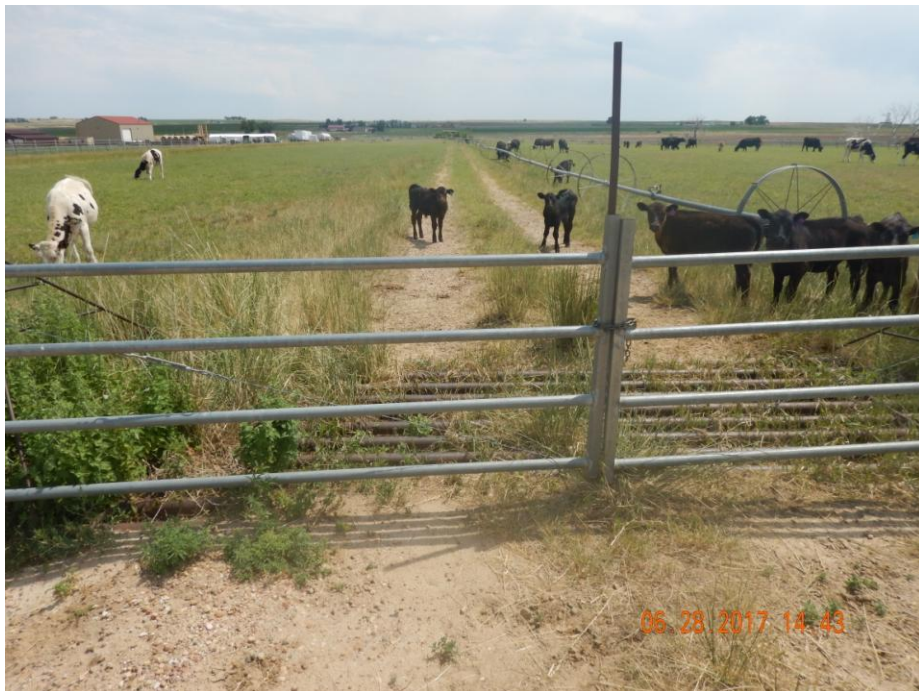
Photo 3: Photo taken from the battery location, north of well, facing south. Photo shows cattle guard and access road have not been reclaimed.

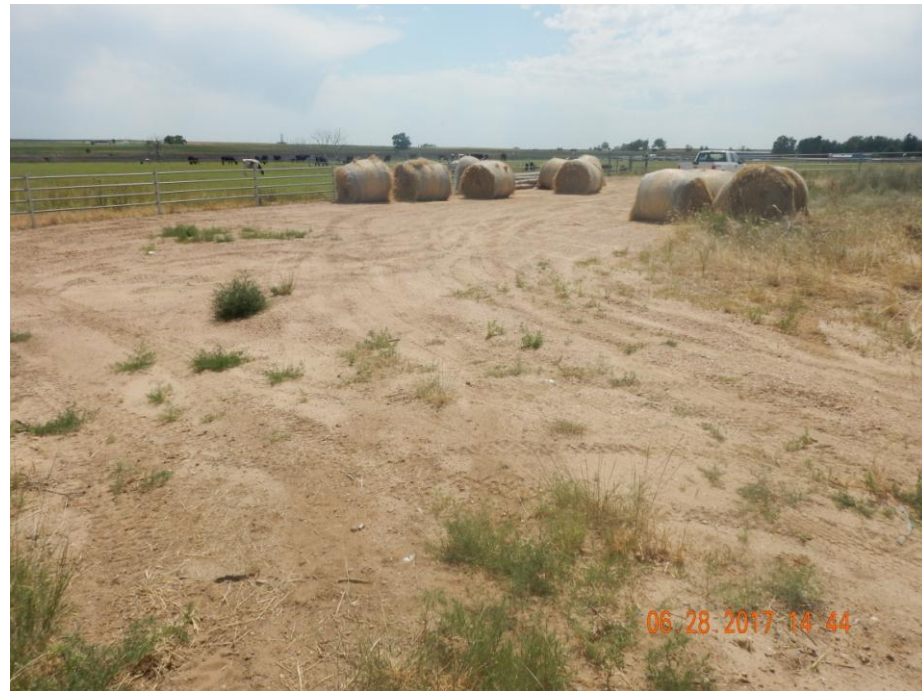
Photo 4: Photo taken from the northeast end of the battery location, facing southwest. Photo shows tank battery location has not been reclaimed. Adjacent reference area is irrigated hay fields.

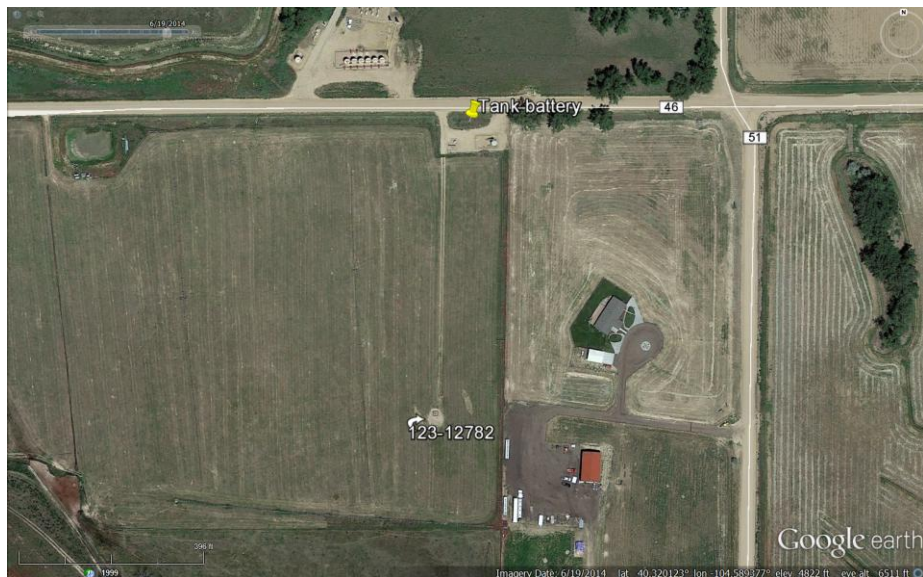
Photo 5: 2014 aerial imagery. Photo shows well and battery location prior to plugging and abandonment.

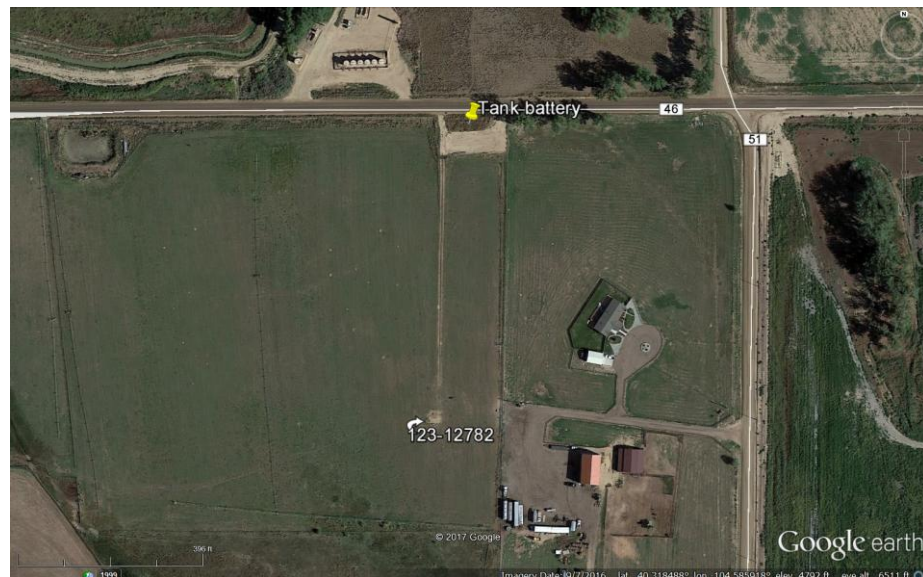
Photo 6: Current, 2016 aerial imagery. Photo shows well and battery location post plugging and abandonment. With exception to the removal of equipment and facilities, very little reclamation work appears to have been conducted since the PA date of 11/15/2015
