# Inspection Photos

Operator: NOBLE ENERGY INC - 100322

Location ID: 327102

Inspection Doc. Number: 682502409

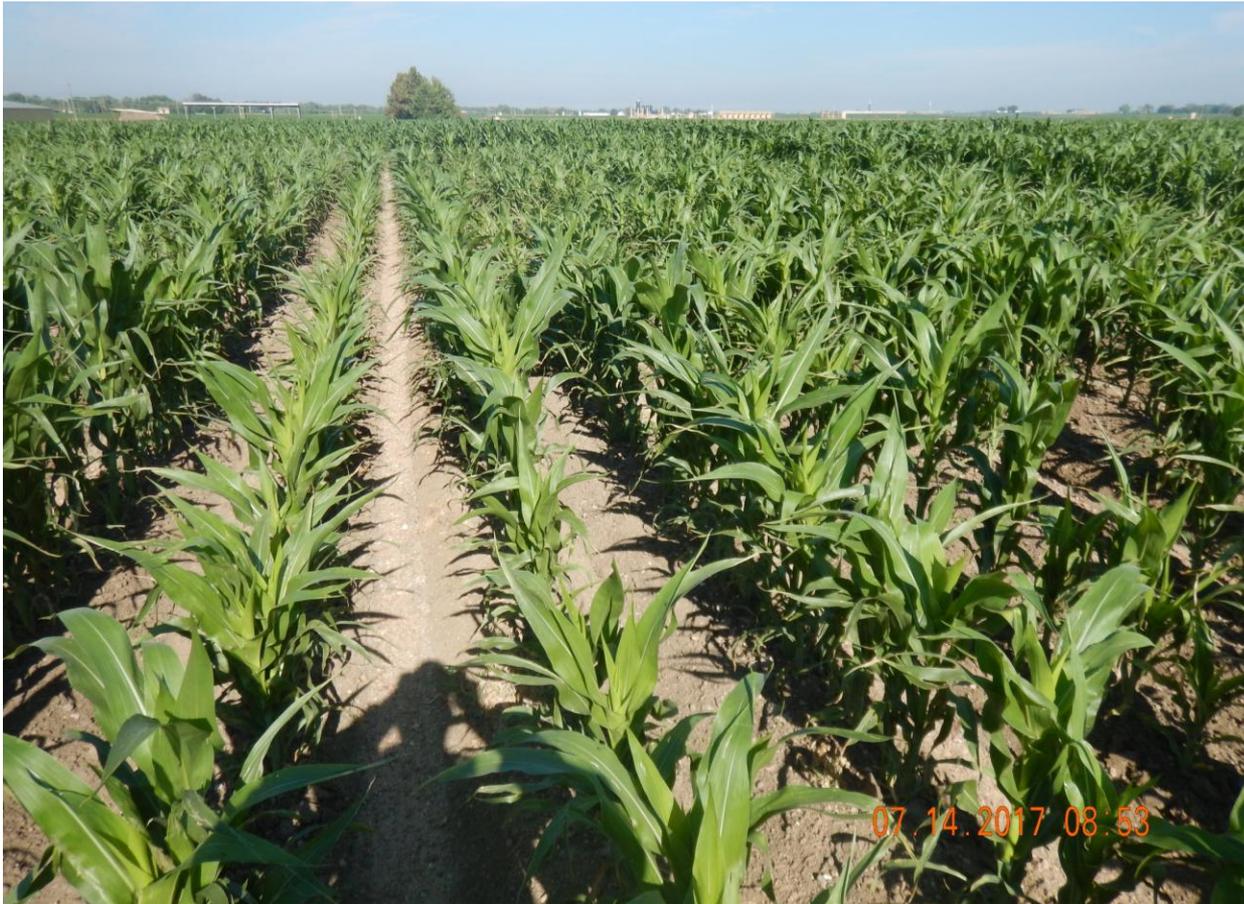
**Photo 1:** Photo taken from the well location, facing west. Photo shows crop (corn) vegetation growth over the well location is stunted when compared to the adjacent reference area.

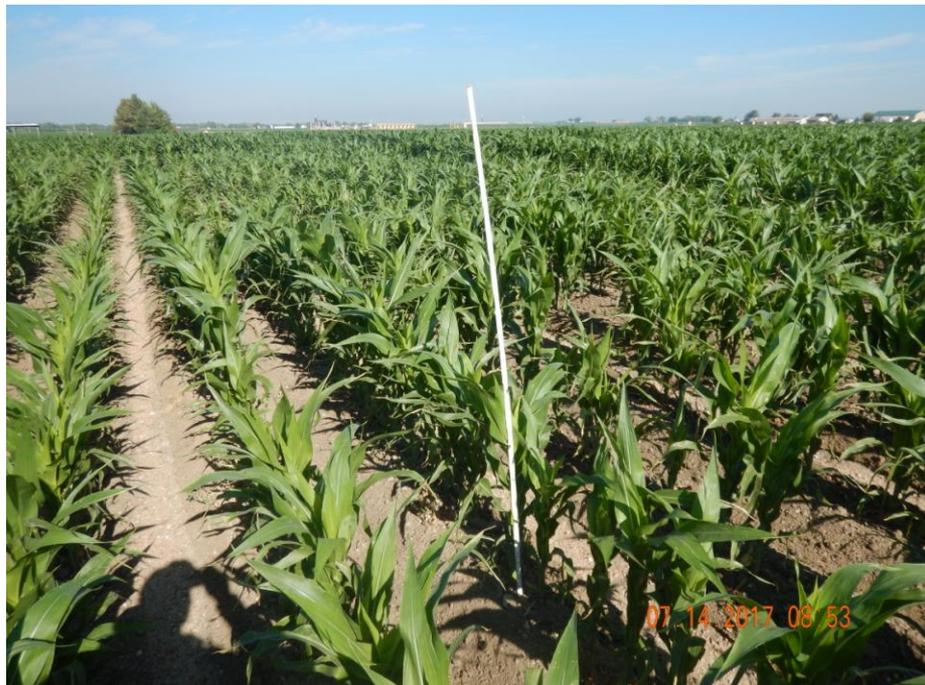
**Photo 2:** Photo taken from the well location, facing west. Photo shows crop (corn) vegetation growth over the well location is stunted when compared to the adjacent reference area. 6 foot measuring stick for reference. Crop height over the disturbance area ranges from 2.5 to 3 feet in height.

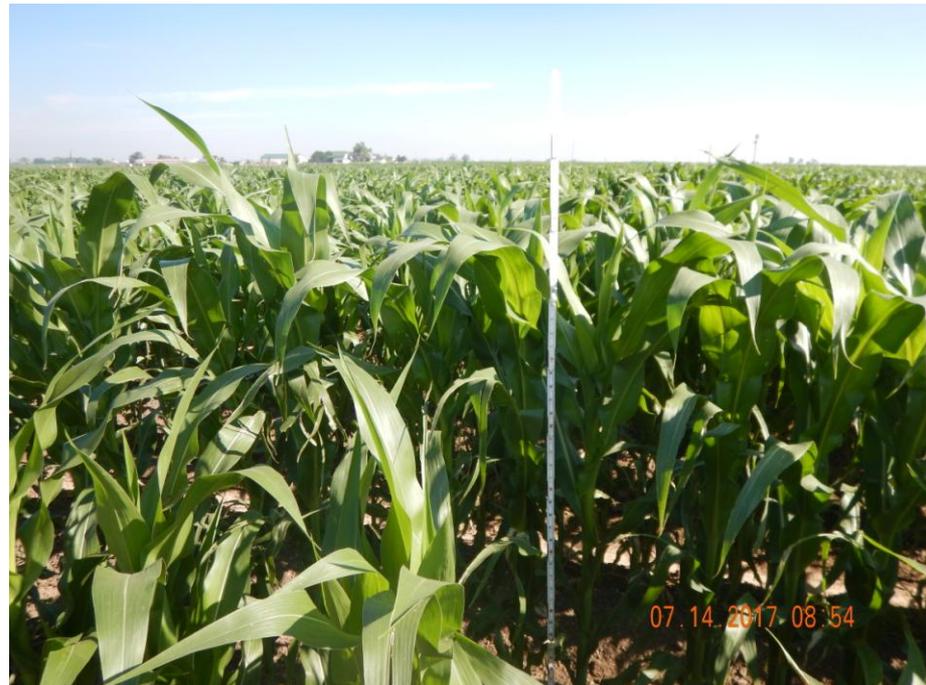
**Photo 3:** Photo taken from the adjacent reference area. Photo shows crop (corn) vegetation growth over the adjacent reference area. 6 foot measuring stick for reference. Crop height over the adjacent reference area ranges from 4.5 to 5 feet in height

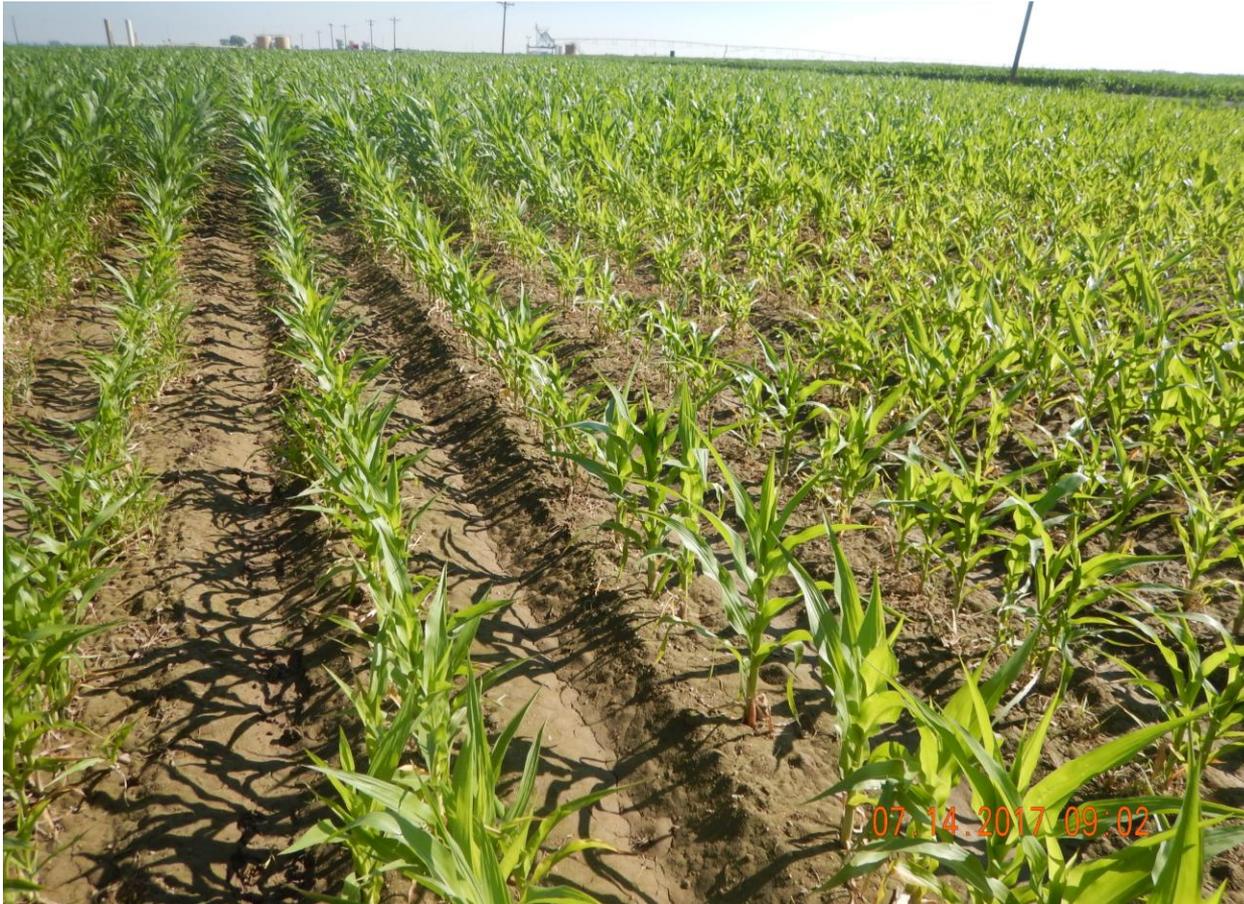
**Photo 1:** Photo taken from the battery location, facing north. Photo shows crop (corn) vegetation growth over the battery location is stunted when compared to the adjacent reference area.

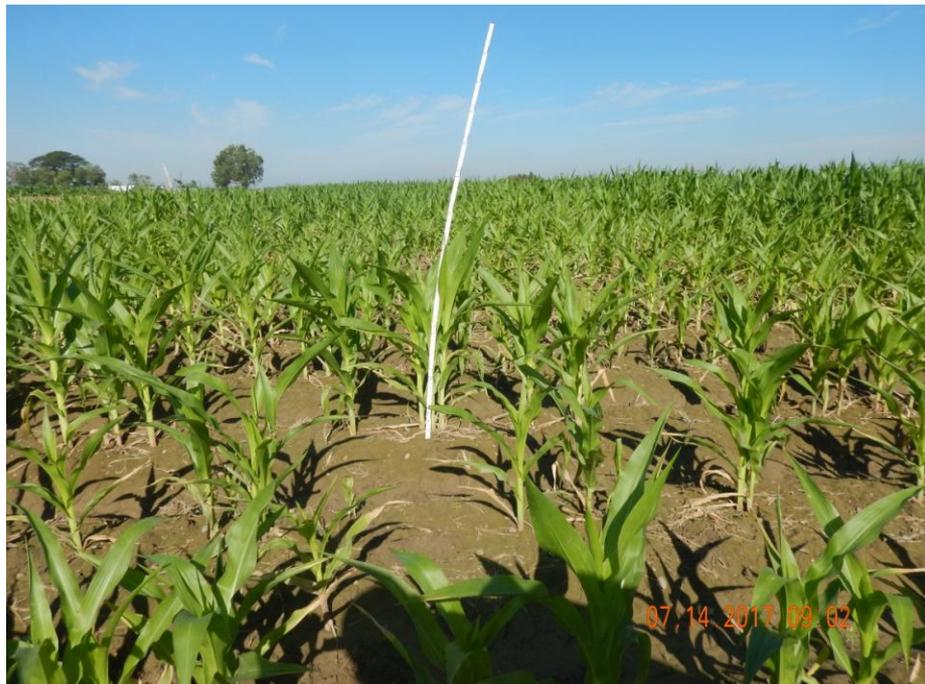
**Photo 5:** Photo taken from the battery location, facing west. Photo shows crop (corn) vegetation growth over the well location is stunted when compared to the adjacent reference area. 6 foot measuring stick for reference. Crop height over the disturbance area ranges from 1 to 2.5 feet in height.

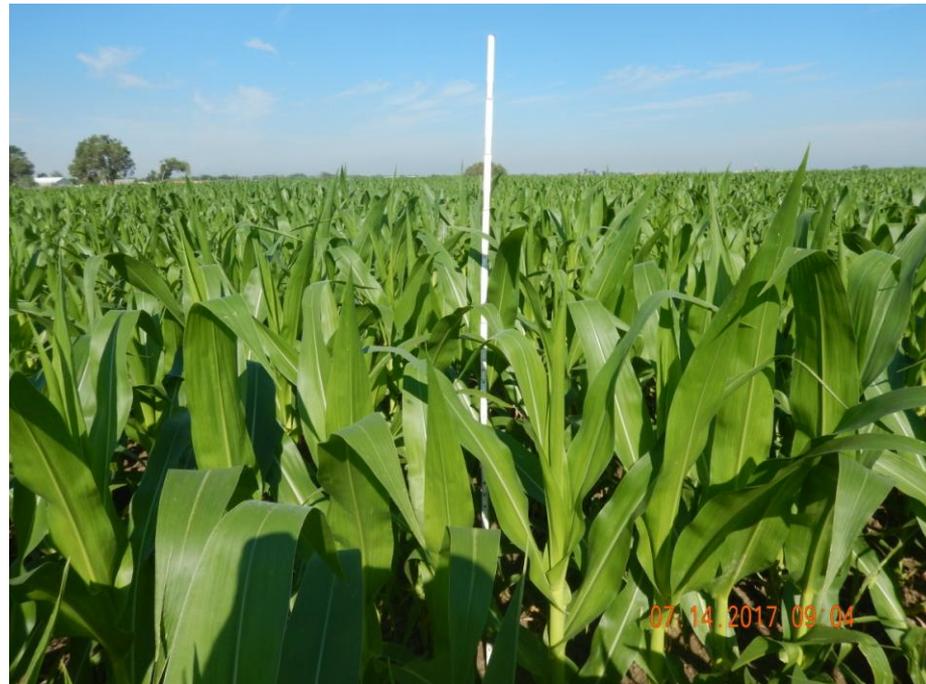
**Photo 6:** Photo taken from the adjacent reference area. Photo shows crop (corn) vegetation growth over the adjacent reference area. 6 foot measuring stick for reference. Crop height over the adjacent reference area ranges from 4.5 to 5 feet in height.
