Inspection Photos

Operator: PDC ENERGY INC - 69175

Location ID: 323307

Inspection Doc. Number: 682502451

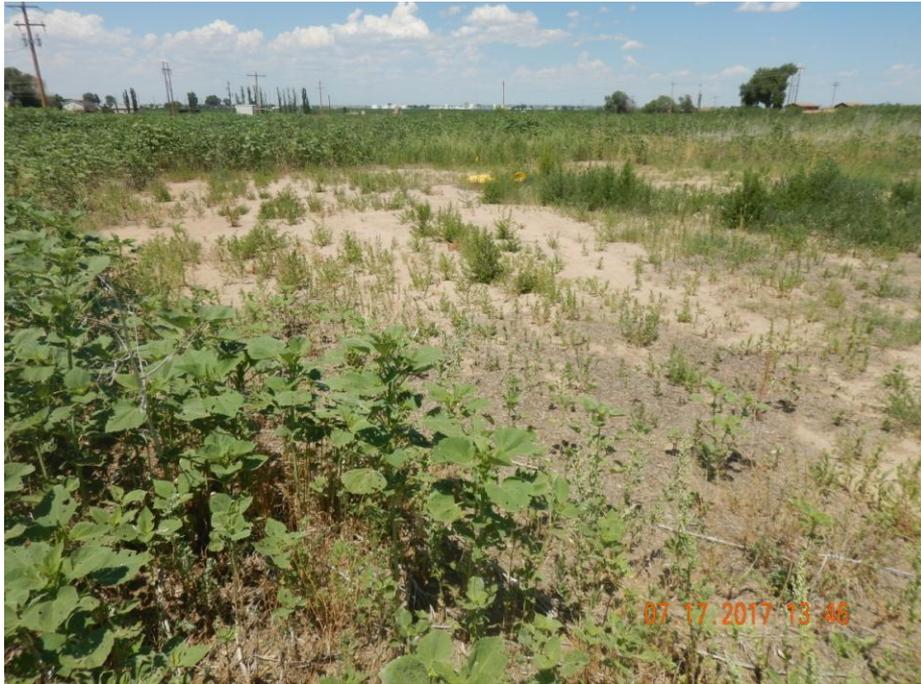
Photo 1: Photo taken from the south end of the location, facing north. Photo shows all equipment has been removed from the location. Photo also shows that location does not appear to be progressing towards reclamation standards; location is predominantly undesirable weedy plant species, or exposed soil with no sign of desirable perennial vegetative establishment.

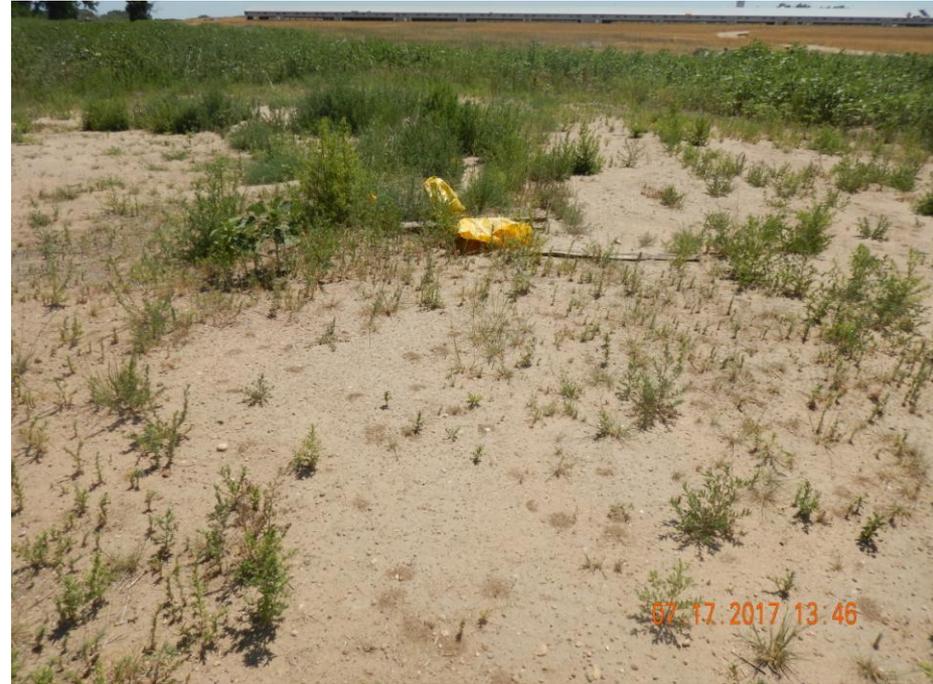
Photo 2: Photo taken from the north end of the location, facing south. Photo shows all equipment has been removed from the location. Photo also shows that location does not appear to be progressing towards reclamation standards; location is predominantly undesirable weedy plant species, or exposed soil with no sign of desirable perennial vegetative establishment.
