Flowline and Final Reclamation Inspection

July 17, 2017

Operator: NOBLE ENERGY INC - 100322

API: 05-123-11782

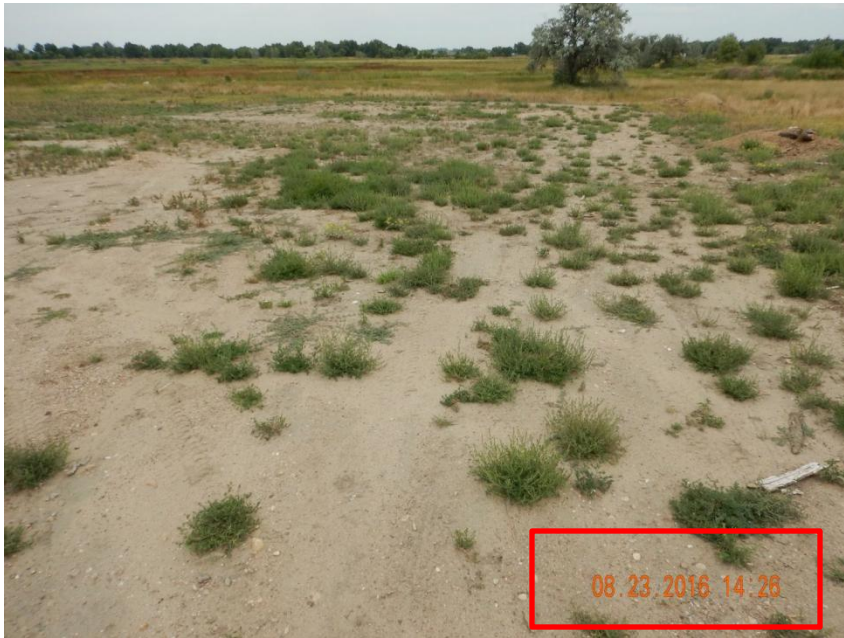
Photo 1. Photo taken 8/23/2016 from the entrance of the location, facing East. Previous inspection documented that large portions have no native, perennial vegetative growth and that weedy, annual plants were the majority of the vegetative growth.

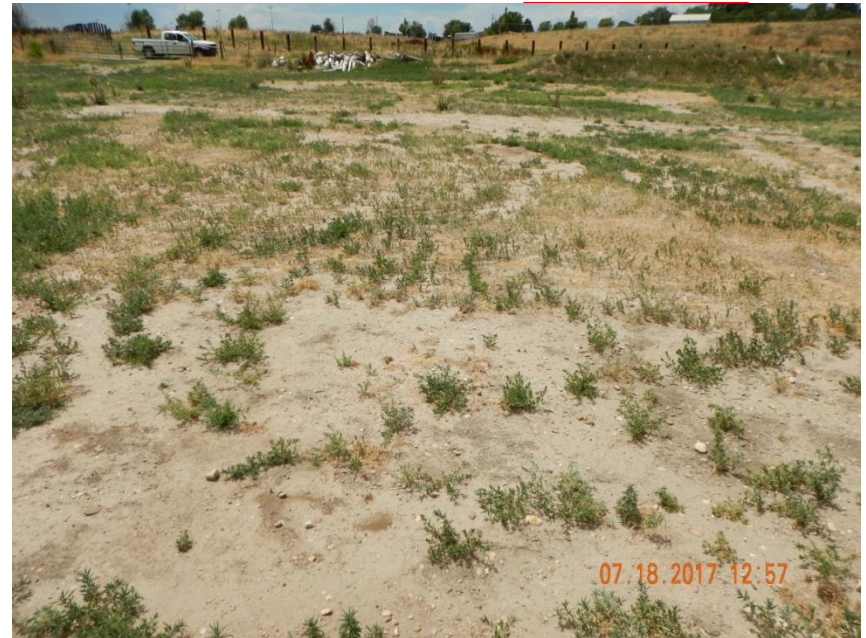
Photo 2. Photo taken from the eastern location, facing West. Appears the location is in the same vegetative condition, approximately one year later. Bare ground with little to no perennial vegetative growth that is reflective of reference areas.

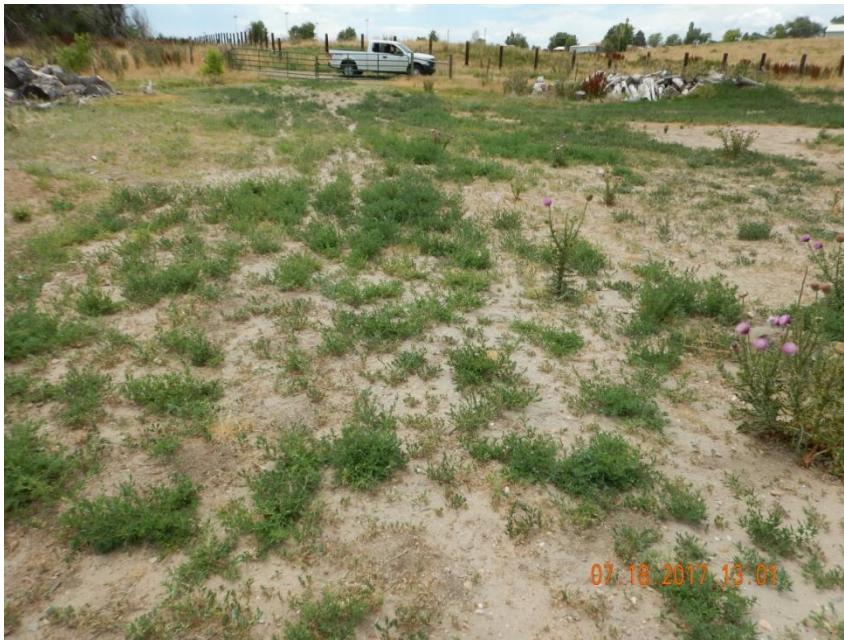
Photo 3. Photo taken from the southern location, facing West. Appears the location is in the same vegetative condition, approximately one year later. Bare ground with little to no perennial vegetative growth that is reflective of reference areas. List B CO Noxious weed, Musk thistle, observed flowering at the location.

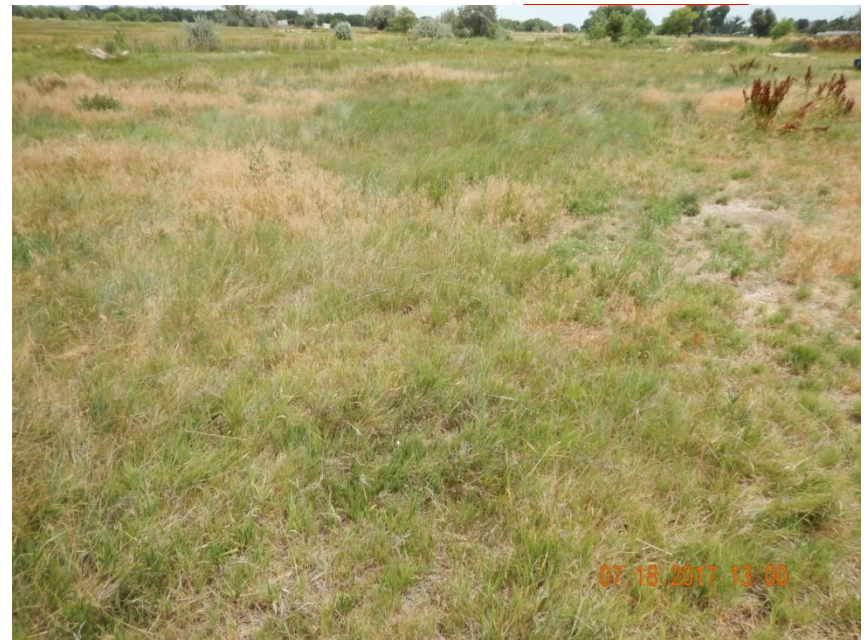
Photo 4. Reference photo taken north of the location, illustrating native, perennial vegetative growth.
