Flowline and Final Reclamation Inspection

July 17, 2017

Operator: NOBLE ENERGY INC - 100322

API: 05-123-18601

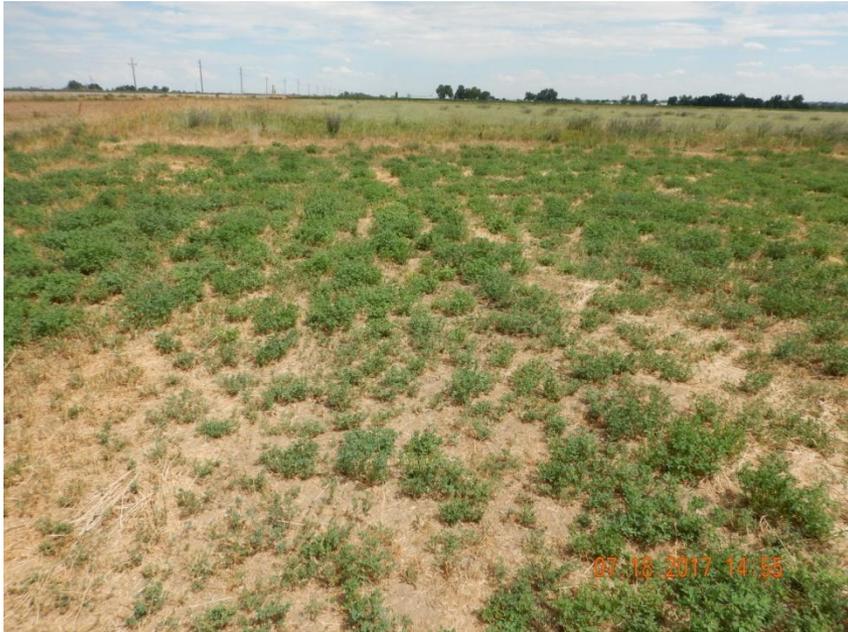
Photo 1. Photo taken from the approximate well location, facing East. Well location appears to be reflective of vegetative reference levels.

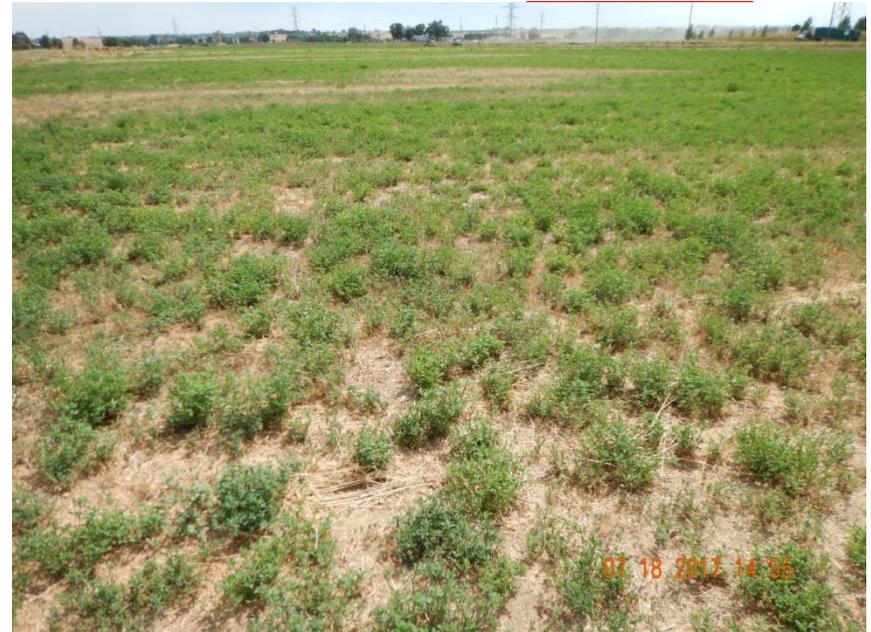
Photo 2. Reference photo taken south location, facing South.

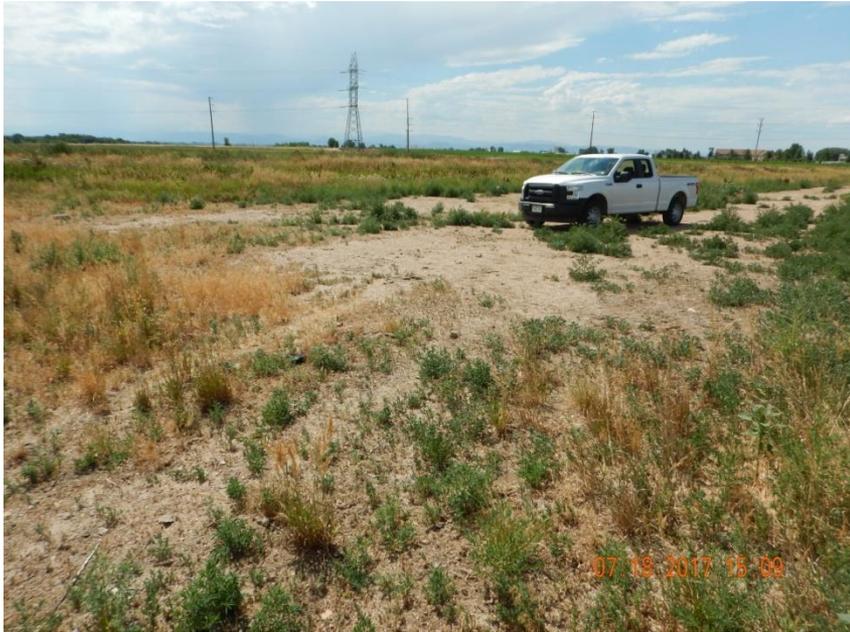
Photo 3. Photo taken from the battery location, facing West. Disturbance evident due to bare ground, gravel remains and weedy, annual vegetation not reflective of reference crop vegetative levels. The battery location has not been reclaimed per Rule 1004.

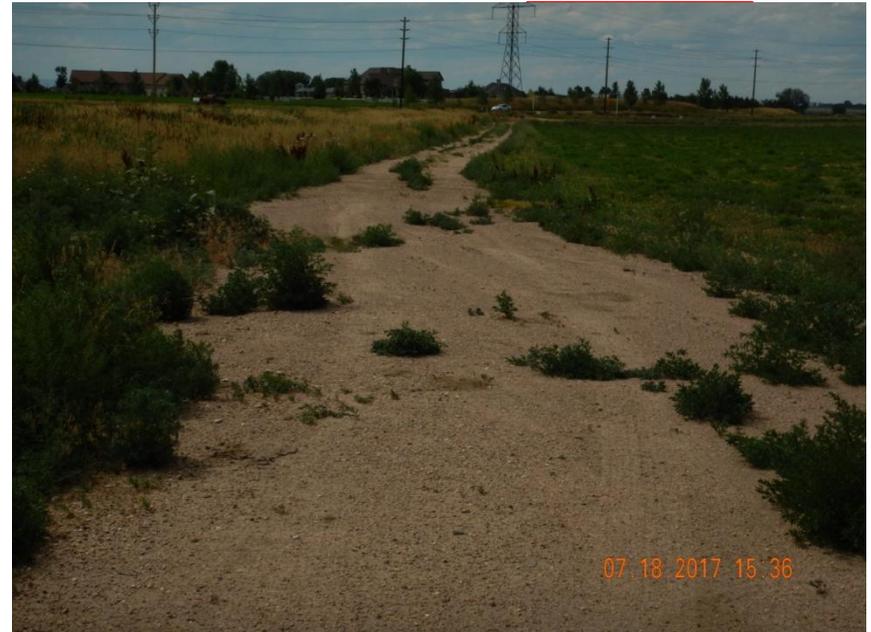
Photo 4. Photo taken from the battery location, facing West along the access road. The access road has not been reclaimed per Rule 1004.
