Inspection Photos

Operator: PETRO-CANADA RESOURCES (USA) INC -
72085

Location ID: 311680

Inspection Doc. Number: 675103761

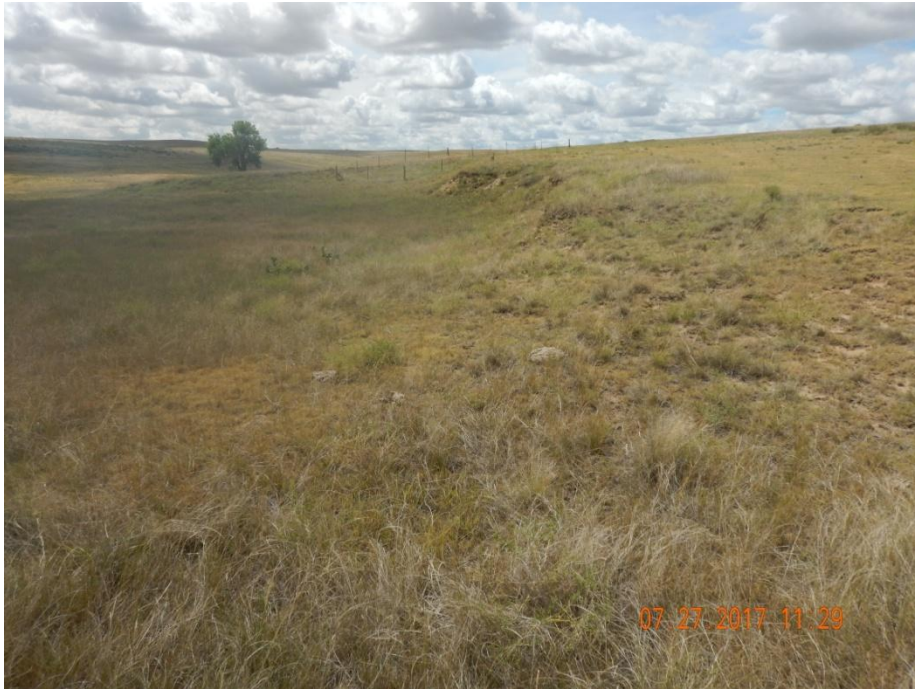
Photo 1: Photo taken from the northwest corner of the location, facing southeast. Photo shows erosion on cut bank. Photo shows location has not been re-contoured per CA's

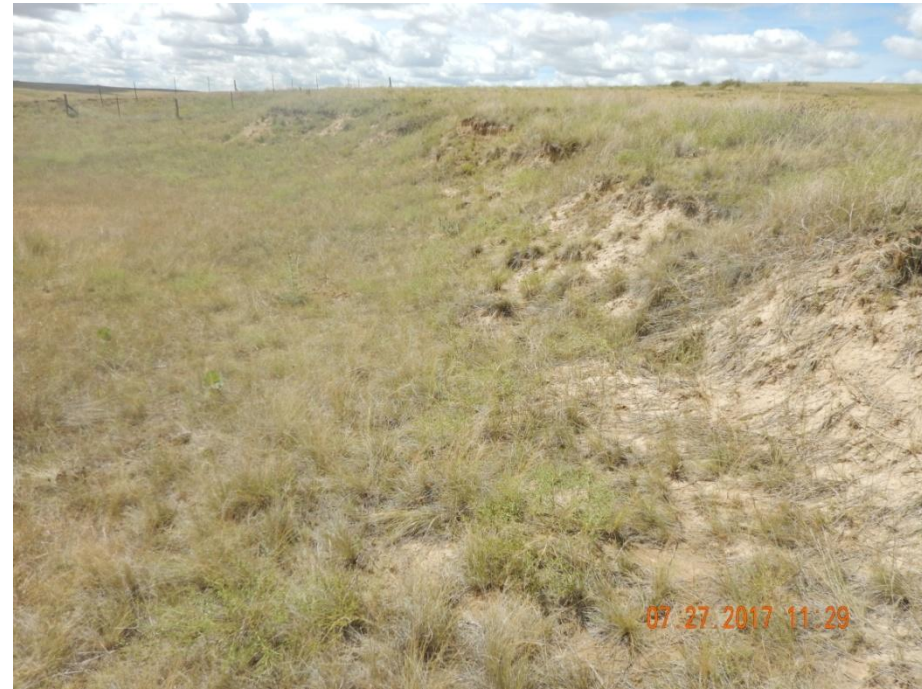
Photo 2: Photo taken from the west end of the location, facing southeast. Photo shows erosion on cut bank. Photo shows location has not been re-contoured per CA's

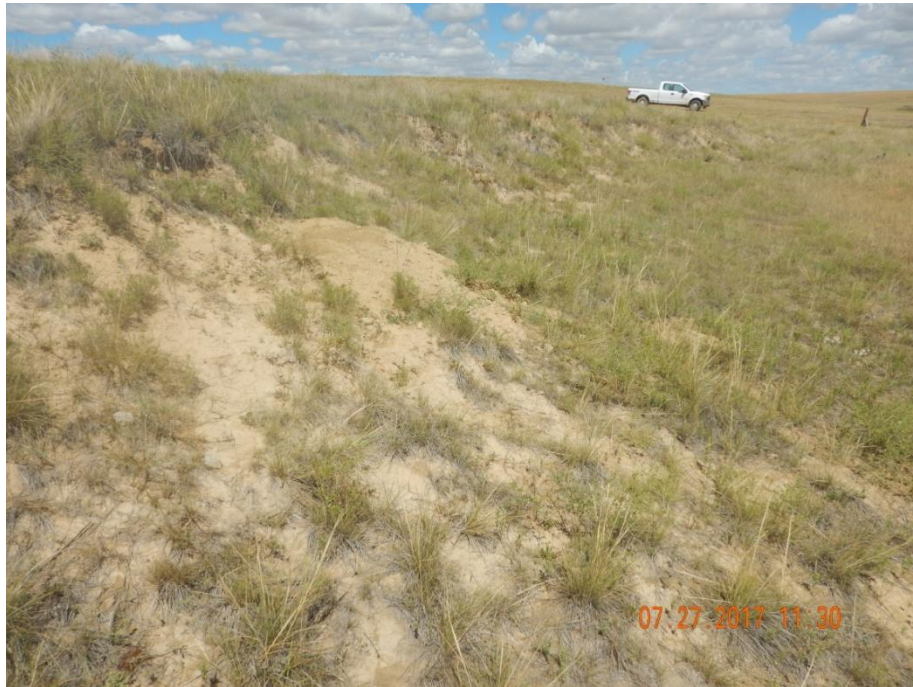
Photo 3: Photo taken from the southwest corner of the location, facing northwest. Photo shows erosion on cut bank. Photo shows location has not been re-contoured per CA's

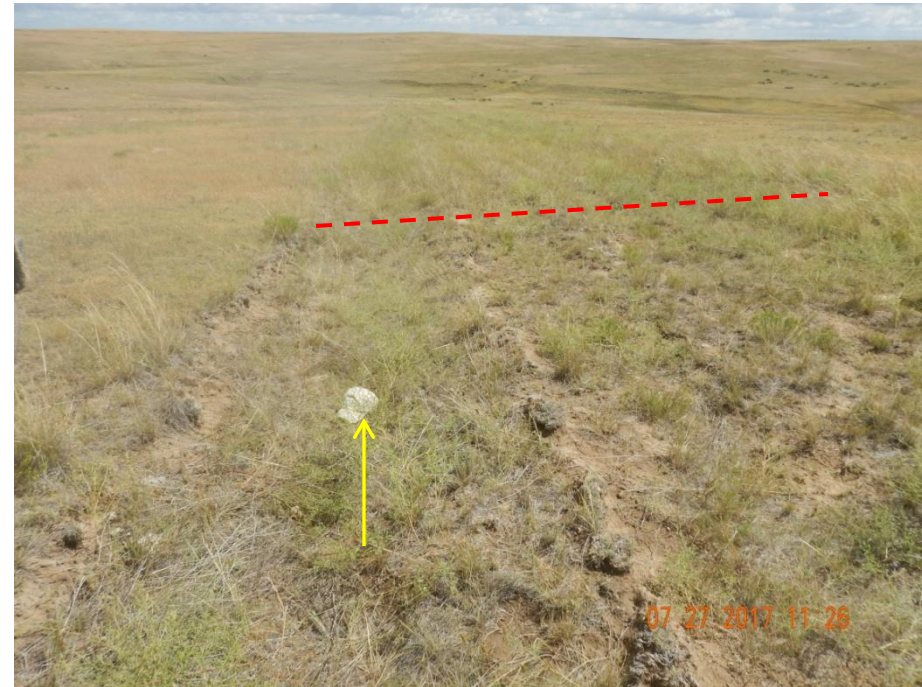
Photo 4: Photo taken from access road southeast of the location, facing north. Photo shows access road had not been re-contoured or re-graded as required per CA's. Hat (indicated by yellow arrow) used for reference. Red line indicates width of road.

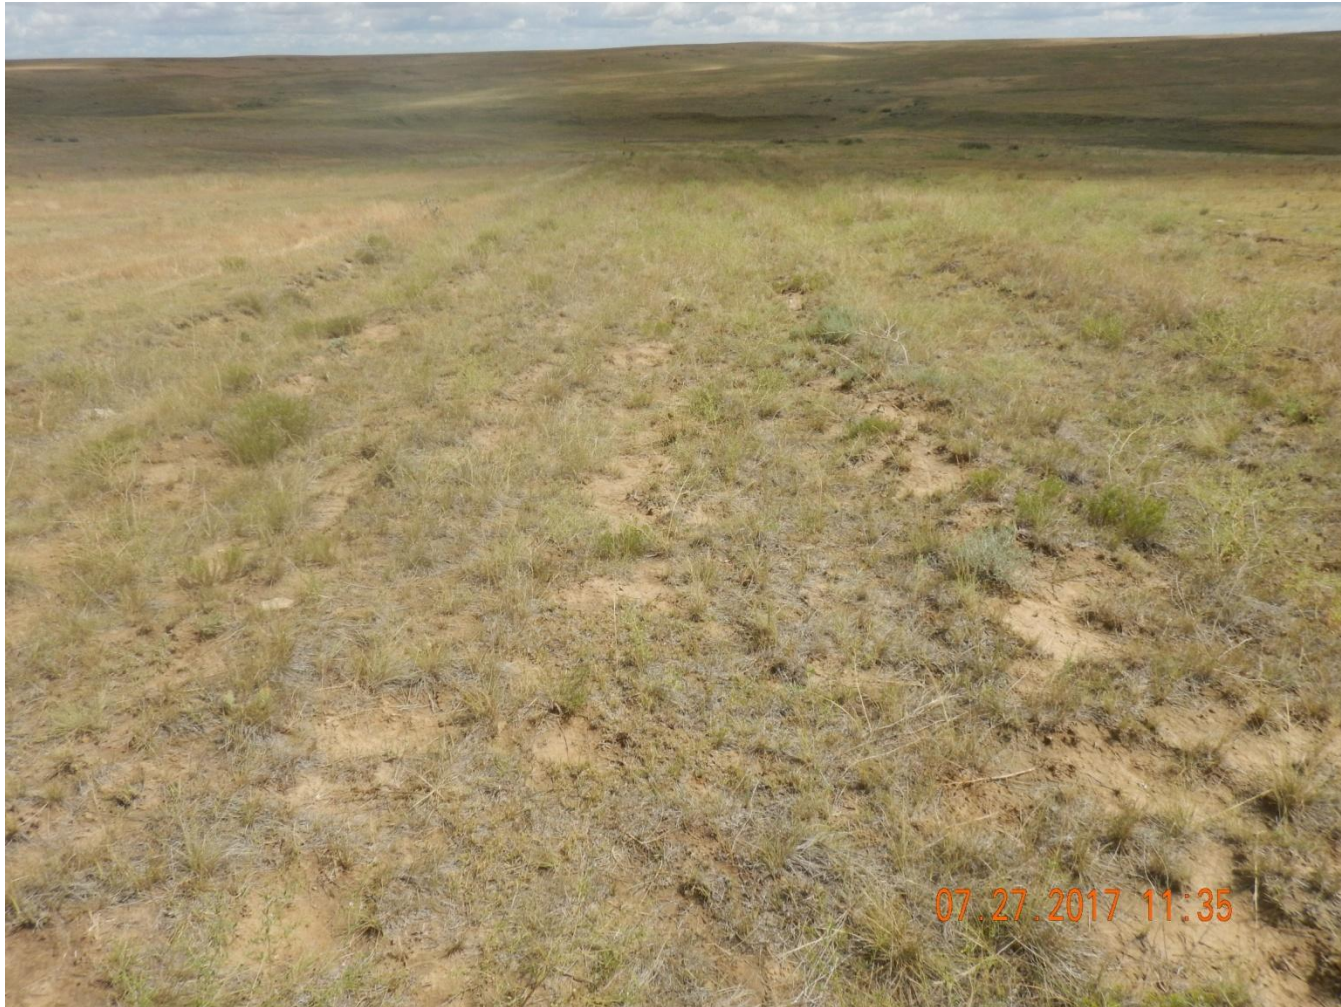
Photo 5: Photo taken from access road southeast of the location, facing north. Photo shows access road had not been re-contoured or re-graded as required per CA's.
