# Inspection Photos

Operator: WESTERN OPERATING COMPANY - 95620

Location ID: 319767

Inspection Doc. Number: 675103769

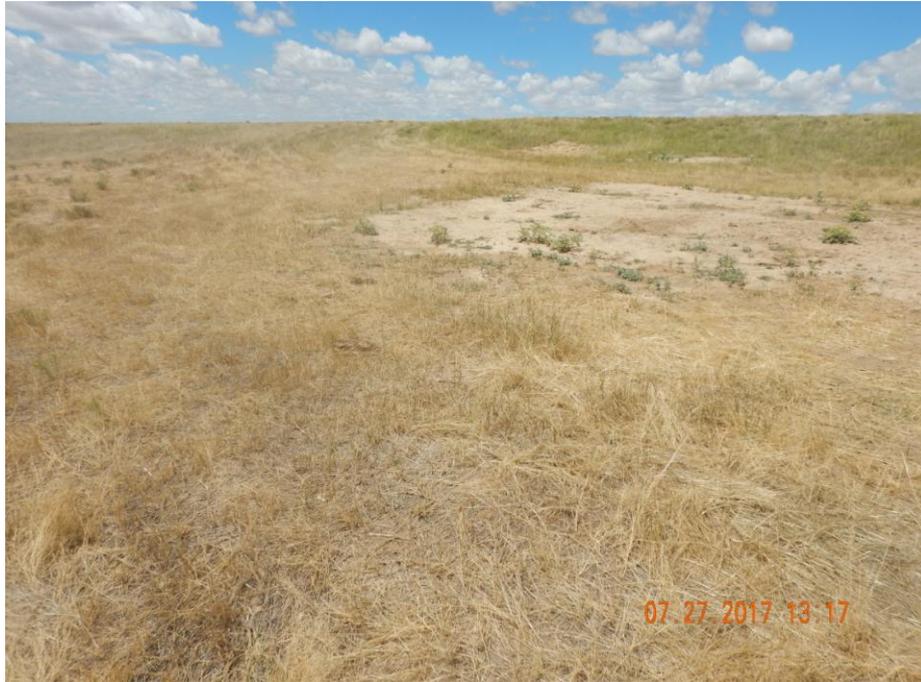
**Photo 1:** Photo taken from the south end of the well location, facing northwest. Photo shows well and equipment has been removed. Location still appears to require compaction alleviation, re-contouring, re-grading and re-vegetating.

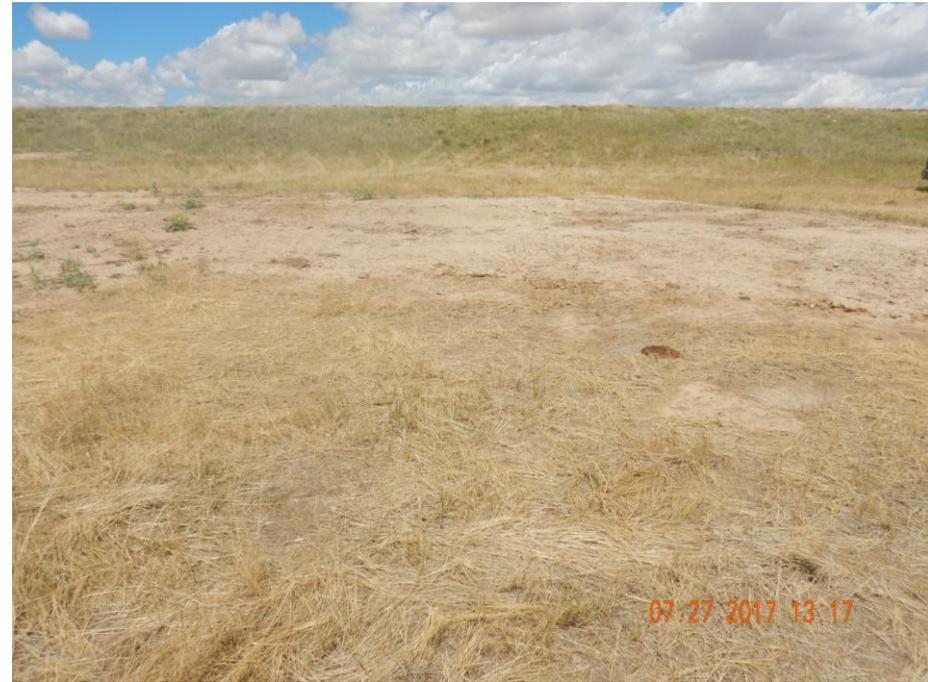
**Photo 2:** Photo taken from the south end of the well location, facing north. Photo shows well and equipment has been removed. Location still appears to require compaction alleviation, re-contouring, re-grading and re-vegetating.

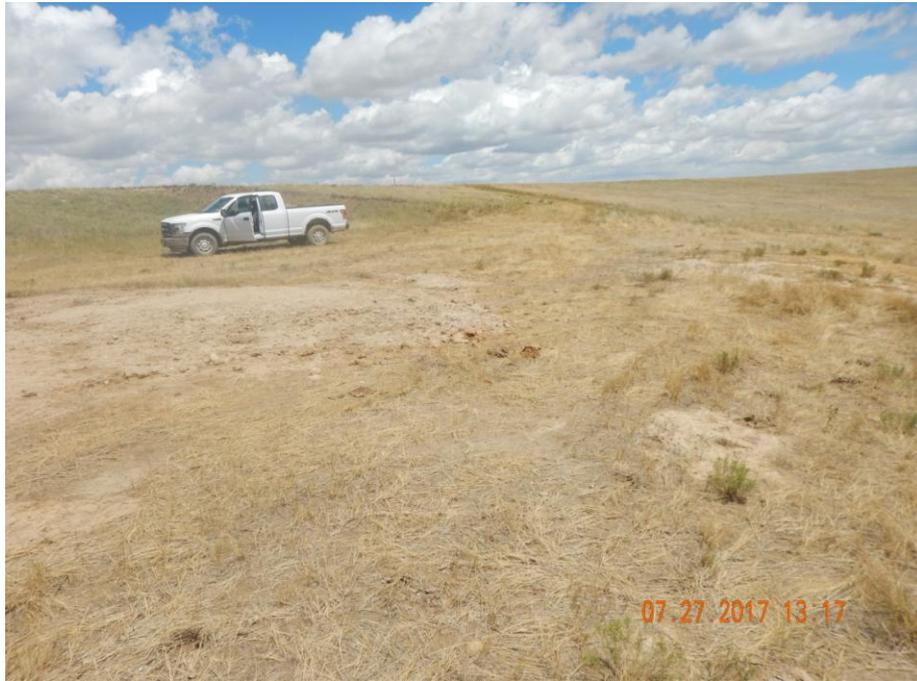
**Photo 3:** Photo taken from the south end of the well location, facing northeast. Photo shows well and equipment has been removed. Location still appears to require compaction alleviation, re-contouring, re-grading and re-vegetating.

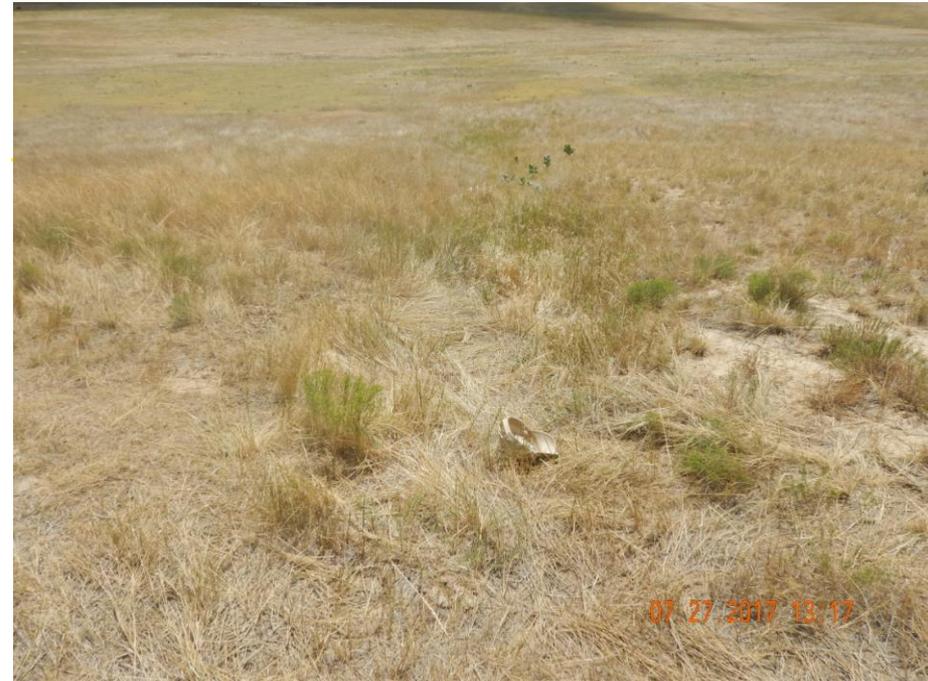
**Photo 4:** Photo taken well location facing south. Photo shows area of the down slope portion of the well location where erosion is evident. This should be repaired during the re-contouring of the location.

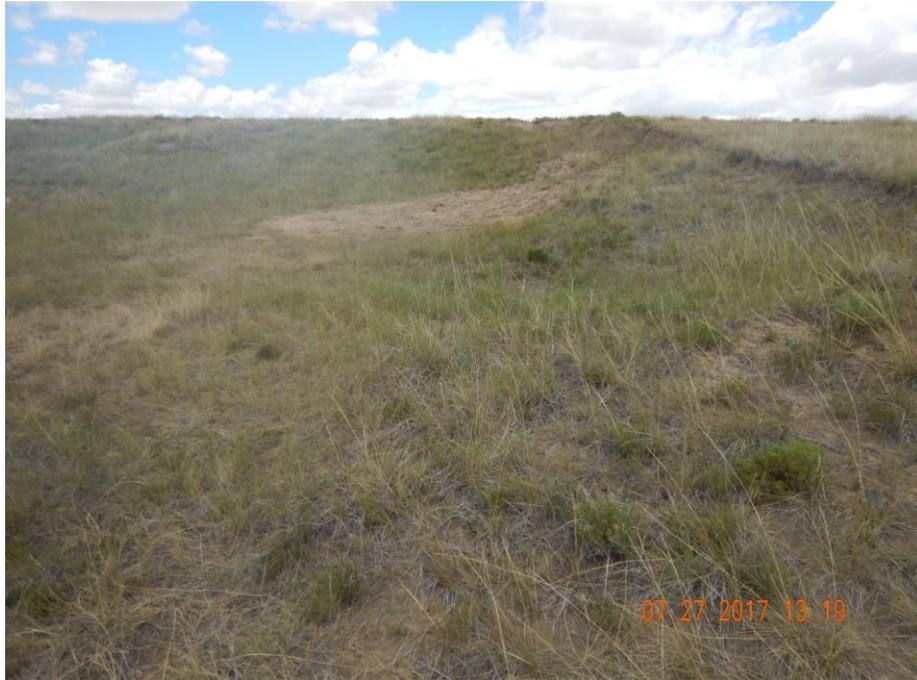
**Photo 5:** Photo taken from the northeast end of the well location, facing north. Photo shows location still appears to require re-contouring and re-grading.

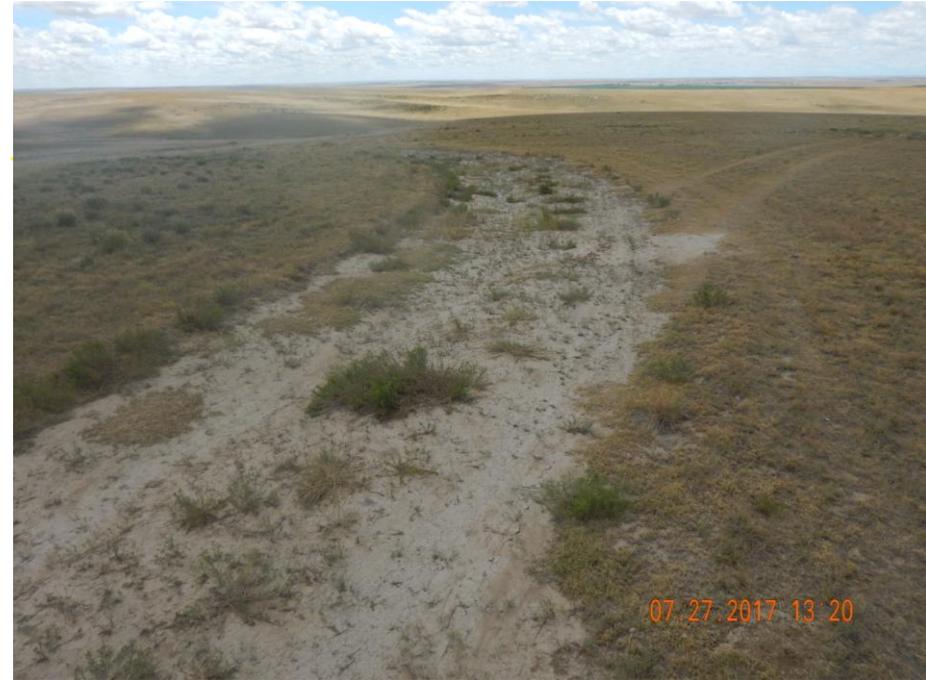
**Photo 6:** Photo taken from the access road on the northwest end of the well location. Photo shows access road still requires compaction alleviation, re-contouring, re-grading and re-vegetating

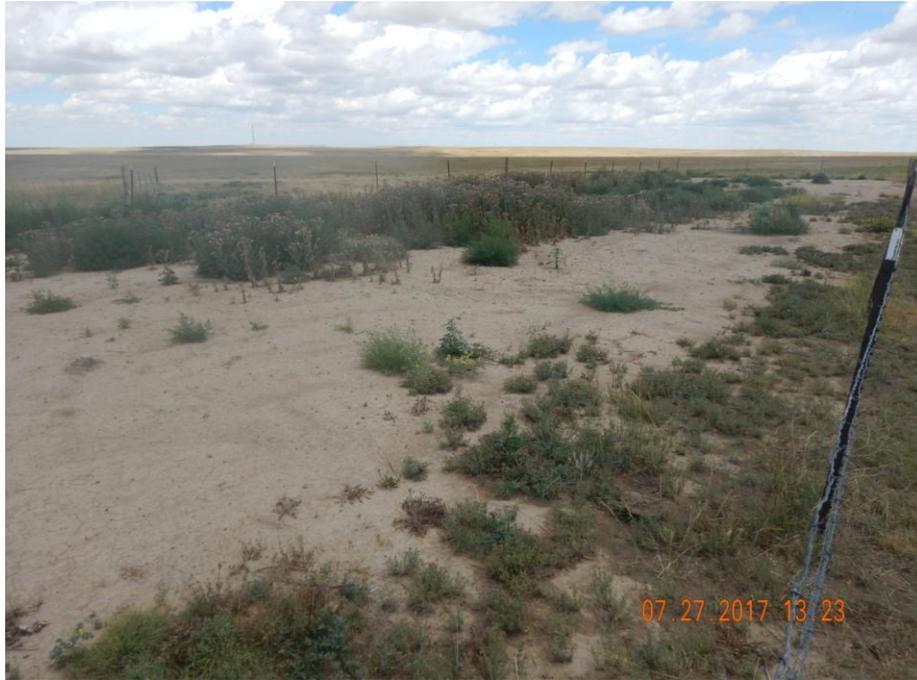
**Photo 7:** Photo taken from southwest corner of the battery location. Photo shows facilities have been removed. Location appears to still require compaction alleviation and revegetation.

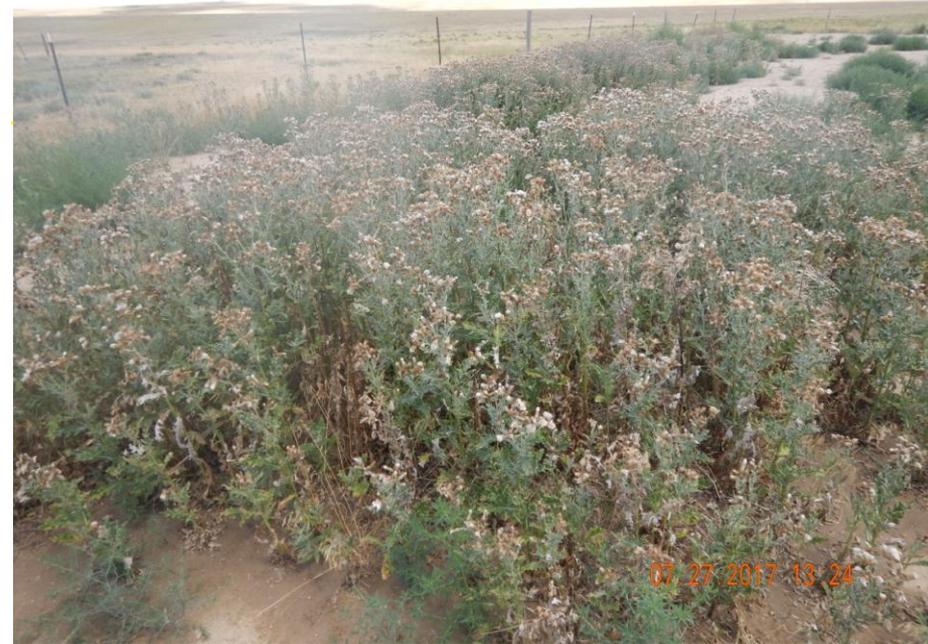
**Photo 8:** Photo taken from the battery location. Photo shows Canada thistle has established in the battery location. This is a Colorado State listed noxious weed and needs to be managed and removed.
