Stormwater Inspection

August 11, 2017

Operator: K P KAUFFMAN COMPANY INC - 46290

Location ID: 320780

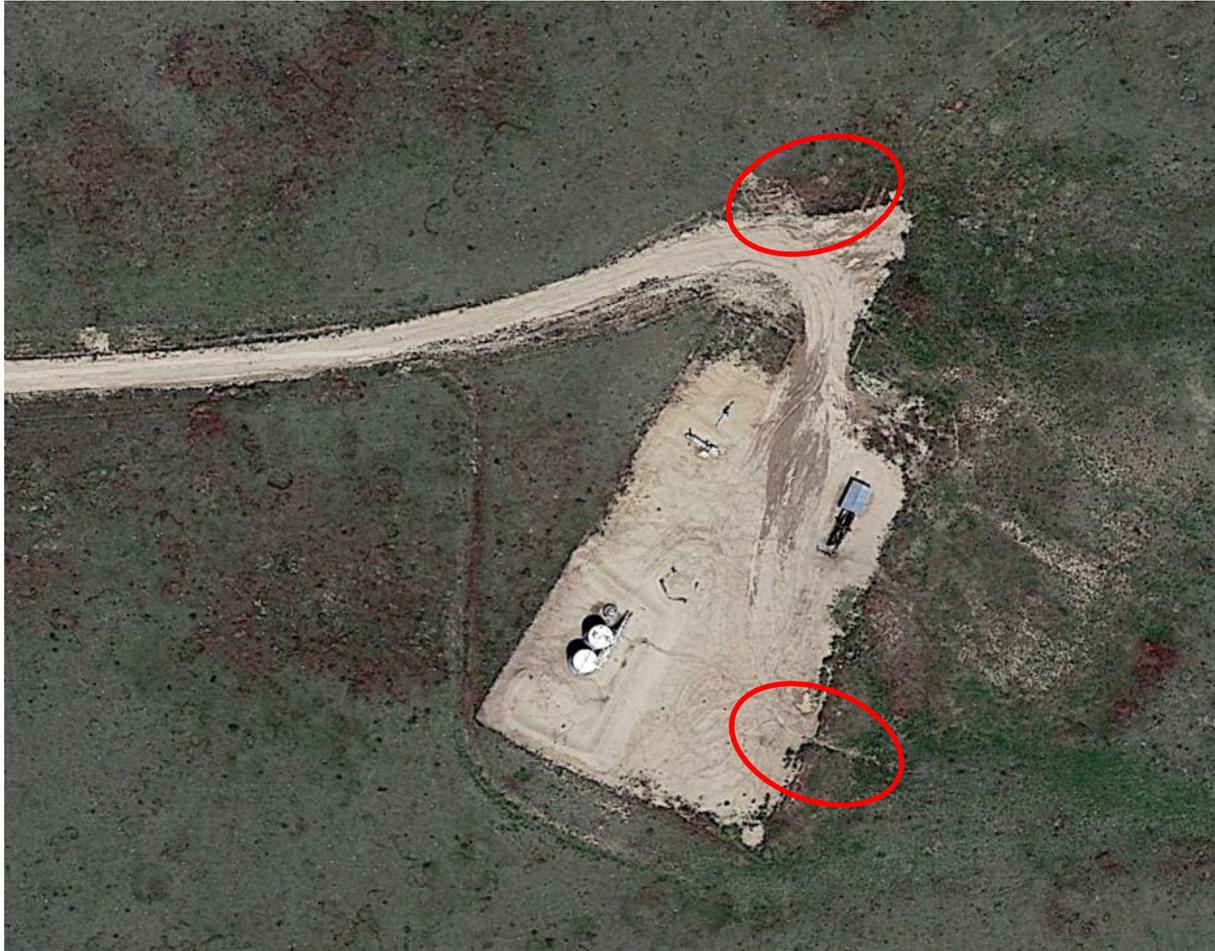
Google Earth aerial imagery taken 6/14/2016 illustrating well location during operations. Two points of discharge were observed along a portion of the access road and along the southeastern well location (highlighted in the red circles). Also, List B Colorado Noxious weeds were observed throughout the main access road and well location.

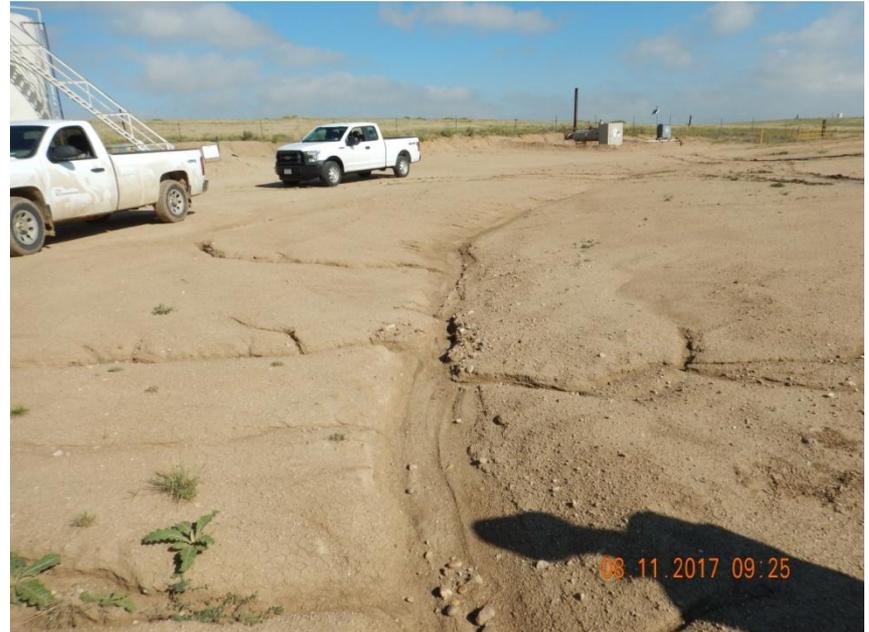
Photo 2. Photo taken from the southeastern well location, facing Northwest. Rill/gully erosion throughout the location that is causing sediment discharge off location.

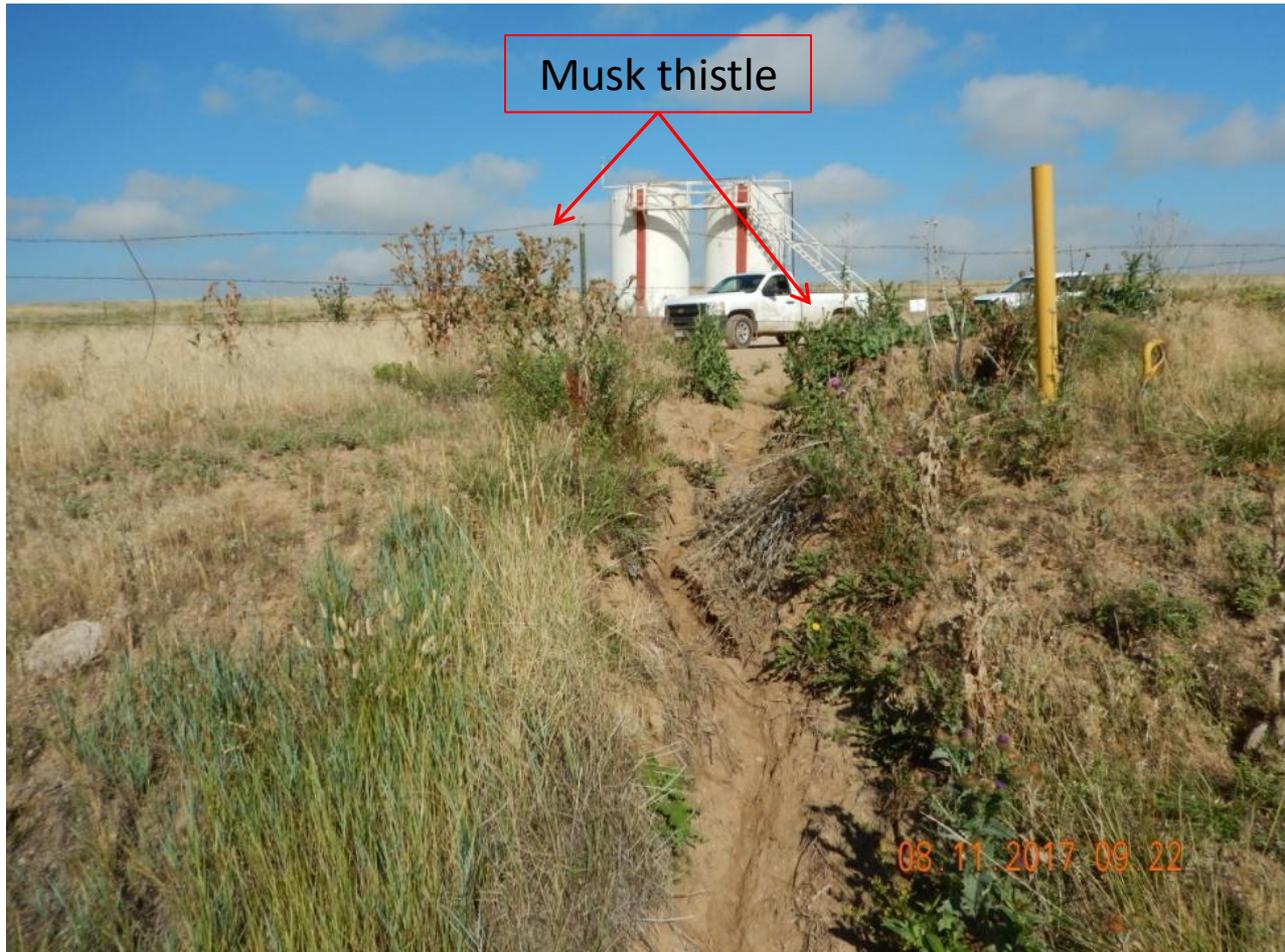
Photo 3. Photo taken from the discharge point, facing West. Gully erosion occurring this is causing sediment discharge off location. Also, a List B Colorado Noxious weed, Musk thistle, shown in this photo and was observed throughout the well location and access road.

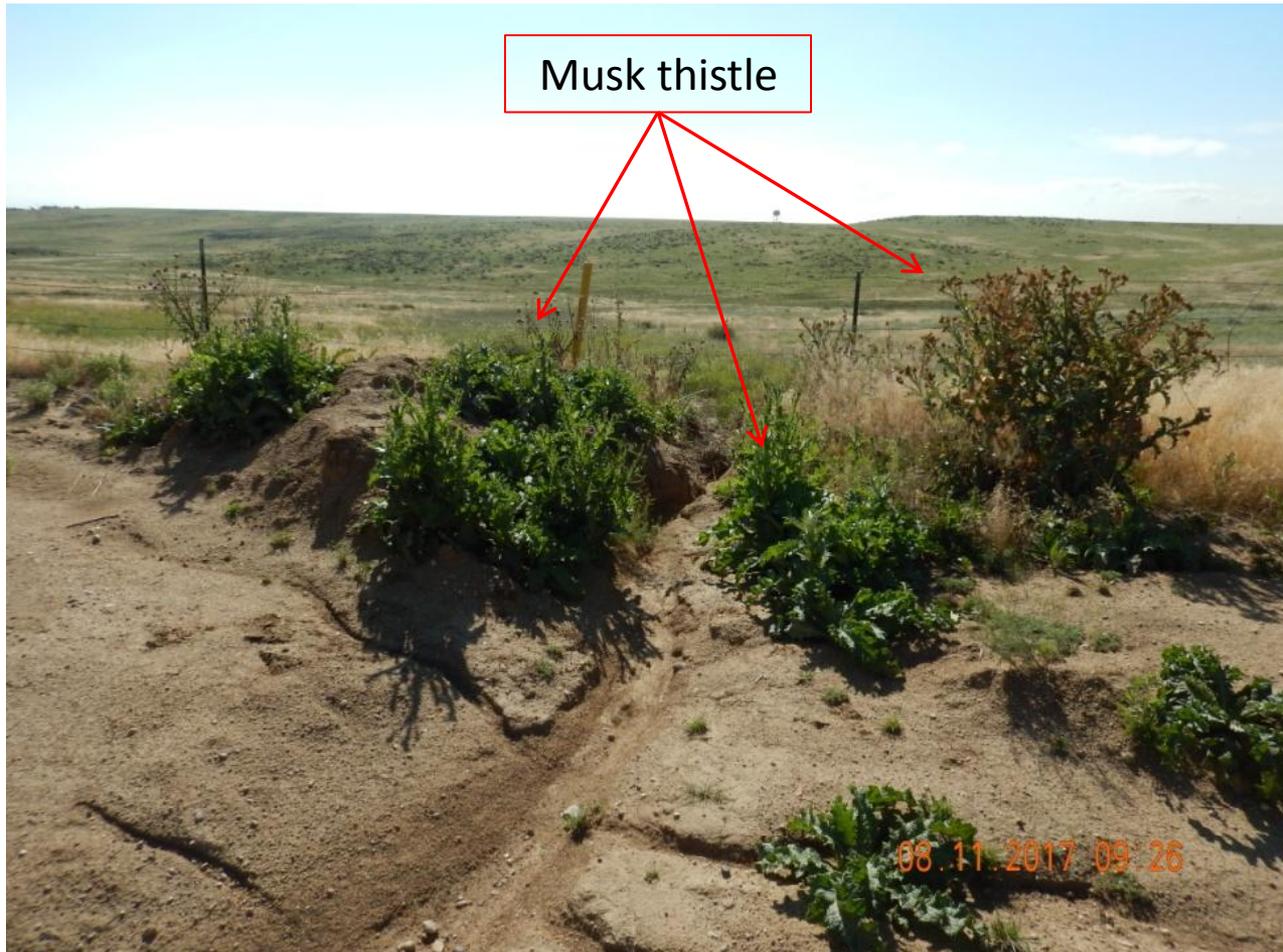
Photo 4. Photo taken from the discharge point, facing East. Gully erosion occurring this is causing sediment discharge off location. Also, a List B Colorado Noxious weed, Musk thistle, shown in this photo and was observed throughout the well location and access road.

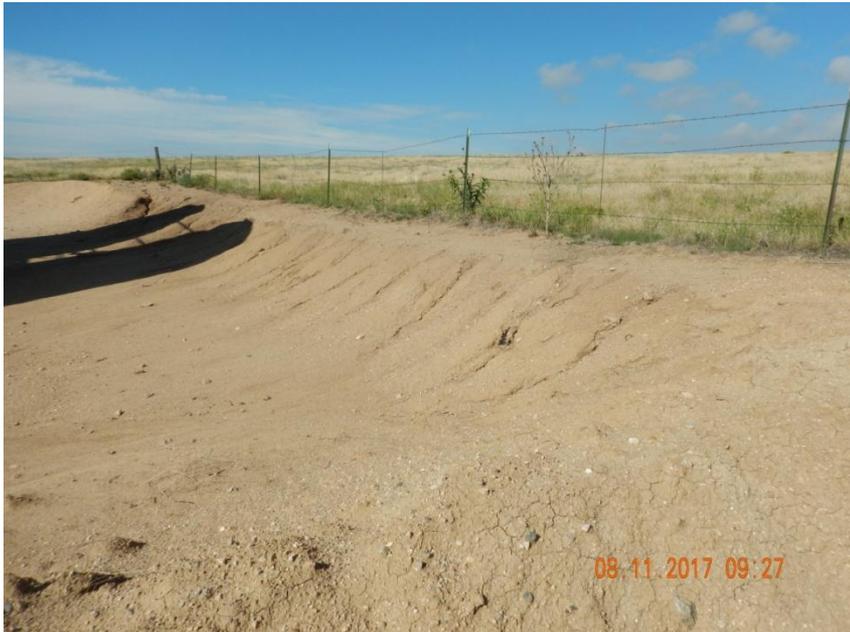
Photo 5. Photo taken from the western location, facing Southwest. Rill erosion occurring throughout the cut slope contributing to sediment discharge off location. Cut slope needs to be stabilized to prevent erosion and stabilize the production area.

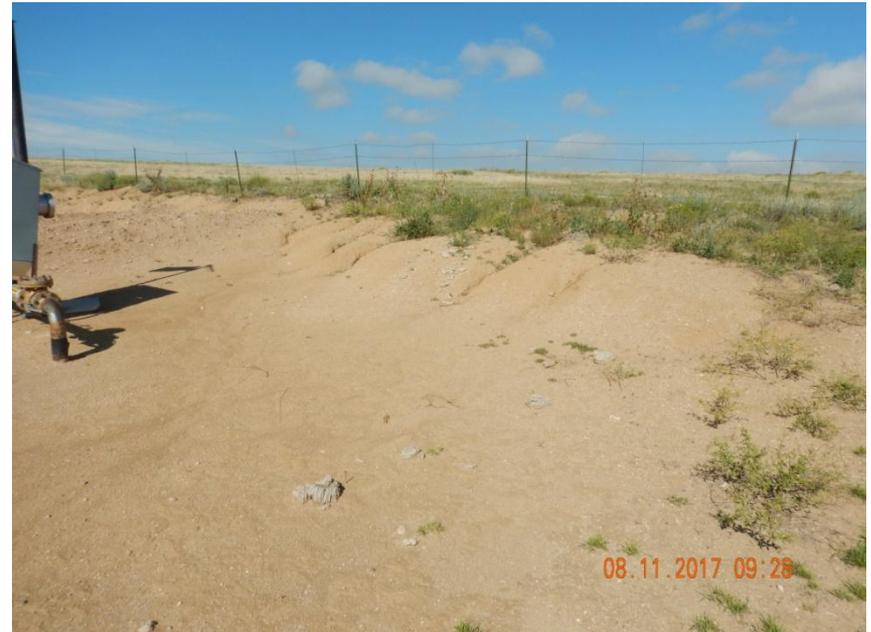
Photo 6. Photo taken from the northwestern location, facing Southwest. Rill erosion occurring throughout the cut slope contributing to sediment discharge off location. Cut slope needs to be stabilized to prevent erosion and stabilize the production area.

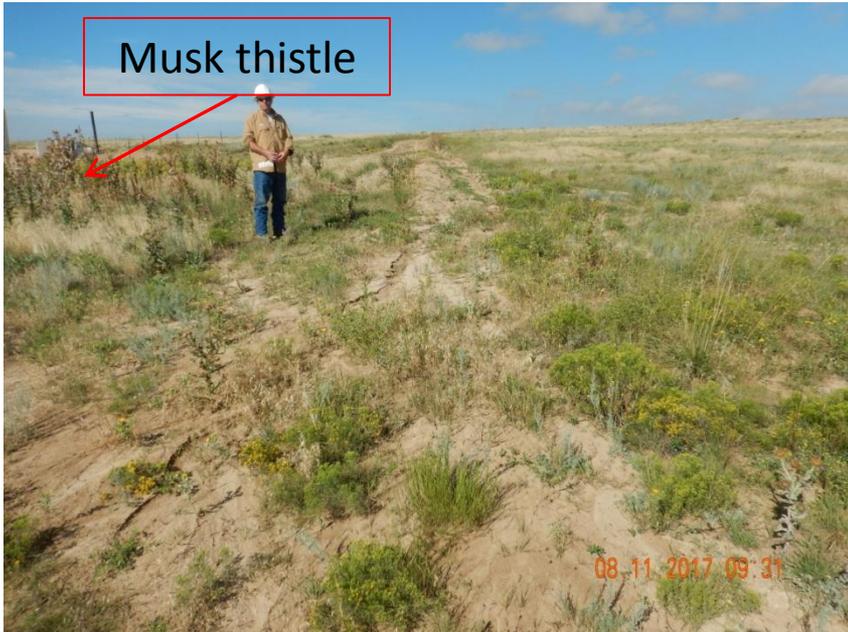
Photo 7. Photo taken from the second discharge point off the main access road, facing West. Photo illustrates rill erosion and sediment deposition.

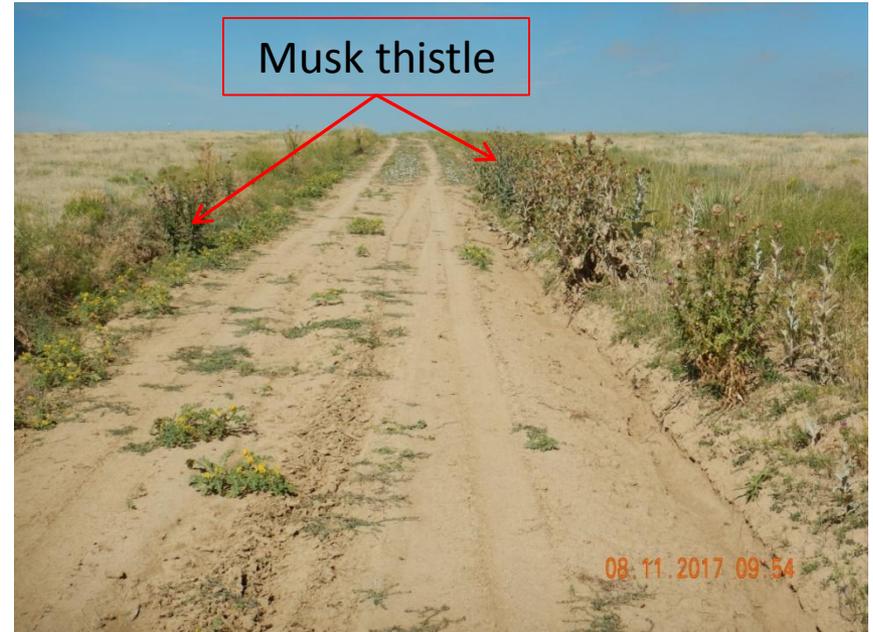
Photo 8. Photo taken from a portion of the main access road, facing West. List B Colorado Noxious weeds, Musk thistle and Canada thistle, were observed throughout the main access road.
