Stormwater Inspection

August 11, 2017

Operator: RENEGADE OIL & GAS COMPANY LLC- #74165

Inspection Photos
Location Name: Smith/Halverson Tank Battery
Location ID: 319860

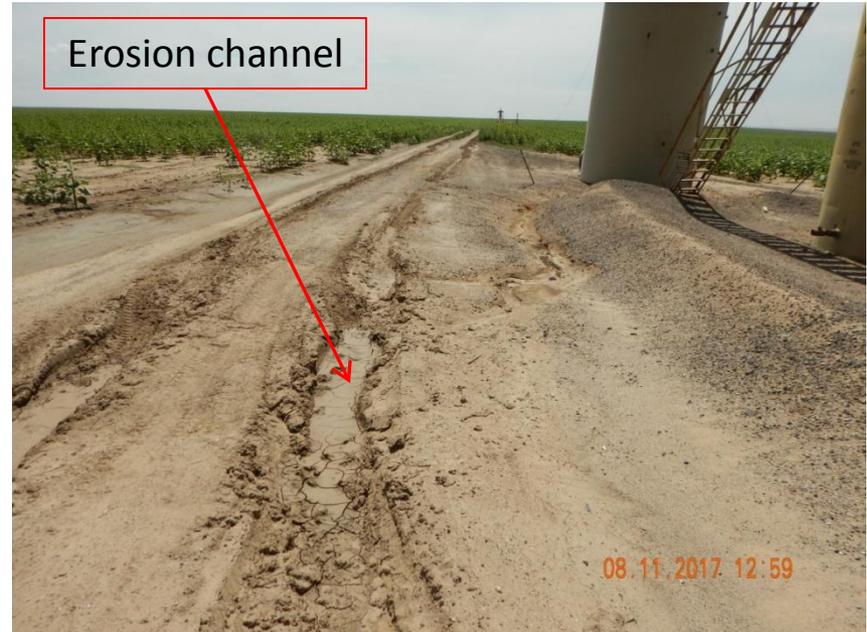
Photo 2. Photo taken from the entrance of the tank battery location, facing South. Stormwater erosion evident as an erosion channel funnels around the northern battery location and continues off location into the adjacent cropland.

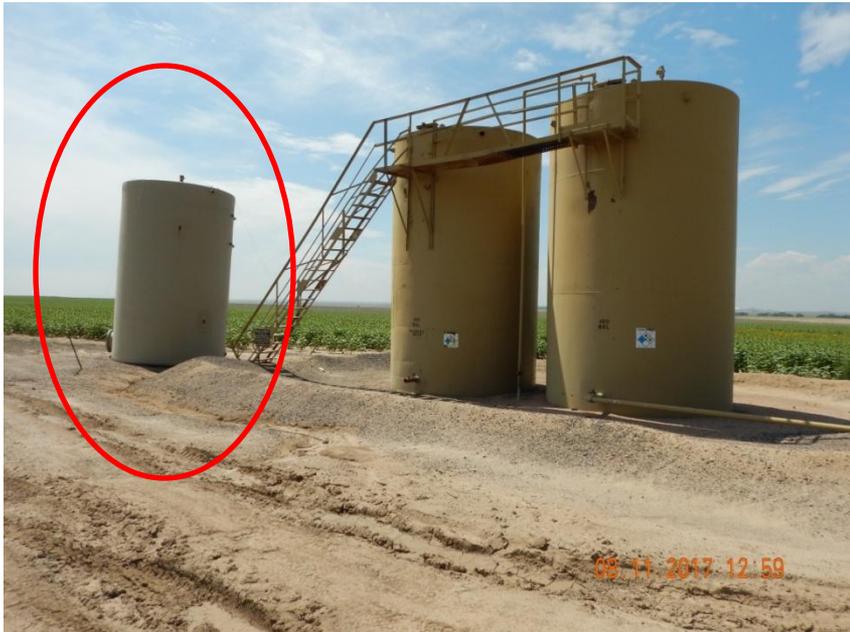
Photo 3. Photo of the tank battery location, facing Southwest. Appears an unused tank is being stored at location and needs to be removed within 90 days of this inspection.

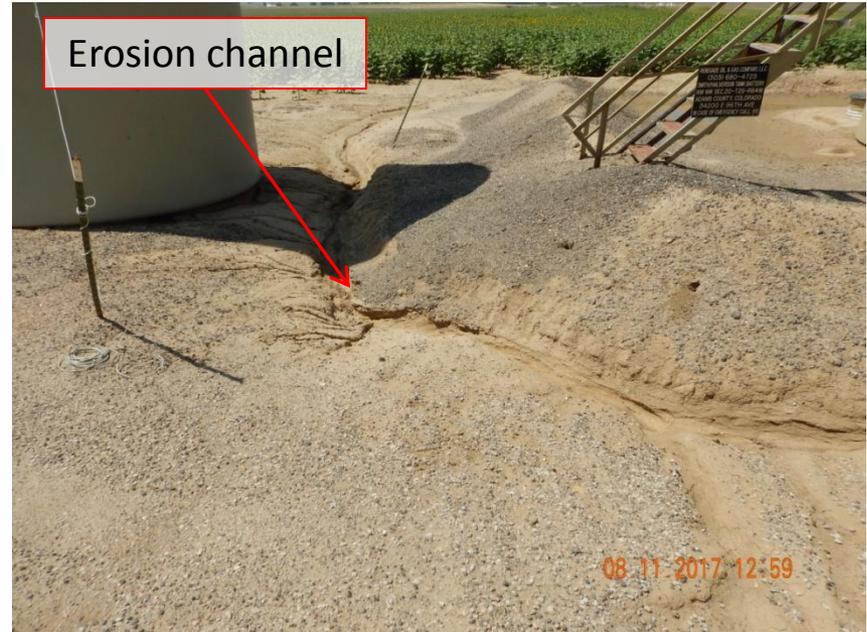
Photo 4. Photo taken from the eastern tank battery location, facing West. Gully erosion forming at location that is contributing to sediment discharge off location.

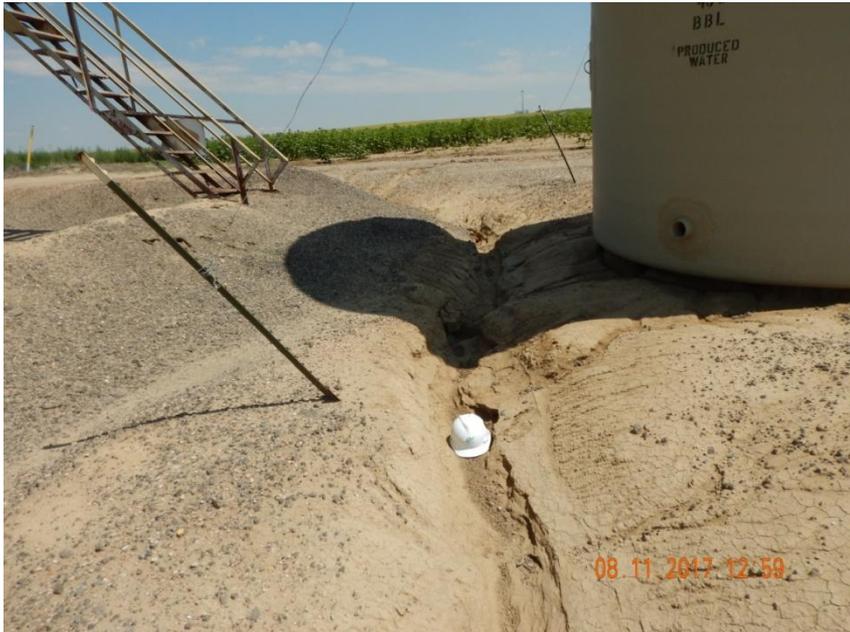
Photo 5. Photo taken from the western tank battery location, facing East. Gully erosion forming at location this is contributing to sediment discharge off location.

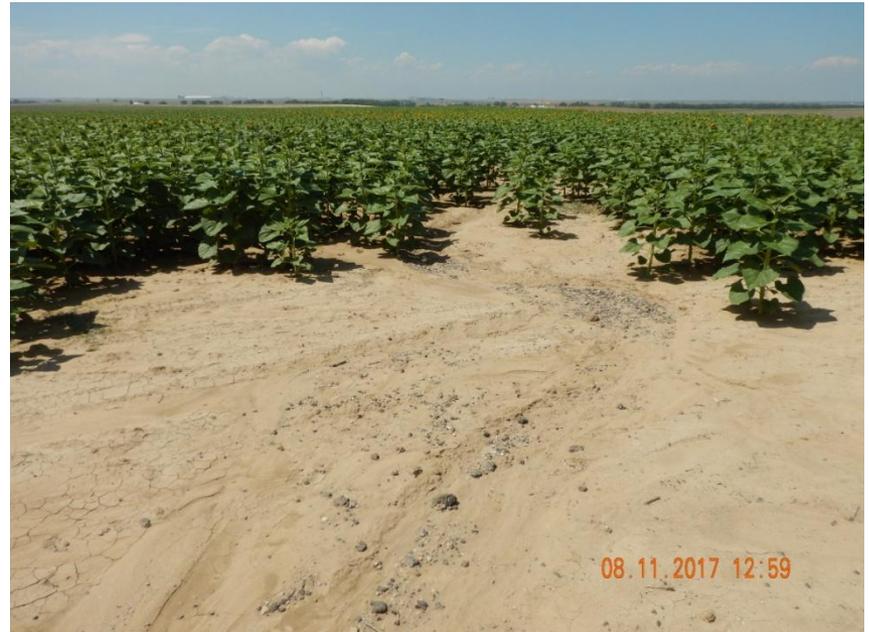
Photo 6. Photo taken from the western tank battery location, facing West. Photo taken from the point of discharge.
