Inspection Photos

Operator: PDC ENERGY INC - 69175

Location ID: 319218

Inspection Doc. Number: 675103830

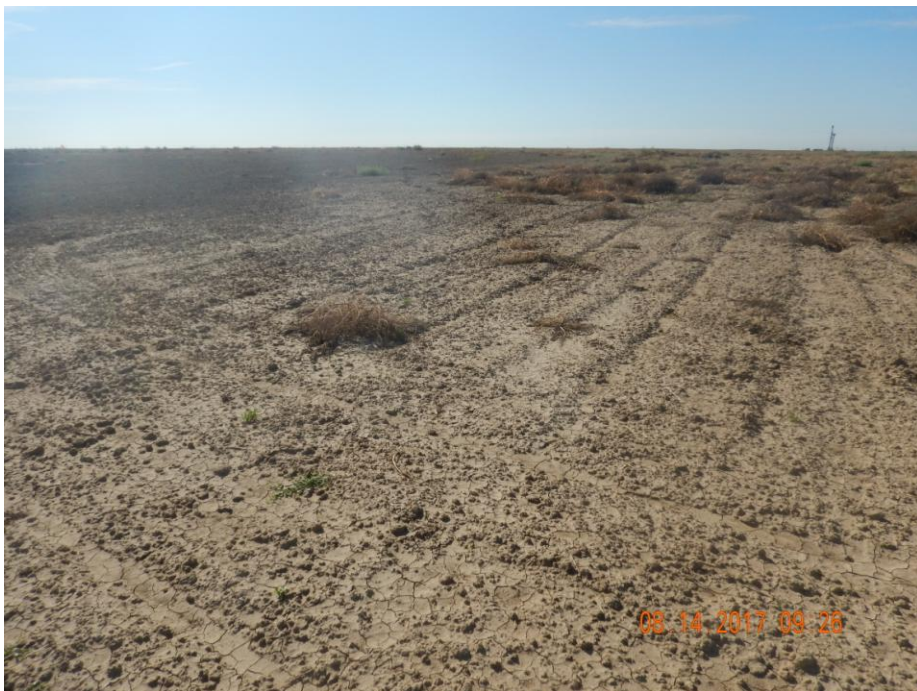
Photo 1: Photo taken from the west end of the location, facing south. Photo shows no additional BMPs have been implemented and used in conjunction with surface roughening per CA's from inspection doc. #682502162

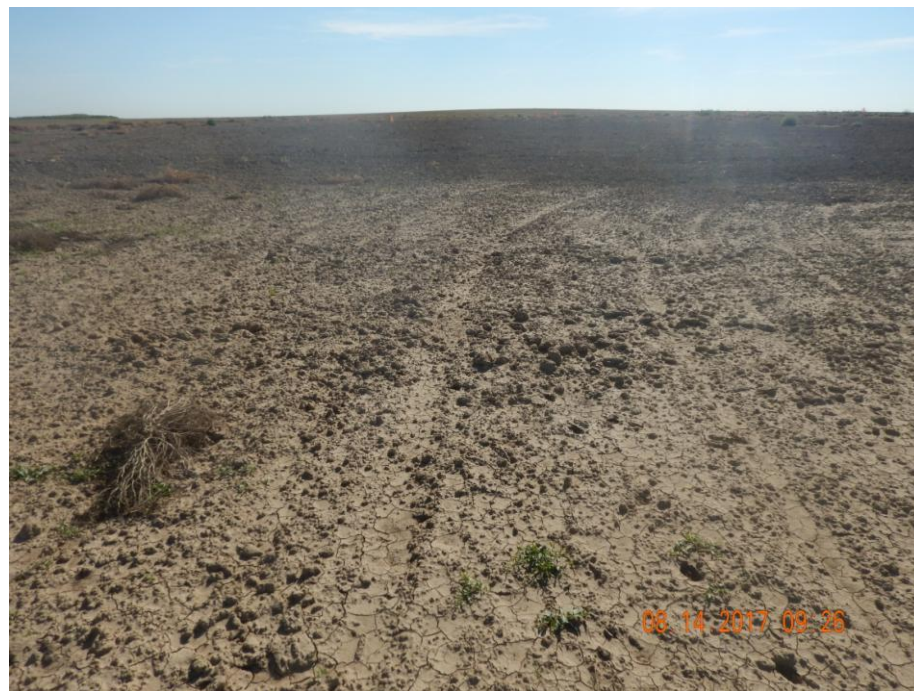
Photo 2: Photo taken from the west end of the location, facing east. Photo shows no additional BMPs have been implemented and used in conjunction with surface roughening per CA's from inspection doc. #682502162

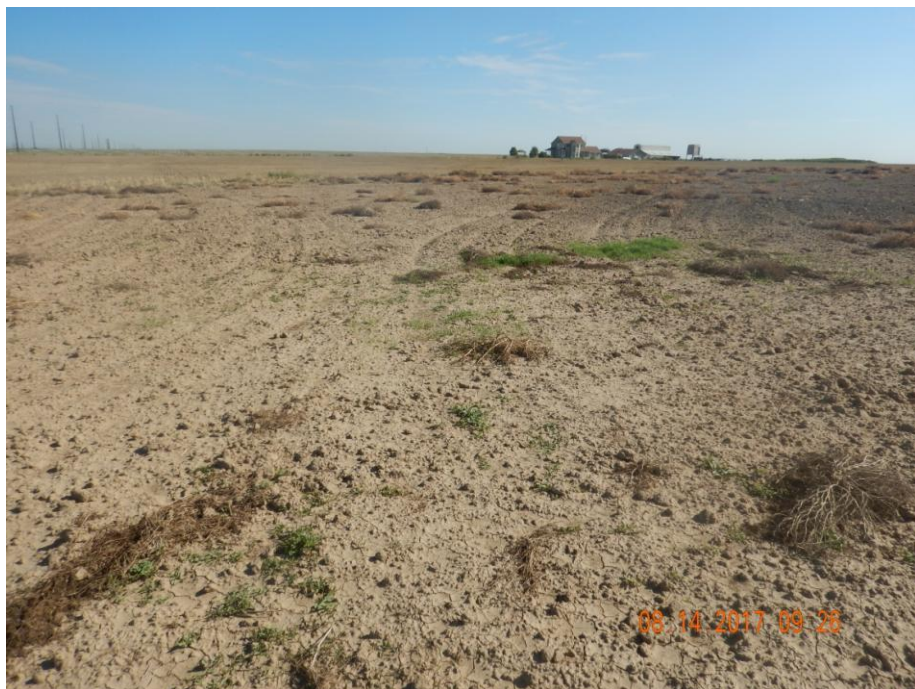
Photo 3: Photo taken from the west end of the location, facing north. Photo shows no additional BMPs have been implemented and used in conjunction with surface roughening per CA's from inspection doc. #682502162
