# Inspection Photos

Operator: EXTRACTION OIL & GAS INC - 10459

Location ID: 323581

Inspection Doc. Number: 675103897

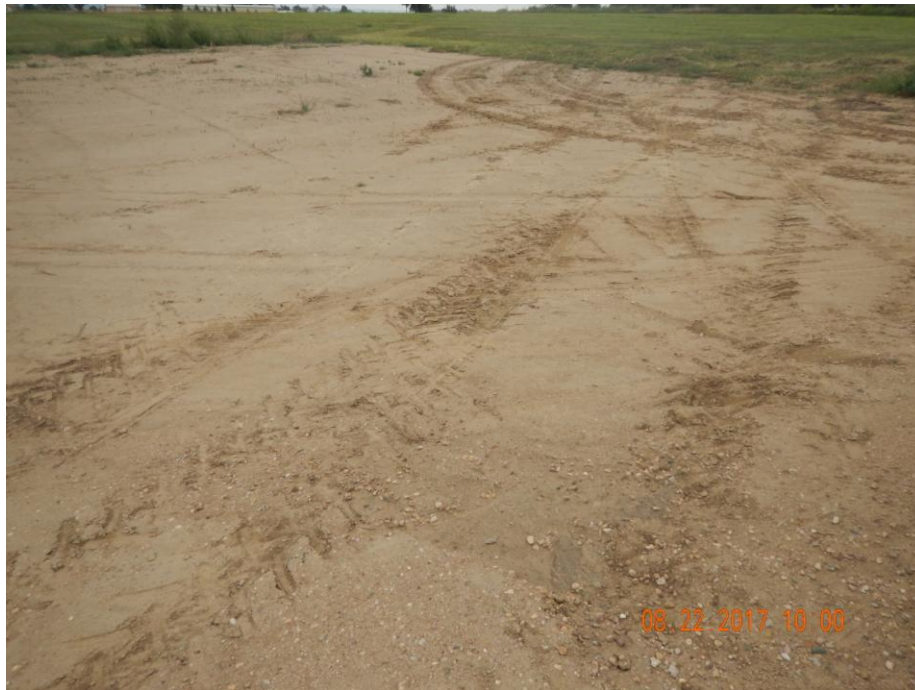
**Photo 1:** Photo taken from the center of the location, facing northeast. Photo shows the gully formations on the north half of the location have been repaired. However, no BMPs have been installed to mitigate future stormwater degradation concerns.

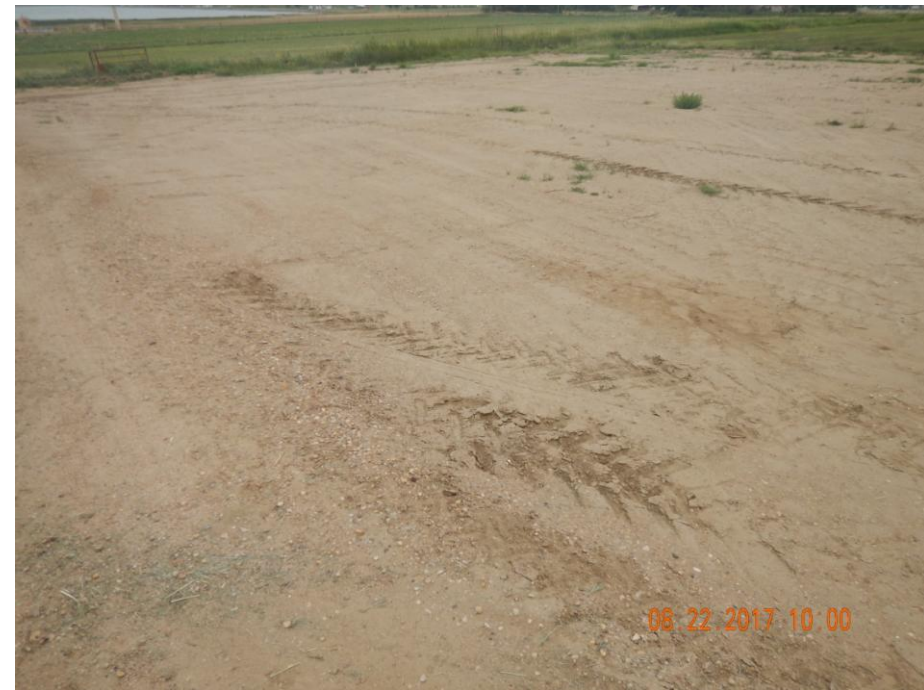
**Photo 2:** Photo taken from the center of the location, facing southwest. Photo shows the gully formations on the north half of the location have been repaired. However, no BMPs have been installed to mitigate future stormwater degradation concerns.

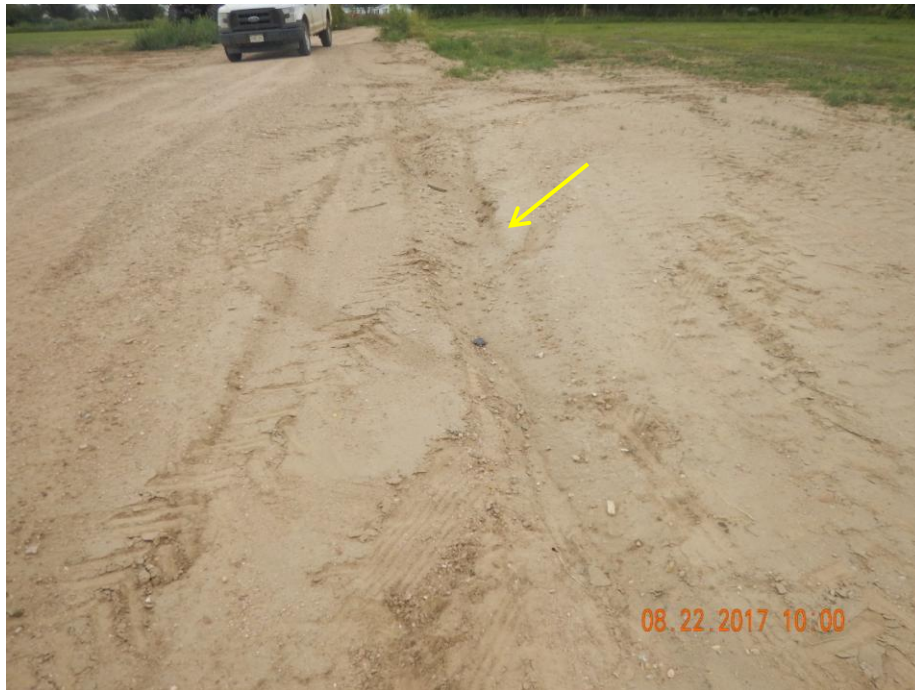
**Photo 3:** Photo taken from the south central area of the location, facing east. Photo shows the gully formations are beginning to form again on the southern end of the location. No BMPs have been installed to mitigate stormwater degradation concerns

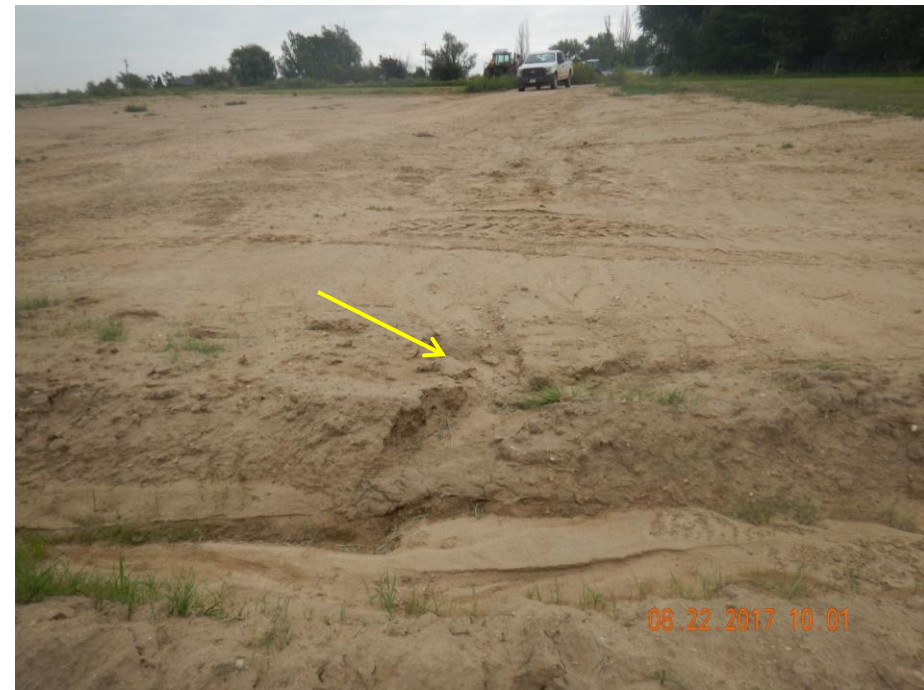
**Photo 4:** Photo taken from the ditch that runs North/South on the west end of the location, facing east. It is unclear if ditch had been repaired since previous inspection; stormwater degradation remains evident and sediment laden storm water discharge from the location is being deposited into the irrigation ditch.

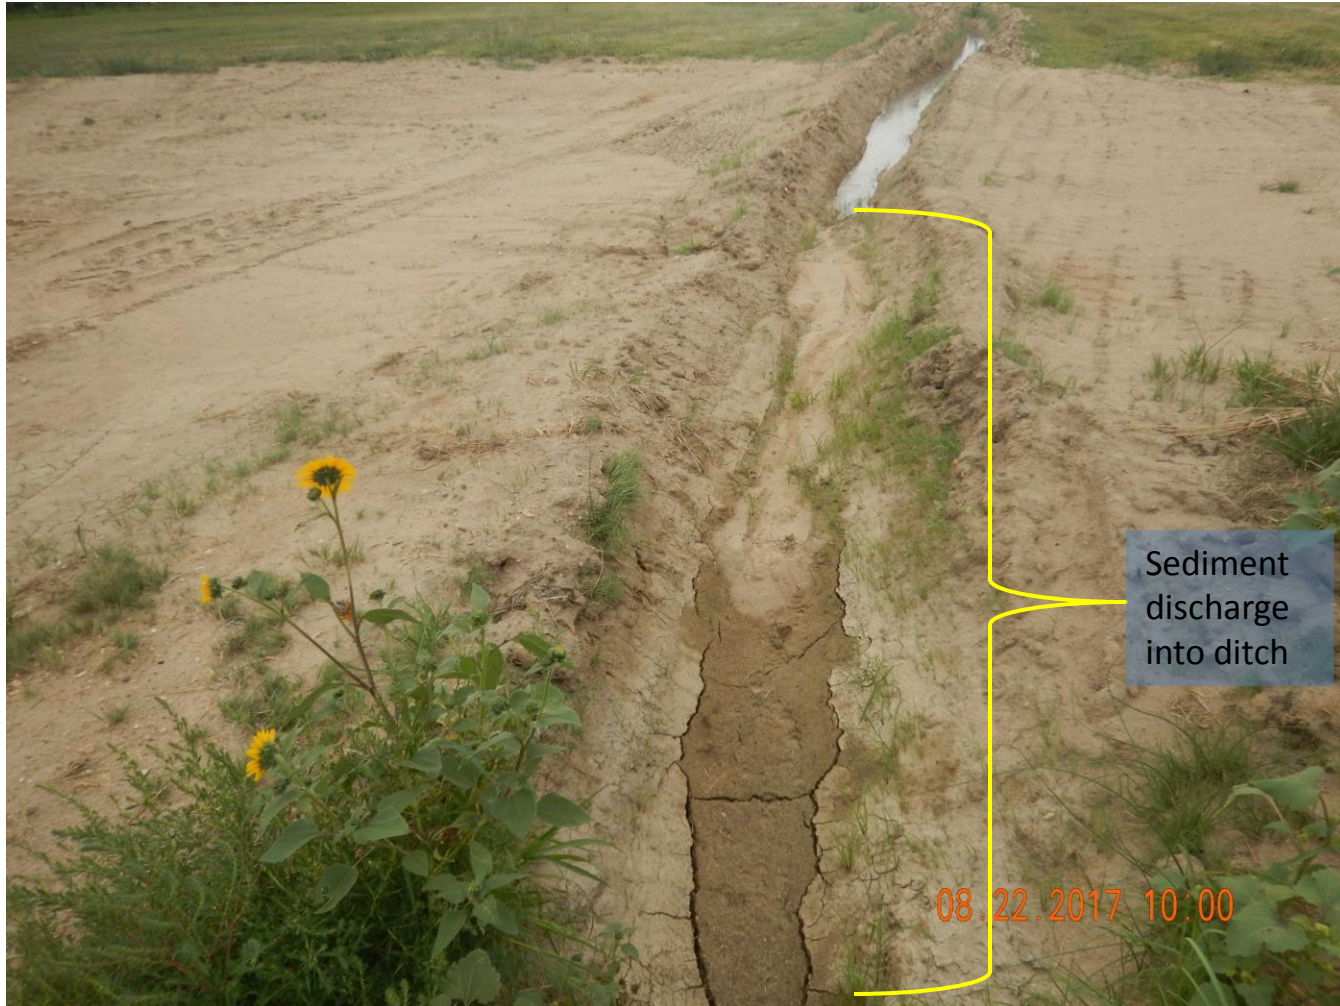
**Photo 5:** Photo taken from the ditch that runs North/South on the west end of the location, facing north. It is unclear if ditch had been repaired since previous inspection; stormwater degradation is remains evident and sediment laden storm water discharge from the location is being deposited into the irrigation ditch.
