Final Reclamation and Stormwater Inspection

August 23, 2017

Operator: PDC ENERGY INC - 69175

Location ID: 327207

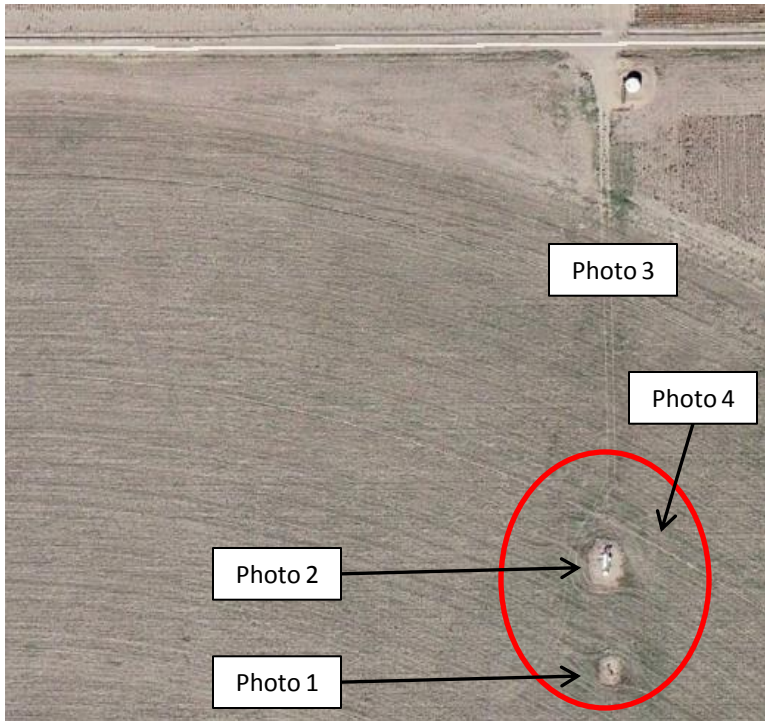
Google Earth aerial imagery taken August 18, 2012 during active operations. The well location does not meet Rule 1004 standards. Even though it does not appear the access road was re-contoured/re-graded, it appears to meet Rule 1004 vegetative standards. Approximate photo reference points shown above.

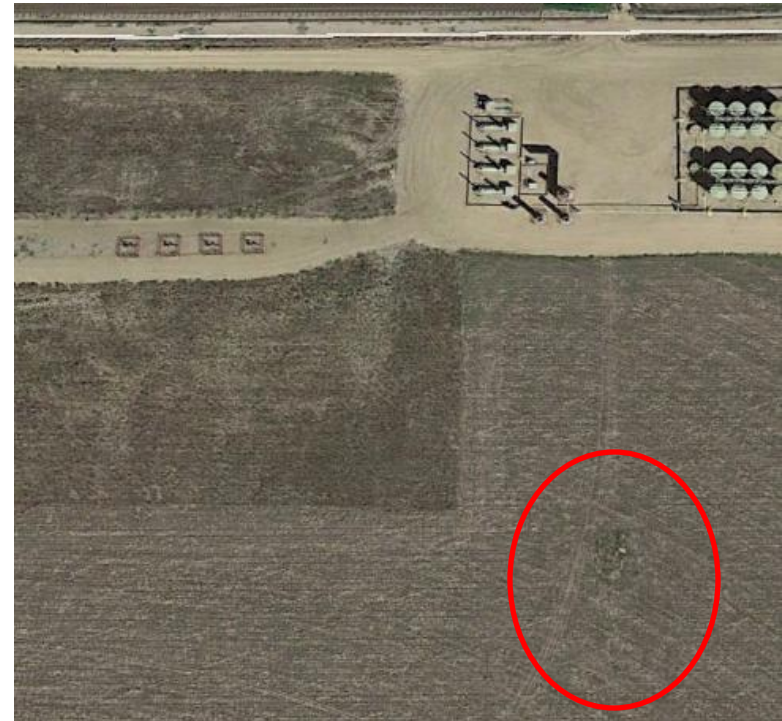
Google Earth aerial imagery taken September 7, 2016. PDC has enlarged the Ram Land location, as shown in the above photo.

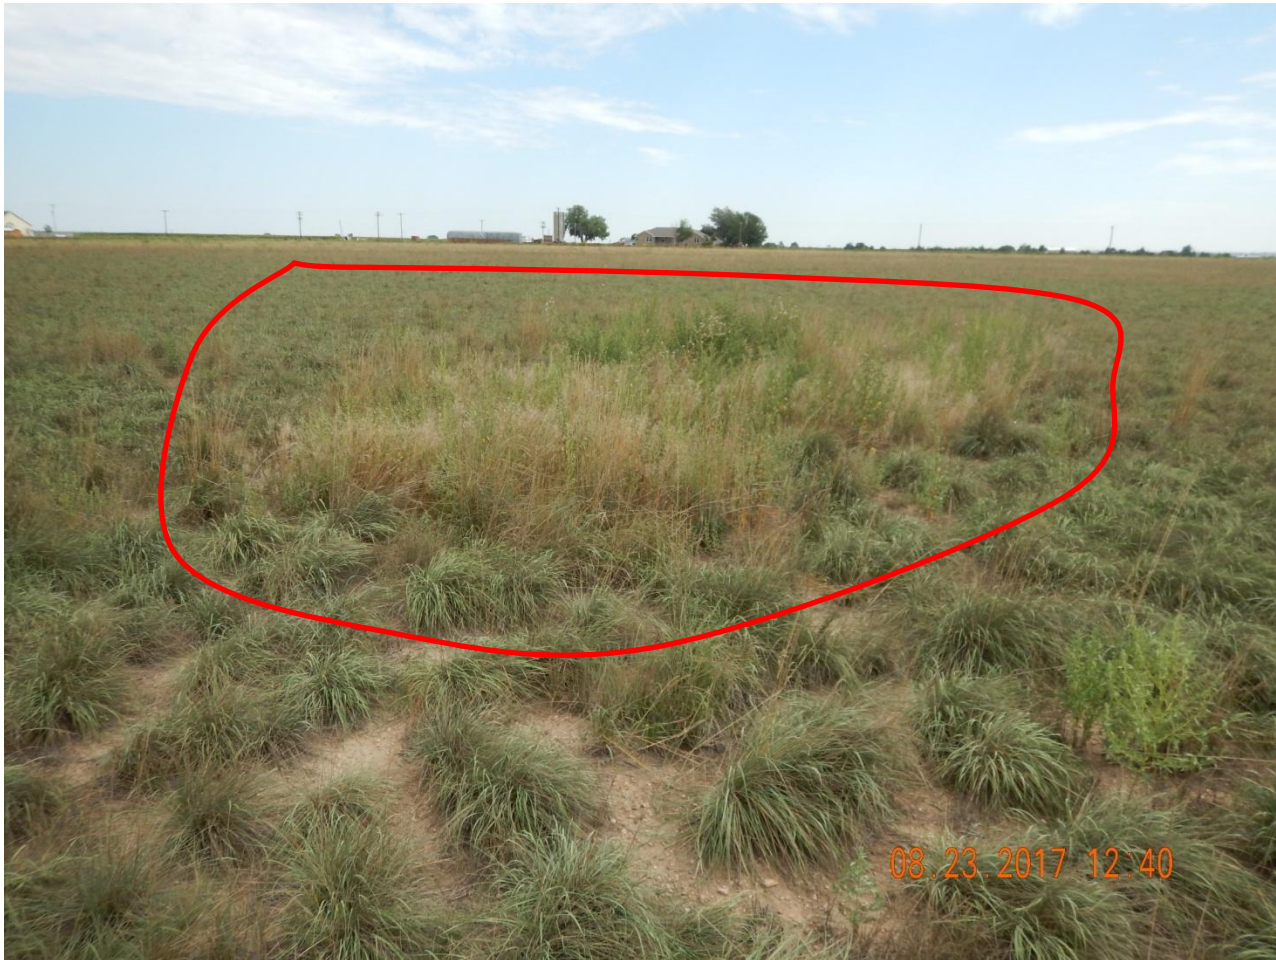
Photo 1. Photo taken from southern well location, facing East. Location (~20'x20') does not meet Rule 1004 standards as the disturbance of the location is evident and mainly consist of weedy, annual vegetation. The disturbance location is not reflective of reference area vegetation that is comprised of Russian wildrye (*Elymus junceus*).

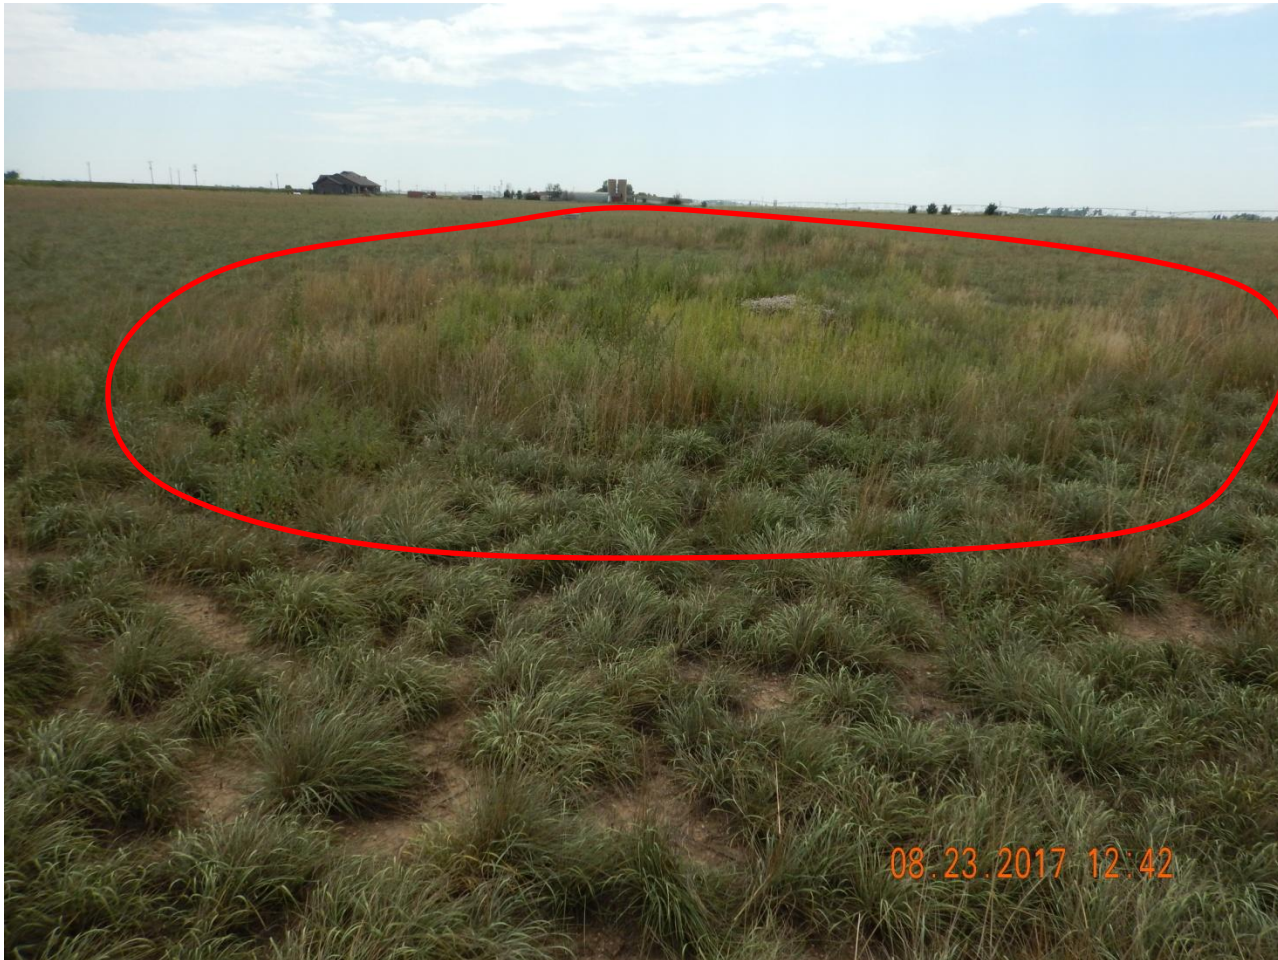
Photo 2. Photo taken from northern well location, facing South. Location (~35'x35') does not meet Rule 1004 standards as the disturbance of the location is evident and mainly consist of weedy, annual vegetation. The disturbance location is not reflective of reference area vegetation that is comprised of Russian wildrye (*Elymus junceus*). Subsidence was observed at the northern well location.

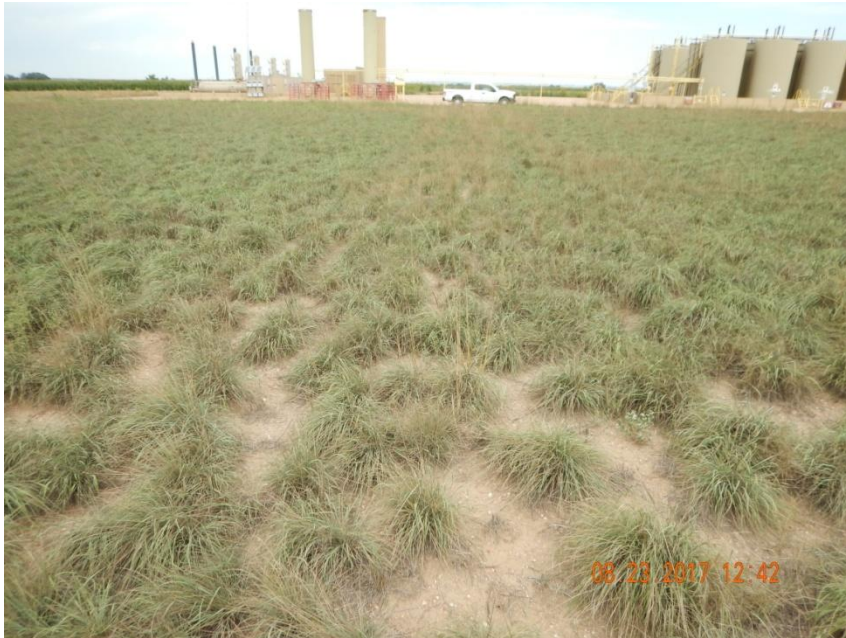
Photo 3. Photo taken from a portion of the access road, facing North. Even though it does not appear the access road was re-contoured/re-graded, it appears to meet Rule 1004 vegetative standards.

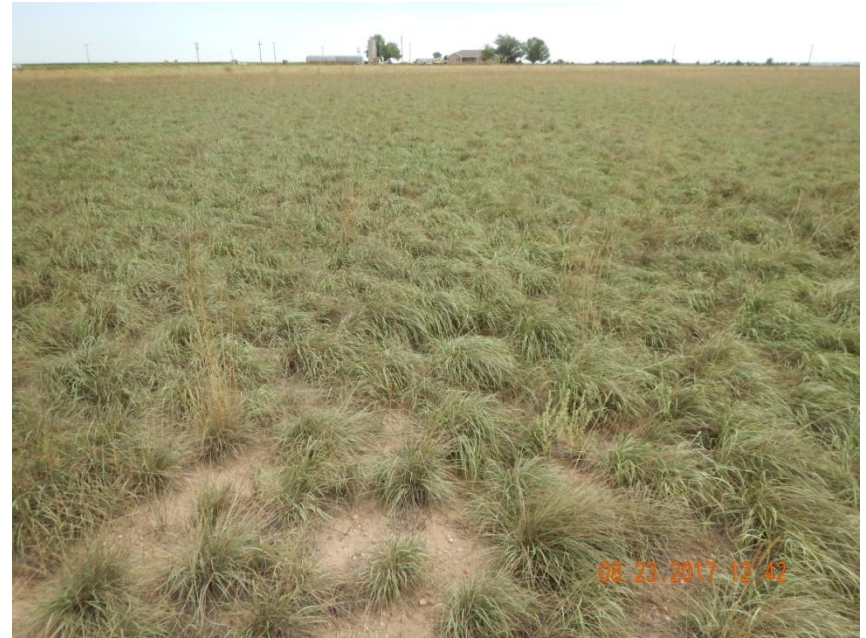
Photo 4. Reference photo taken east of the well location, facing East. Reference area consists of uniform vegetative Russian wildrye (*Elymus junceus*) growth.
