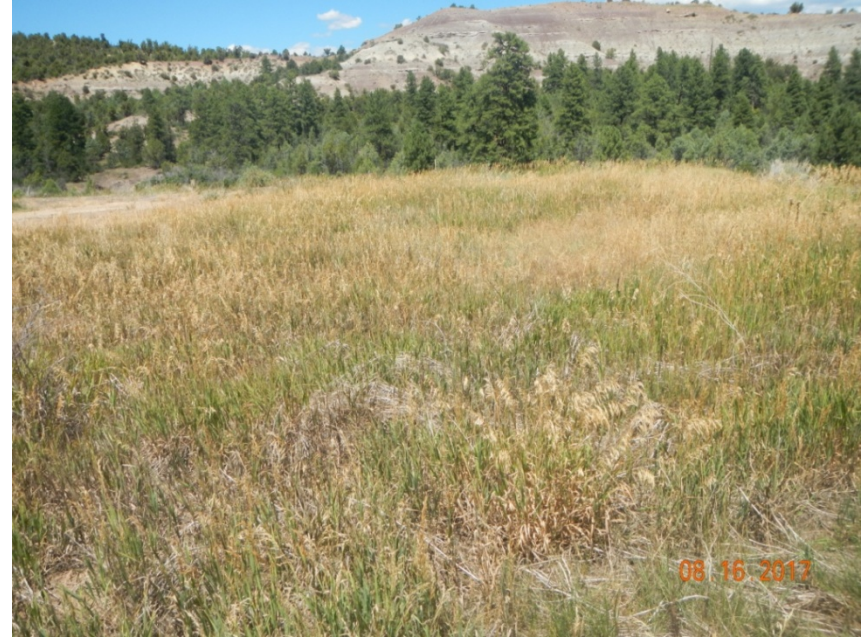
Photo 2: View of the western portion of the project area from the northwestern corner facing southward. Revegetation is largely comprised of western wheatgrass (*Pascopyrum smithii*) and smooth brome (*Bromus inermis*).

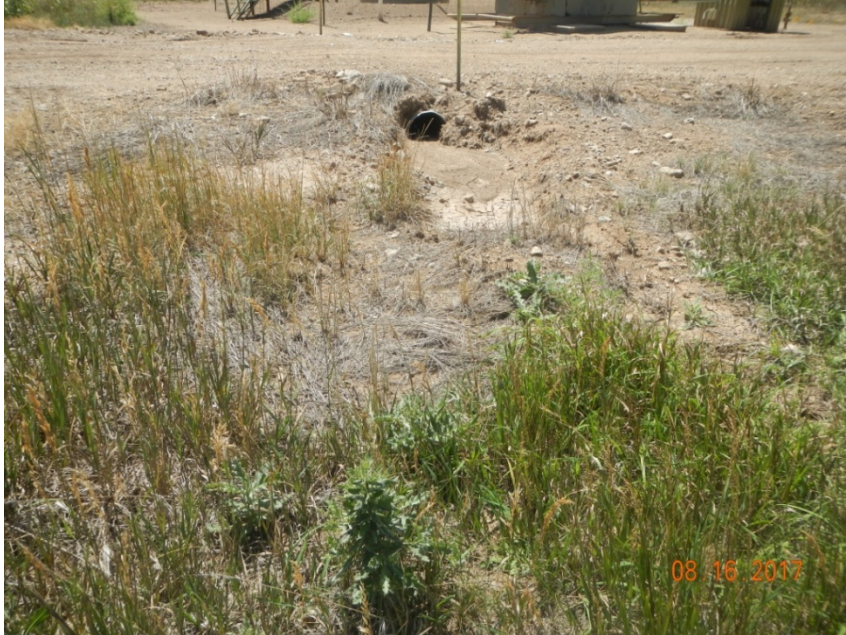
Photo 3: View of culvert on the well pad. Approx. 20 Canada thistles are growing at outlet.

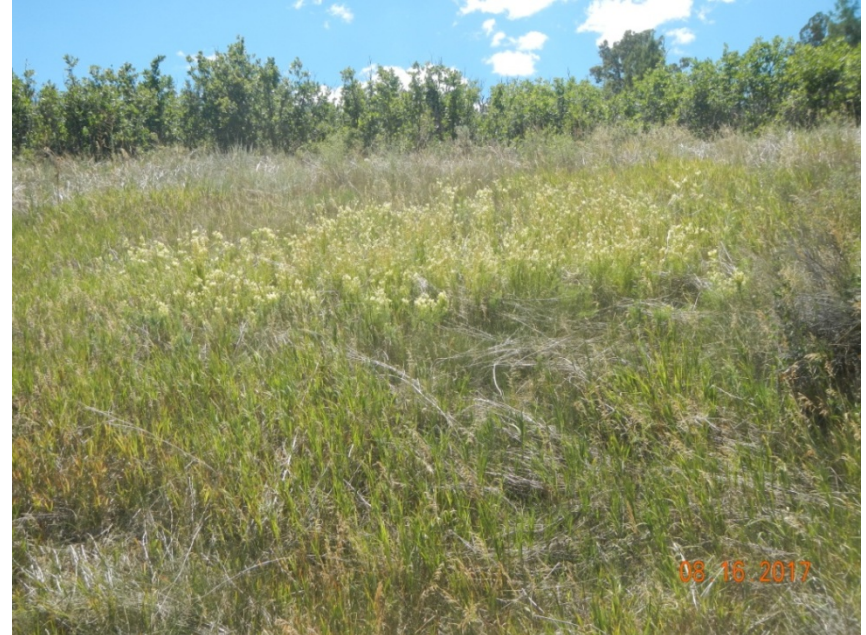
Photo 4: View of yellow toadflax (*Linaria vulgaris*) in the northern portion of the project area. Two populations in the northern portion of the project area, totaling approximately 1500 plants persist.
