# Stormwater Inspection

September 7, 2017

Operator: K P KAUFFMAN COMPANY INC - 46290

Location ID: 320780

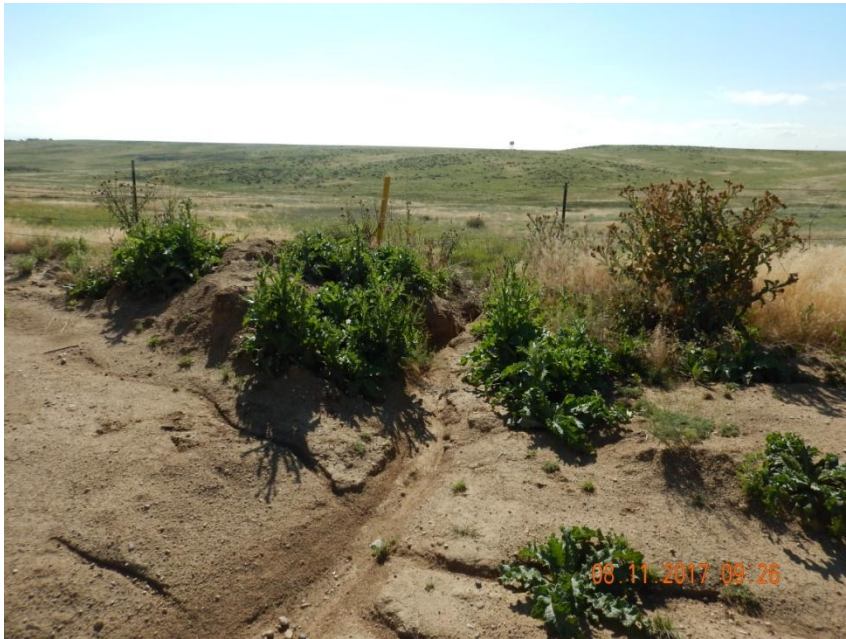
**Photo 1.** Photo taken August 11, 2017 from the discharge point, facing East. Gully erosion occurring this is causing sediment discharge off location. Also, a List B Colorado Noxious weed, Musk thistle, shown in this photo and was observed throughout the well location and access road.

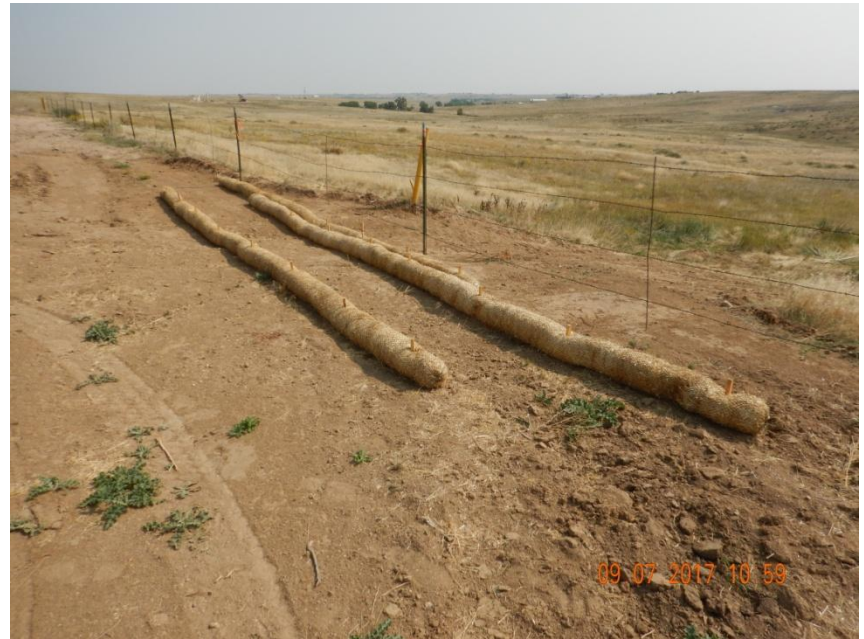
**Photo 2.** Photo taken September 7, 2017 from the previous photo location, facing Northeast. Appears to Operator has repaired the erosion. Operator has installed wattle BMPs but BMP has not been properly installed.

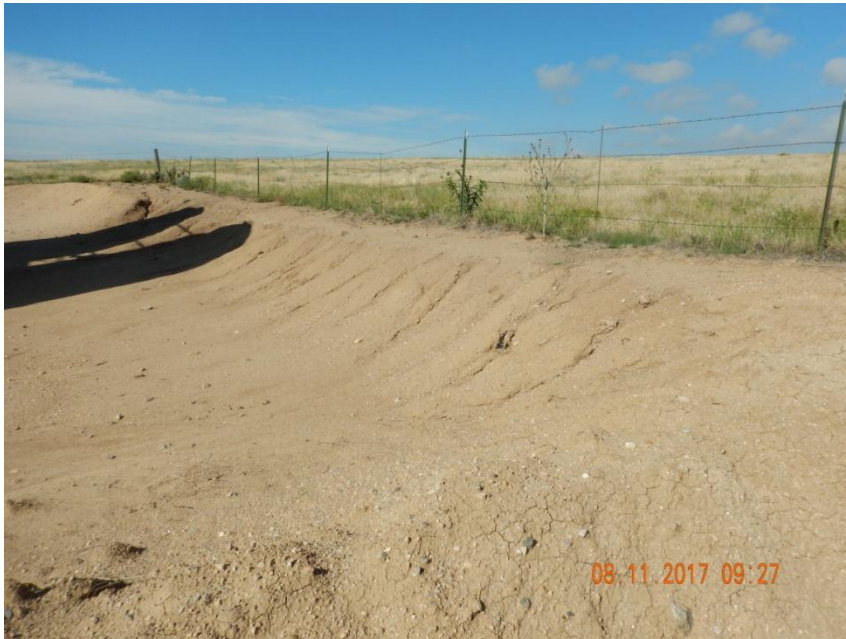
**Photo 3.** Photo taken August 11, 2017 from the western location, facing Southwest. Rill erosion occurring throughout the cut slope contributing to sediment discharge off location. Cut slope needs to be stabilized to prevent erosion and stabilize the production area.

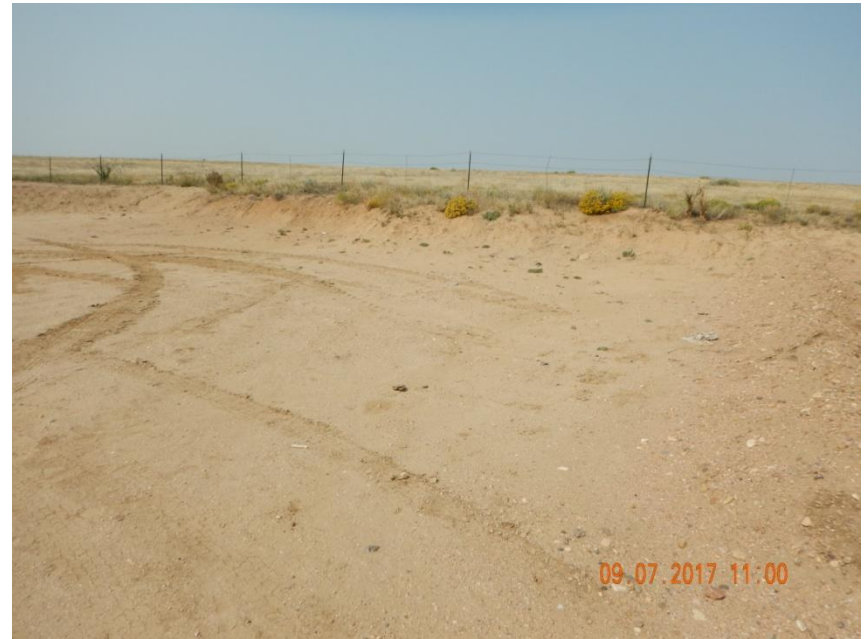
**Photo 4.** Photo taken September 7, 2017 from the previous photo location, facing Southwest. Does not appear the Operator has made repairs to the rill erosion along the cut slope. Does not appear the Operator has installed a BMP to prevent erosion and stabilize the production area.

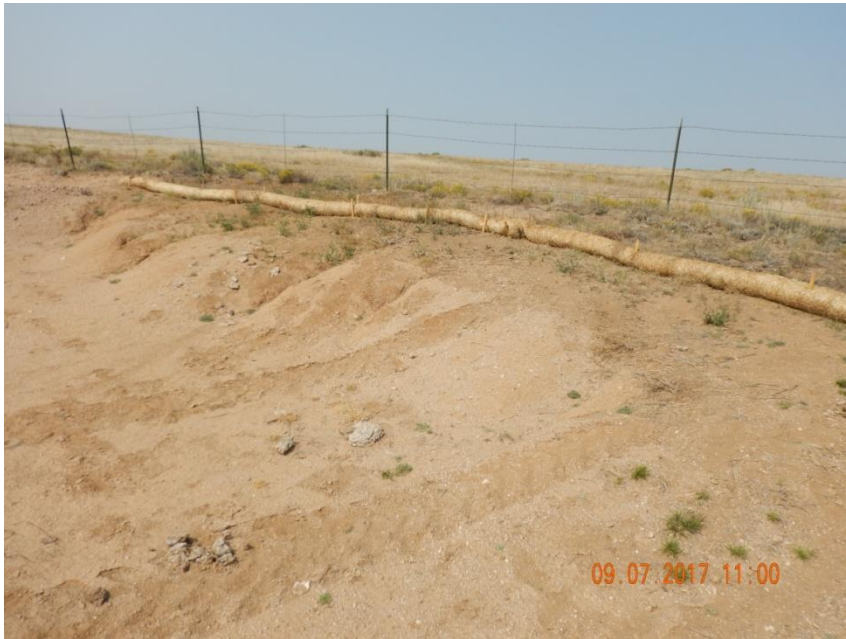
**Photo 5.** Photo taken September 7, 2017 from the northwestern location, facing Southwest. Does not appear the Operator has made repairs to the rill erosion along the cut slope. Operator has installed wattle BMPs but BMP has not been properly installed.

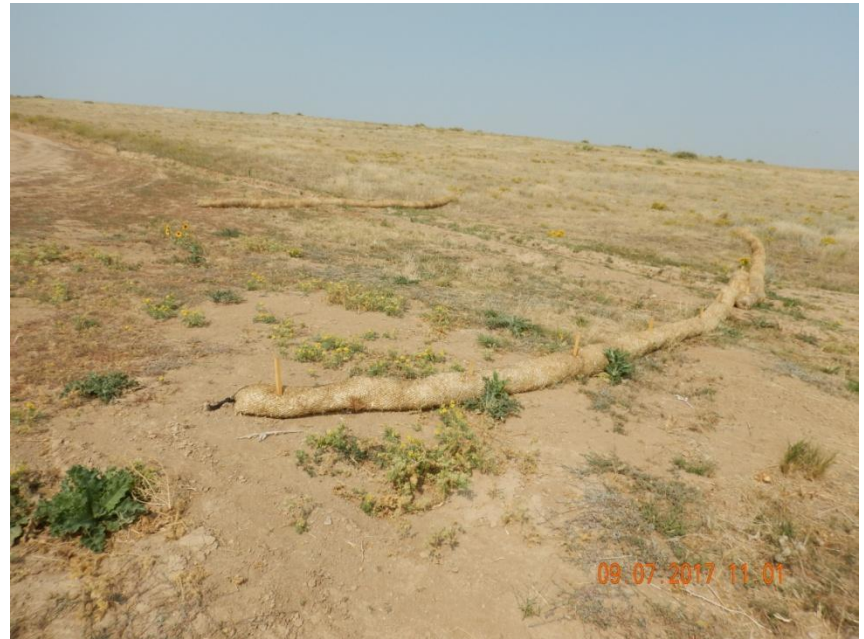
**Photo 6.** Photo taken from the second discharge point off the main access road, facing North. Operator has installed wattle BMPs but BMP has not been properly installed.

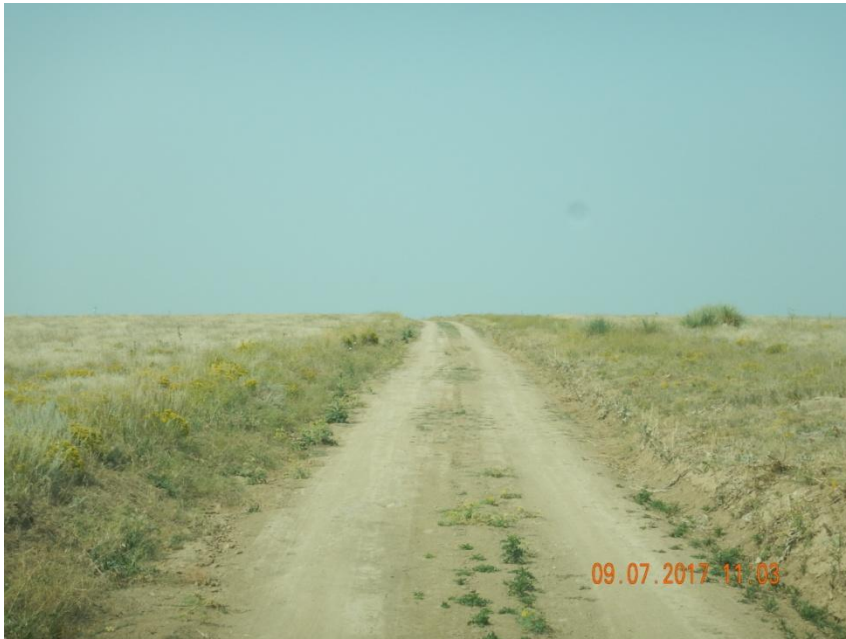
**Photo 7.** Photo taken September 7, 2017 from a portion of the main access road, facing West. Appears Operator has controlled the List B Colorado Noxious weeds, Musk thistle and Canada thistle.

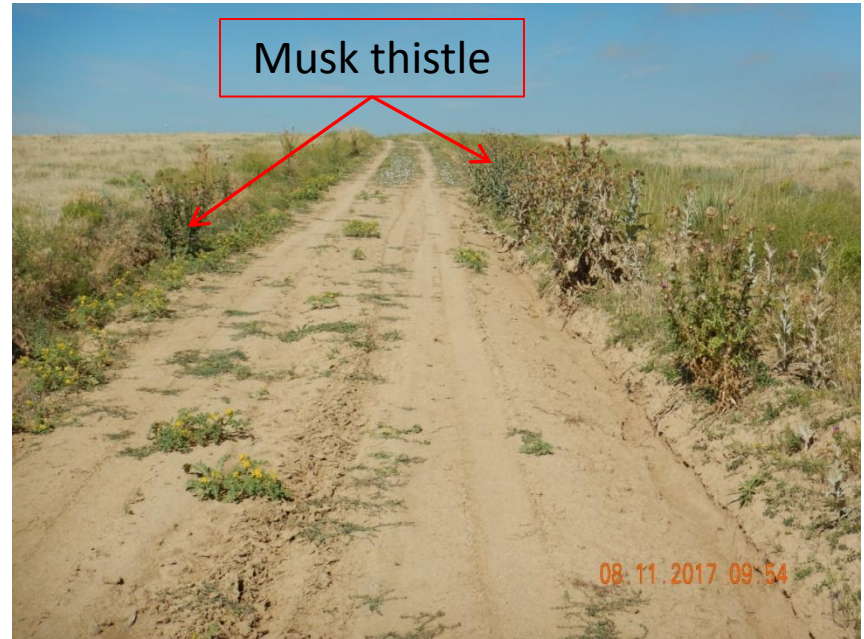
**Photo 8.** Photo taken August 11, 2017 from the previous photo location, facing West. List B Colorado Noxious weeds, Musk thistle and Canada thistle, were observed throughout the main access road.
