Inspection Photos

Operator: PETRO-CANADA RESOURCES (USA)
INC - 72085

Location ID: 311680

Inspection Doc. Number: 682502571
Adams County, CO

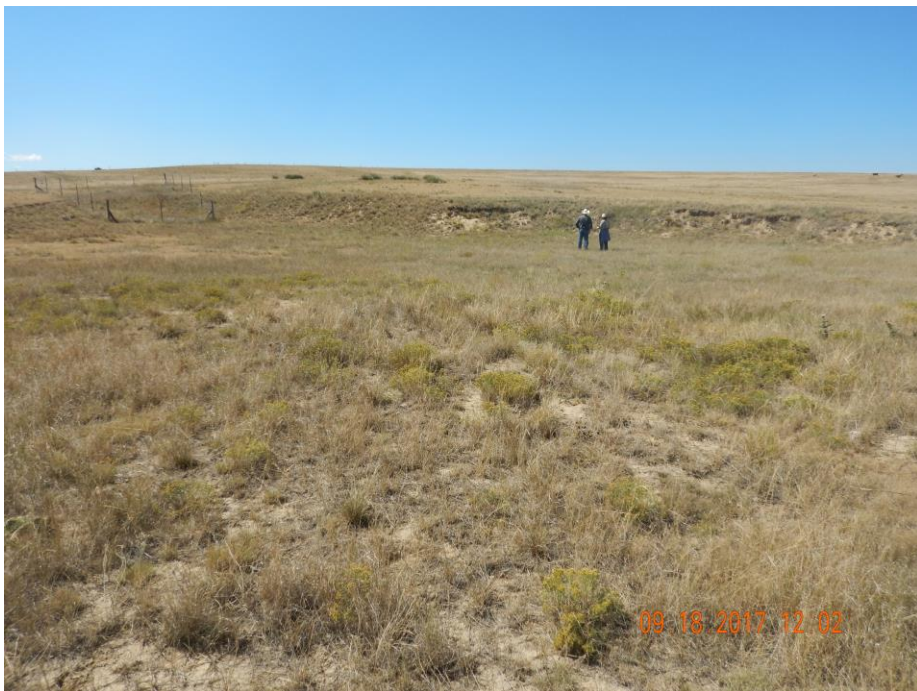
Photo 1: Photo taken from pad location, facing southwest. Photo shows the cut slope of the location remains unreclaimed.

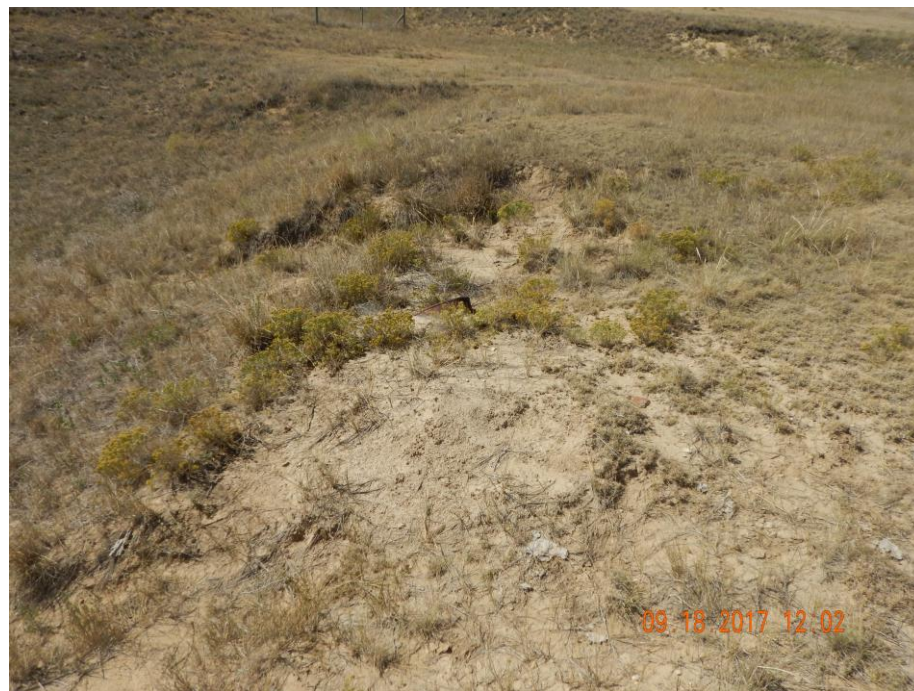
Photo 2: Photo taken from the east end of the pad location. Photo shows erosion degradation due to stormwater runoff. These areas need to be reclaimed.

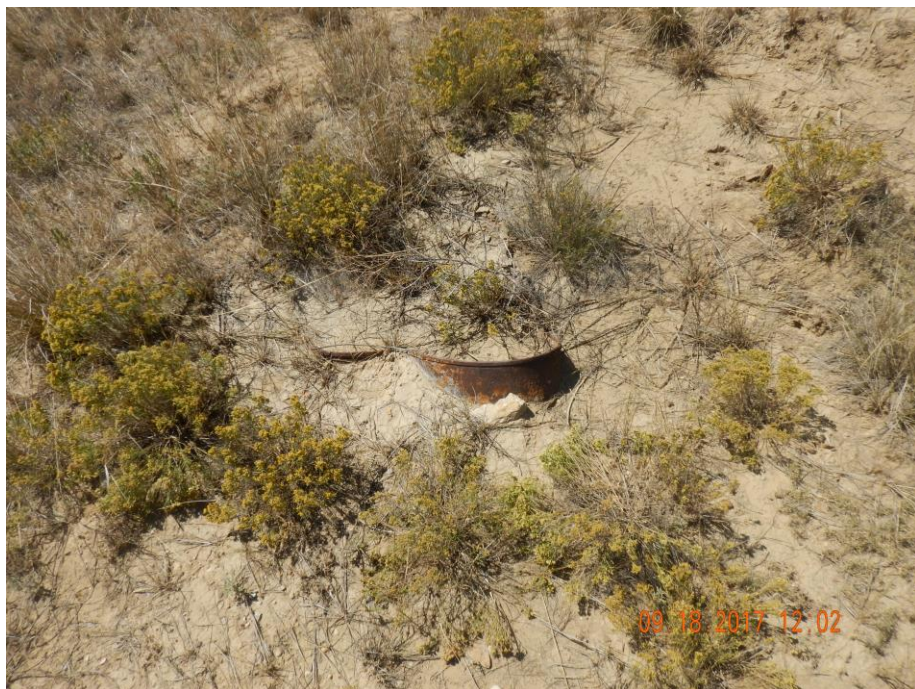
Photo 3: Photo taken from the east end of the pad location. Photo shows trash debris.

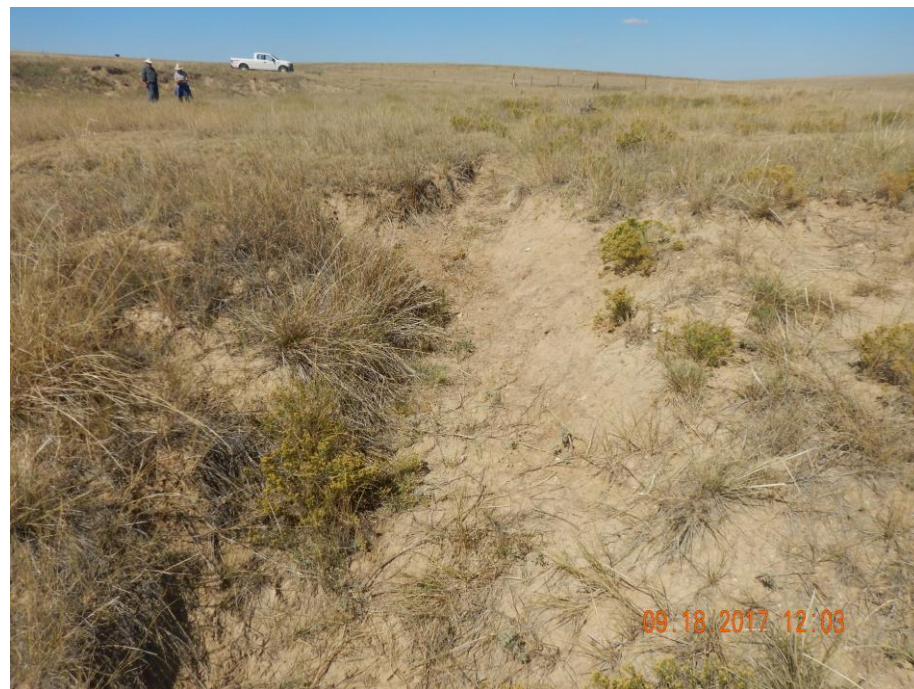
Photo 4: Photo taken from the east end of the pad location, facing northwest. Photo shows erosion degradation due to stormwater runoff. These areas need to be reclaimed.

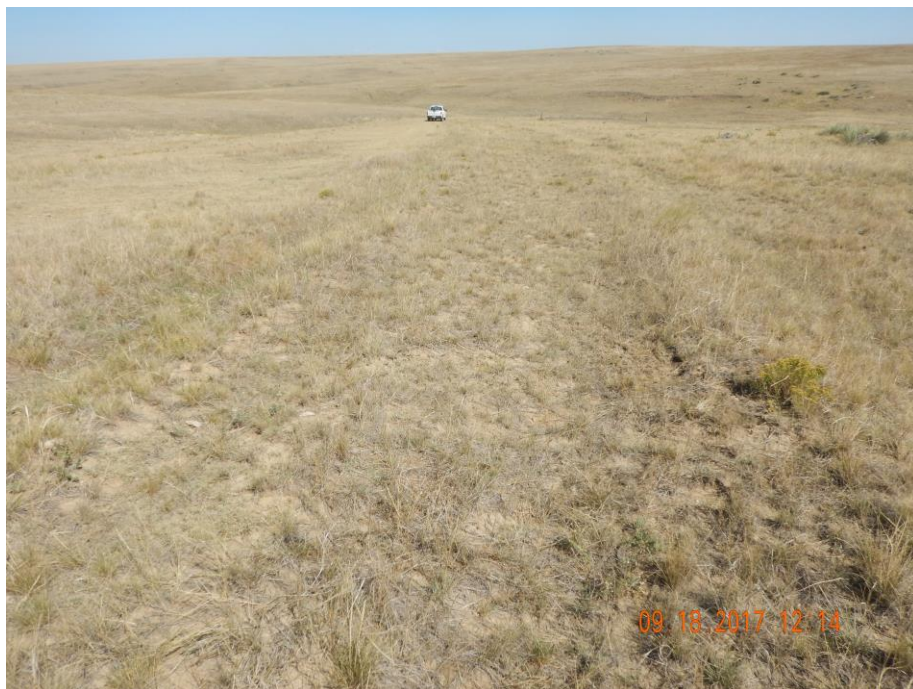
Photo 5: Photo taken from the access road. Photo shows areas of the access road where ruts remain and erosion degradation has occurred. These areas will need to be reclaimed.

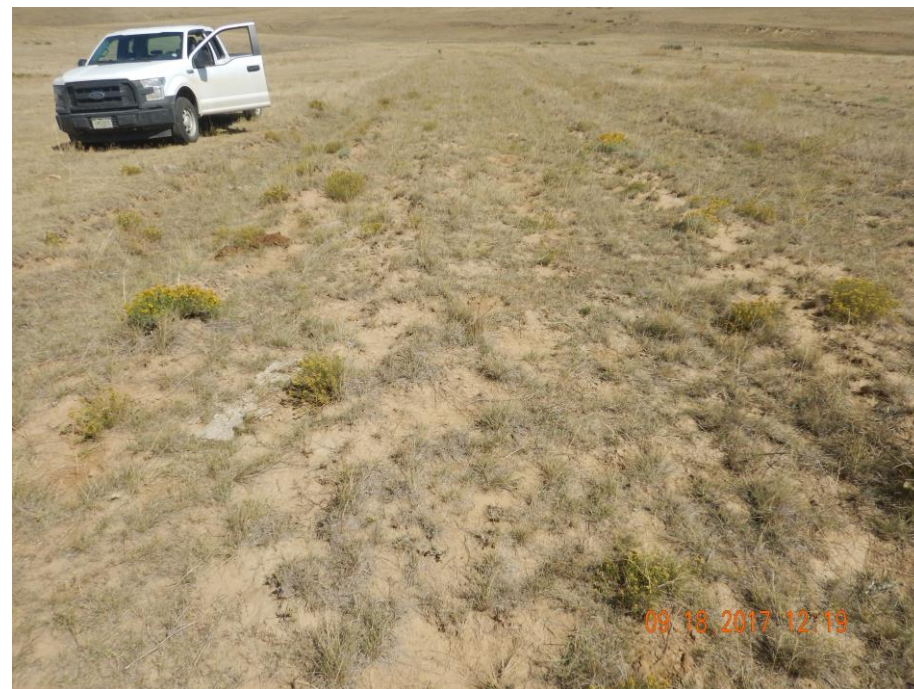
Photo 6: Photo taken from the access road. Photo shows areas of the access road where ruts remain and erosion degradation has occurred. These areas will need to be reclaimed.

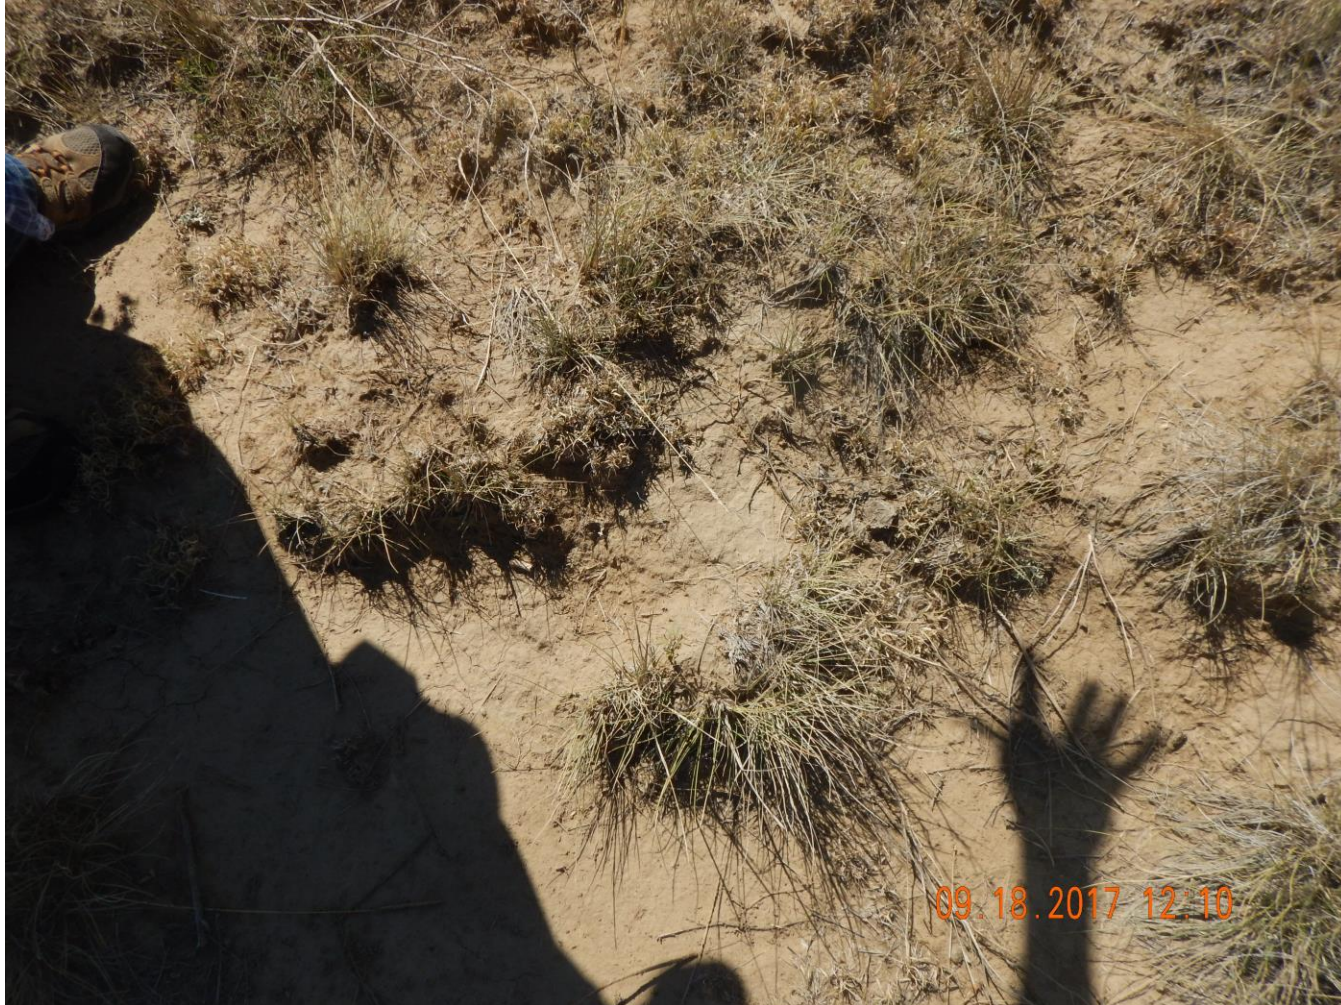
Photo 7: Photo taken from the access road. Photo shows areas of the access road where ruts remain and erosion degradation have occurred. These areas will need to be reclaimed.
