Construction and Stormwater Inspection

September 27, 2017

Operator: 8 NORTH LLC - #10575

Location ID: 443555

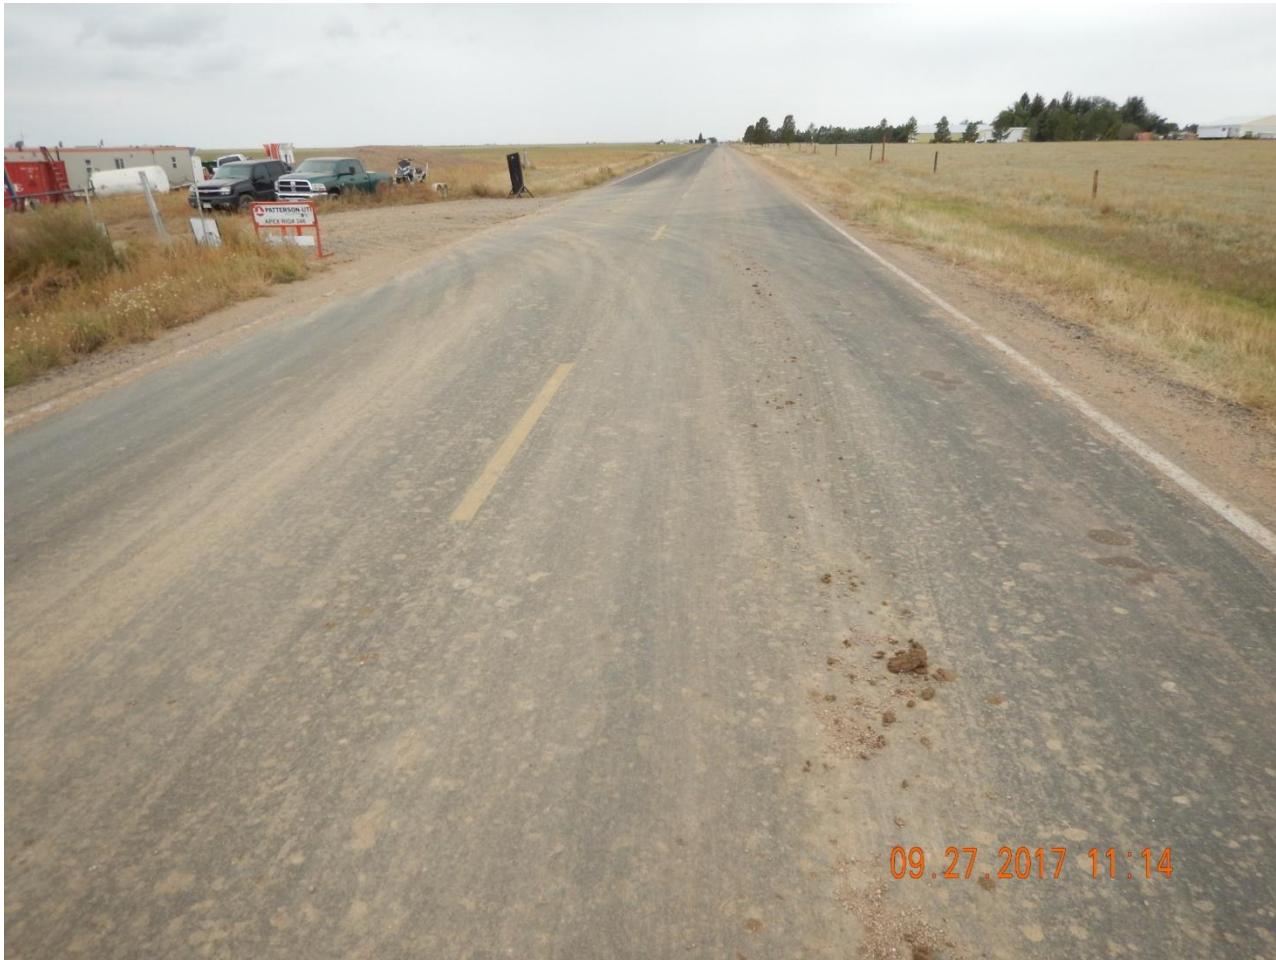
Photo 1. Photo taken from the entrance of location on CR 136, facing West. Tracking pad not adequately maintained to prevent tracking of material offsite.

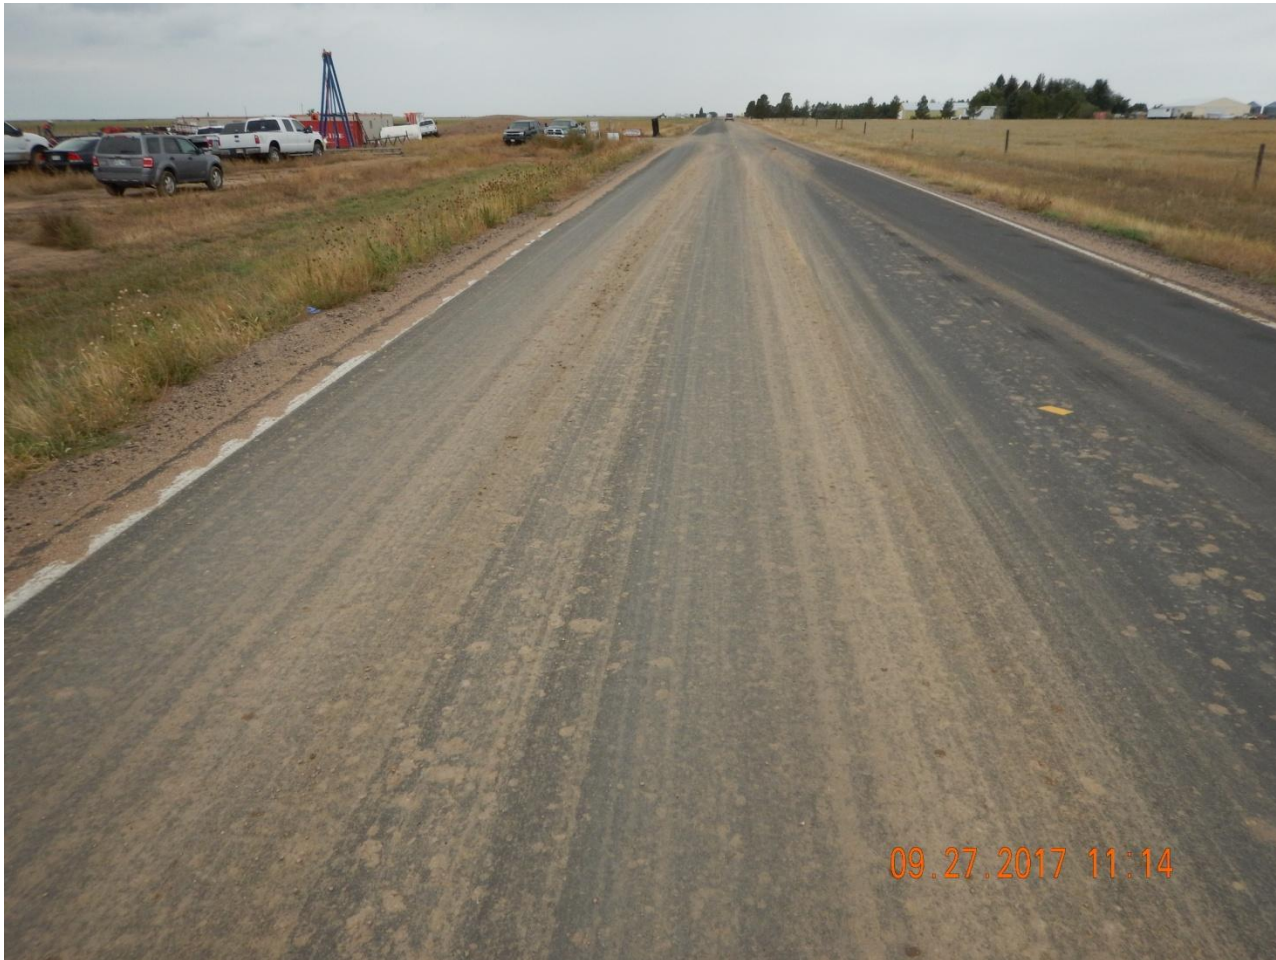
Photo 2. Photo taken from CR 136 east of entrance, facing West. Tracking pad not adequately maintained to prevent tracking of material offsite.

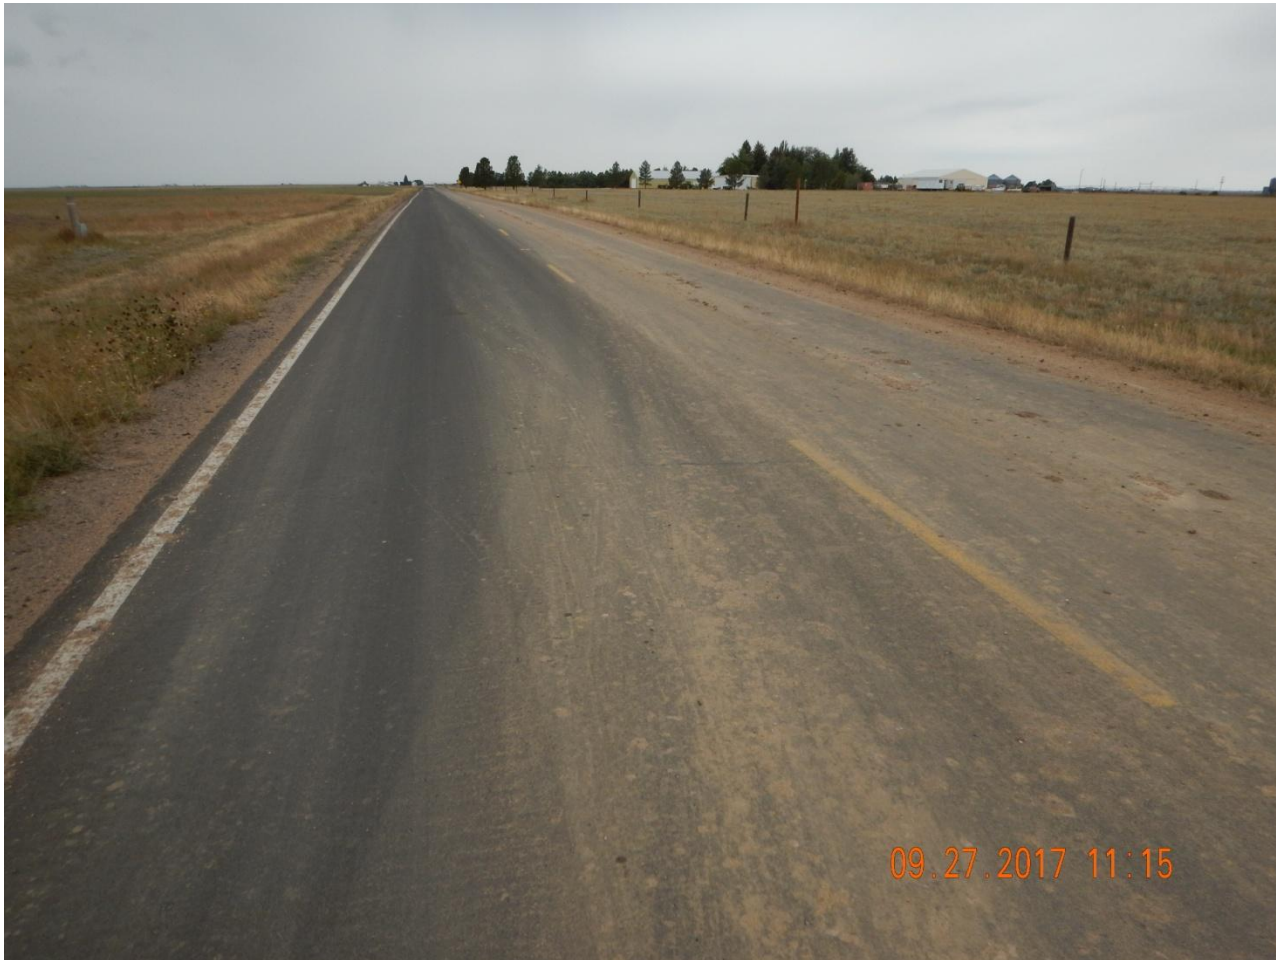
Photo 3. Photo taken from CR 136 west of entrance, facing West. Tracking pad not adequately maintained to prevent tracking of material offsite.

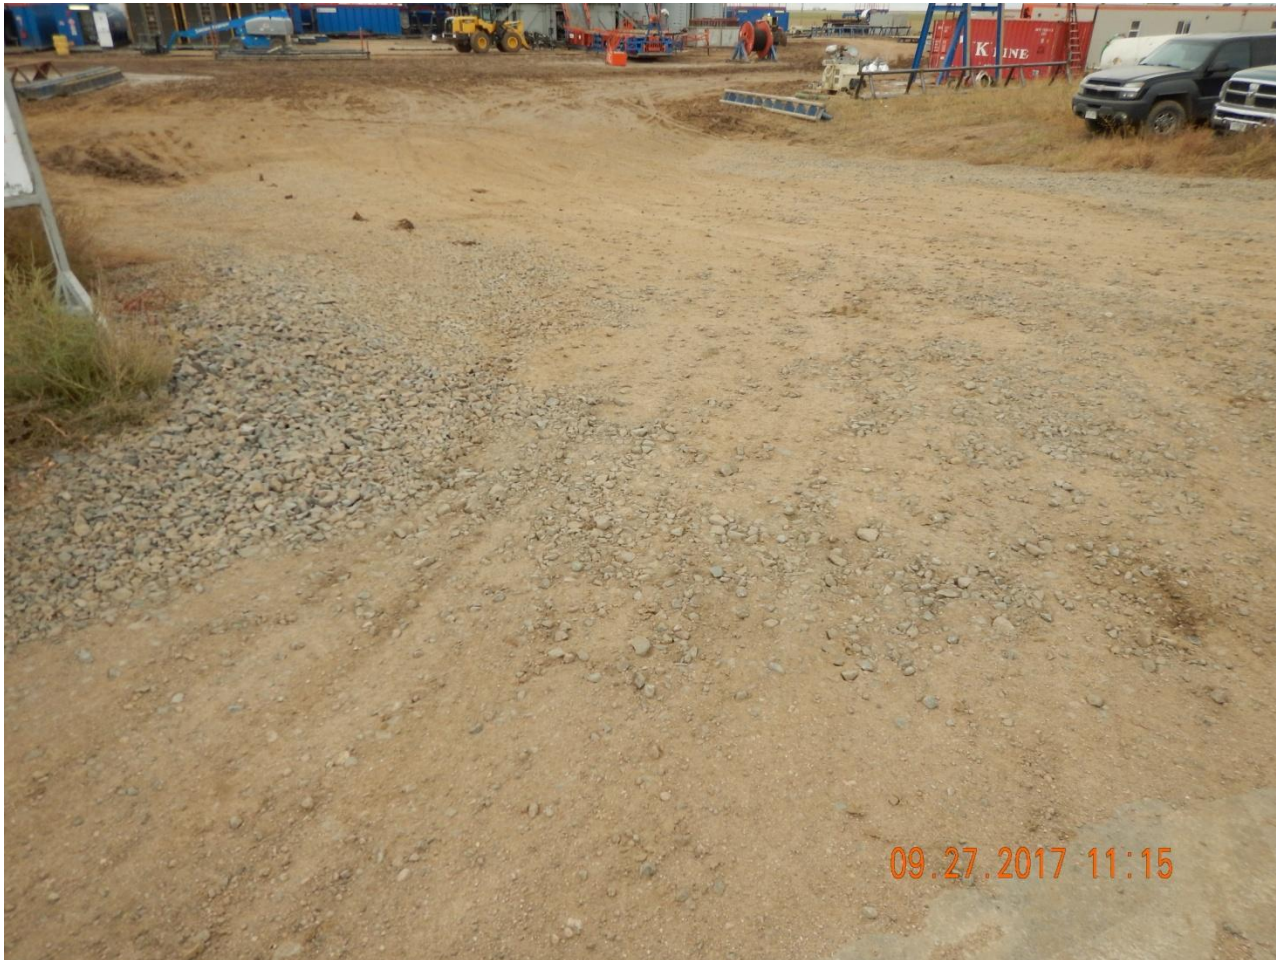
Photo 4. Photo taken from the entrance of location, facing South. Photo illustrates tracking pad not adequately maintained to prevent tracking of material offsite.
