# Inspection Photos

Operator: NOBLE ENERGY INC - 100322

Location ID: 318182

Inspection Doc. Number: 682502619

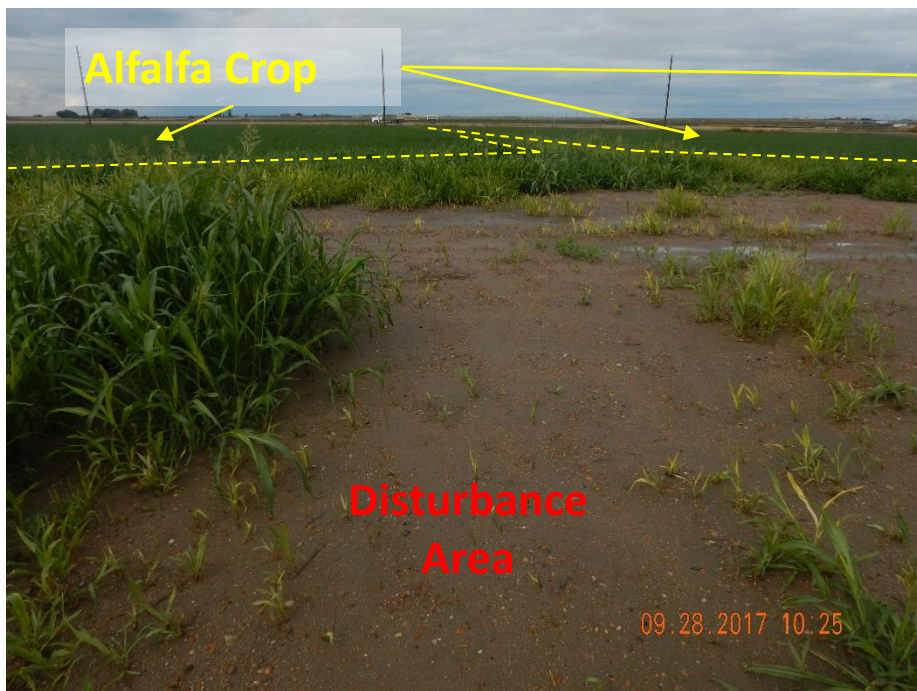
**Photo 1:** Photo taken from the south end of the battery facility, facing west. Previous inspection documented that Noble indicated the surface owner seeded a “sudax grass” into the disturbance area after another prior inspection. Photo shows vegetation appears to have had difficulty establishing on large portions of the disturbance area, establishment was not uniform, and large areas of the location remain predominantly bare and unvegetated. Though inspector is unsure as to when it was planted, the adjacent crop fields with similar sudax grass shows vegetative growth exceeding heights of 7 feet in areas (photo 6). The disturbance areas are within an alfalfa crop field (yellow line used to distinguish disturbance and the reference area). Alfalfa is a perennial crop that reaches heights of 2-3 feet; plant growth w/in the disturbance appears stunted and to have chlorosis.

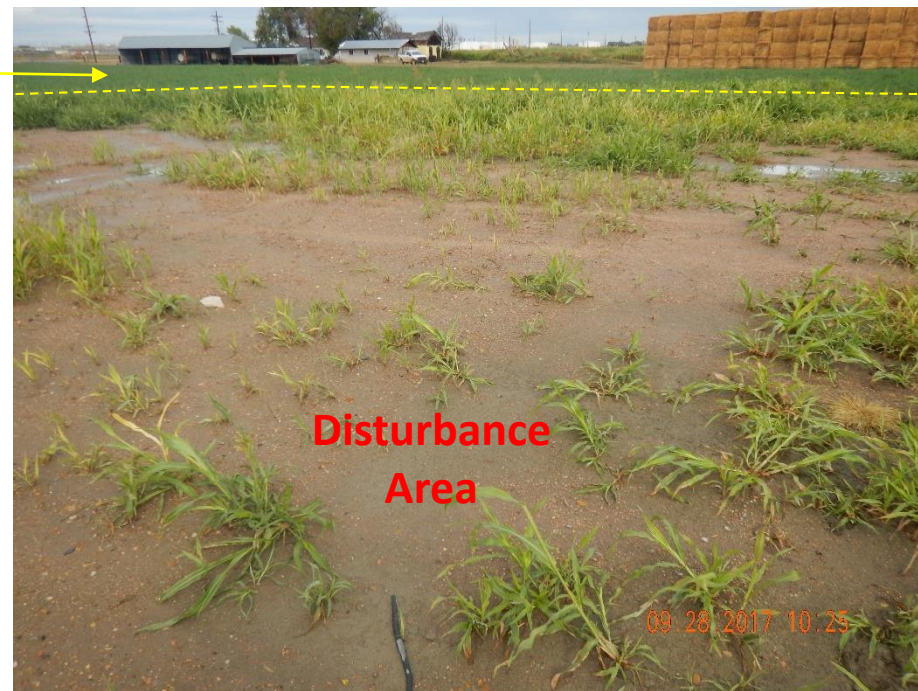
**Photo 2:** Photo taken from the south end of the battery facility, facing northwest. See comments under photo 1

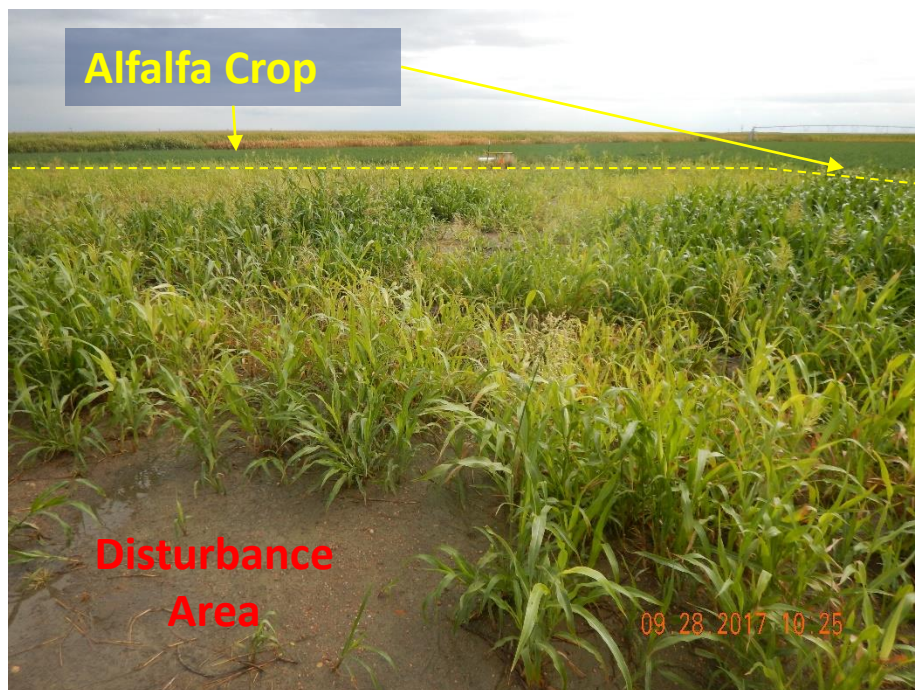
**Photo 3:** Photo taken from the south end of the battery facility, facing northeast. See comments under photo 1

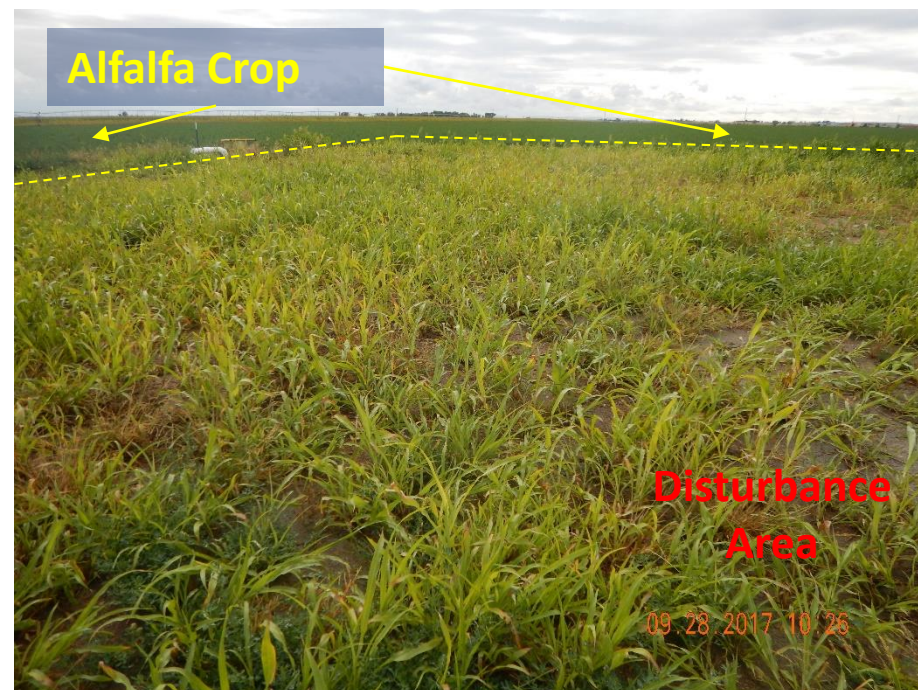
**Photo 4:** Photo taken from the south end of the battery facility, facing east. See comments under photo 1

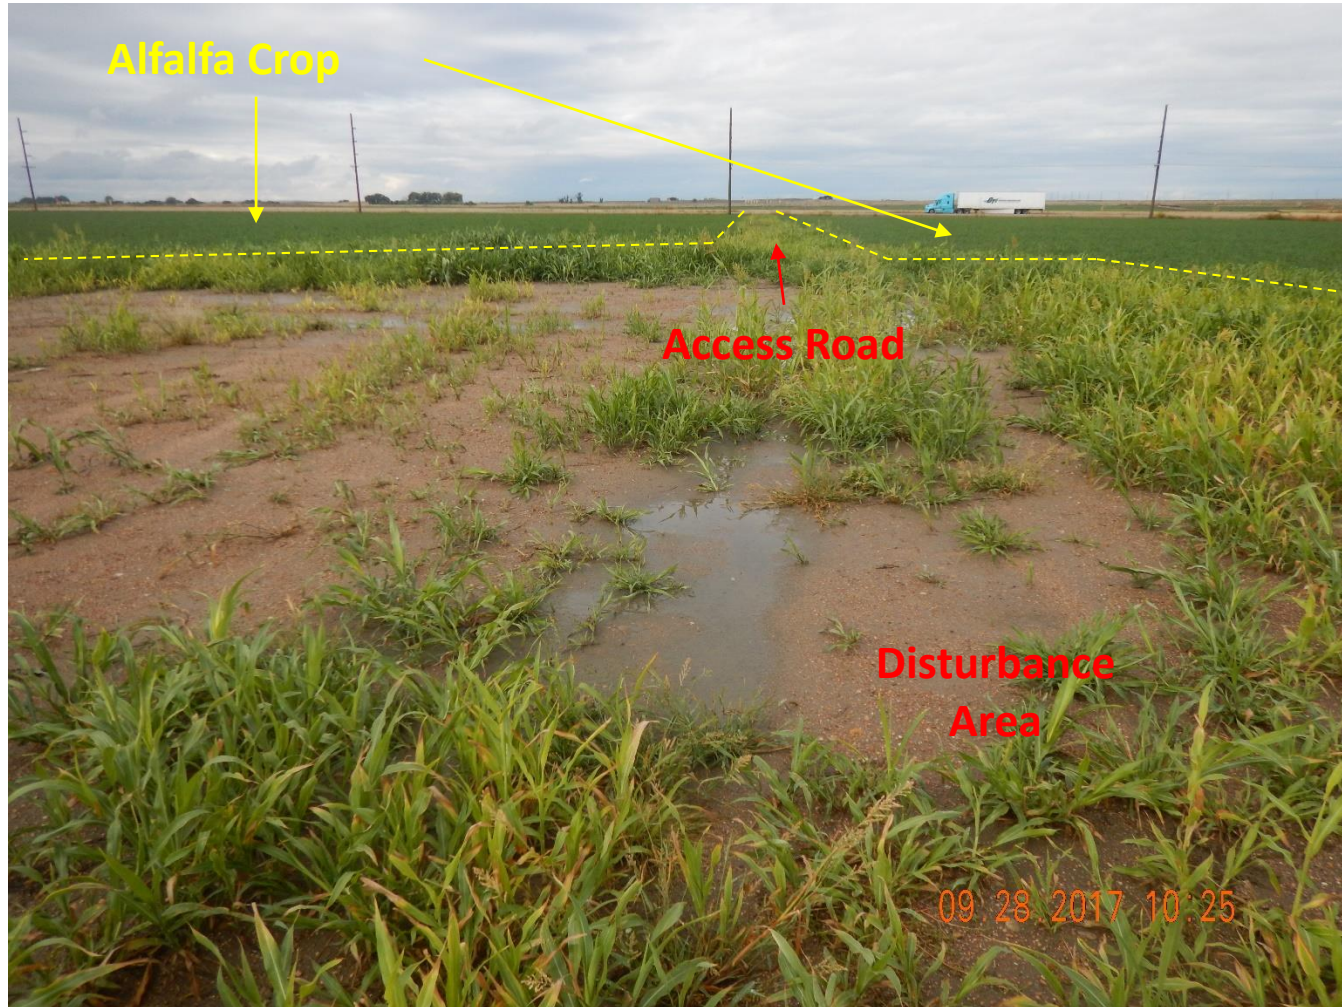
**Photo 5:** Photo taken from the battery location, facing west. Photo shows areas of disturbance, including the access road. See comments under photo 1.

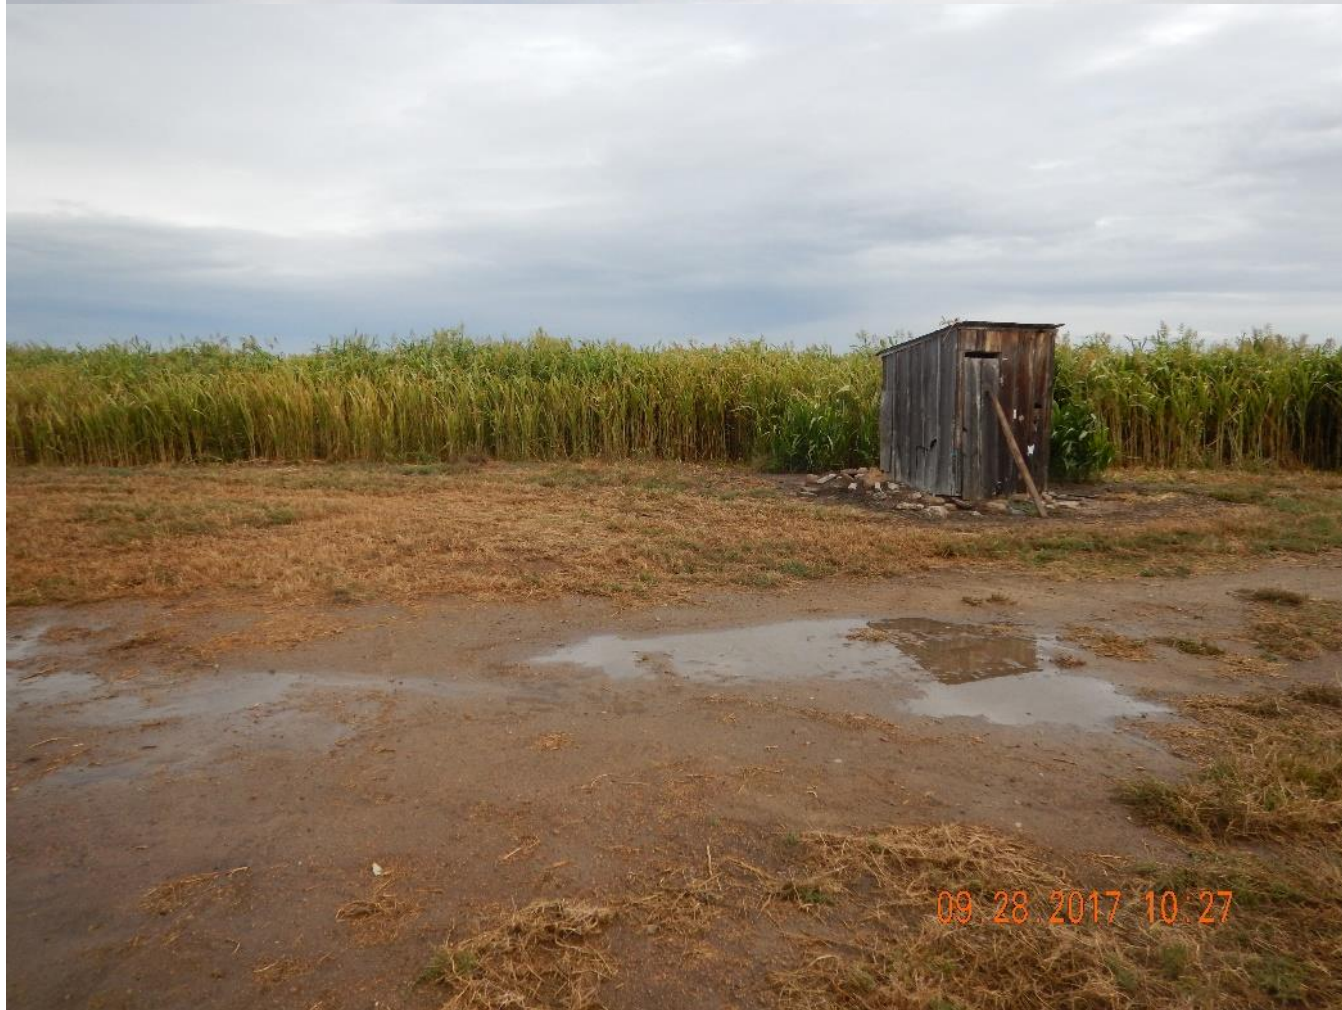
**Photo 6:** Photo taken north of the location. Though inspector is unsure as to when it was planted, photo the adjacent crop fields with similar sudax grass shows vegetative growth exceeding heights of 7 feet in areas.
