Inspection Photos

Operator: NOBLE ENERGY INC - 100322

Location ID: 326853

Inspection Doc. Number: 682502653

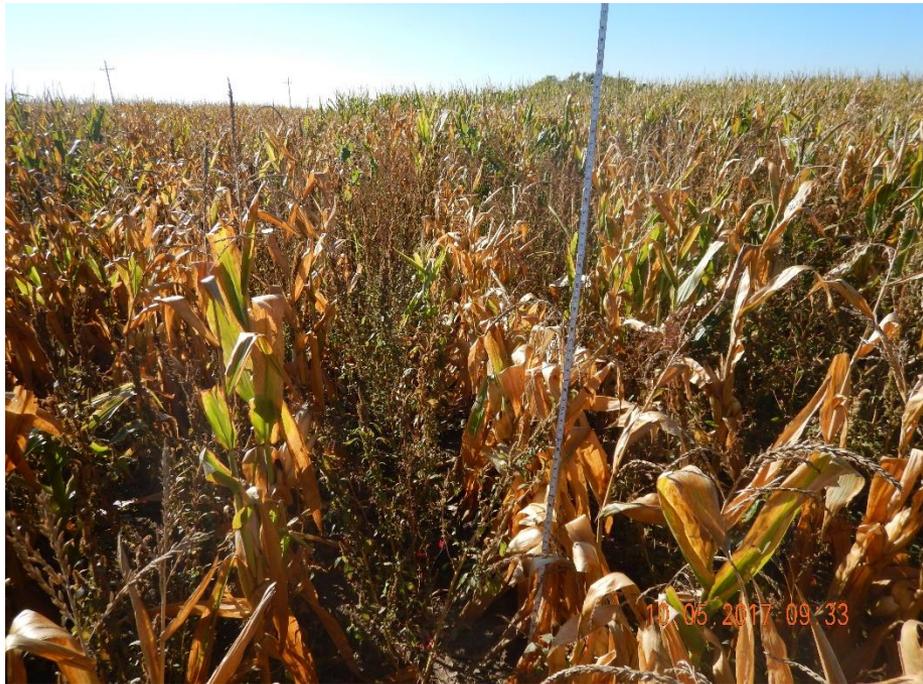
Photo 1: Photo taken from the access road. Photo shows corn crop vegetation is visibly stunted when compared to the adjacent reference area (see photo 2). Unable to find evidence that additional reclamation activities have been conducted per the corrective actions. 6 foot measuring stick for reference.

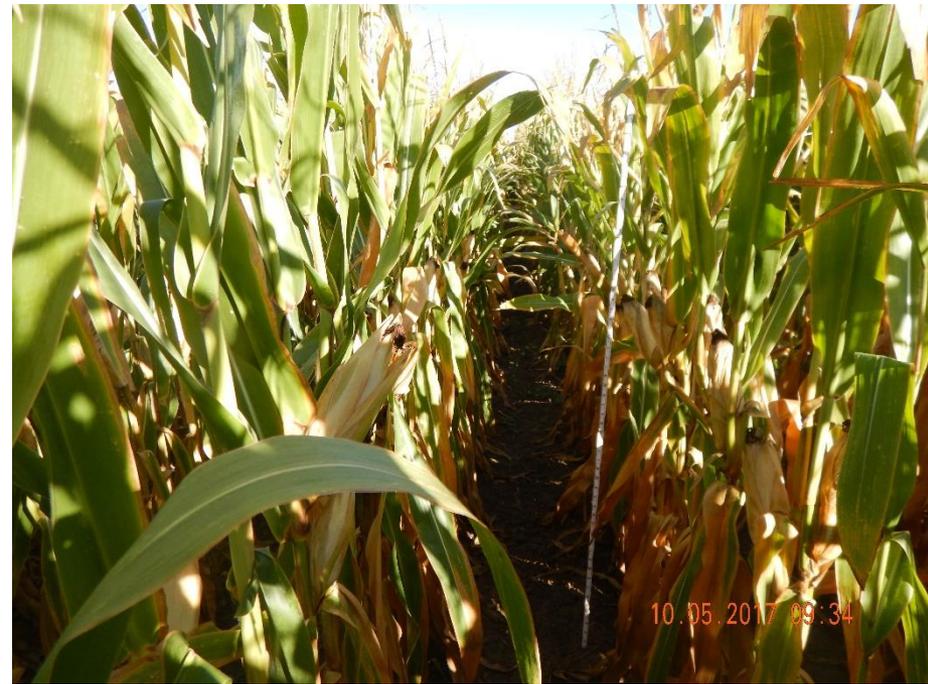
Photo 2: Photo taken from the adjacent reference area. Photo shows crop height in the reference area exceeds 6 feet. 6 foot measuring stick for reference.
