Inspection Photos

Operator: NOBLE ENERGY INC - 100322

Location ID: 322834

Inspection Doc. Number: 682502659

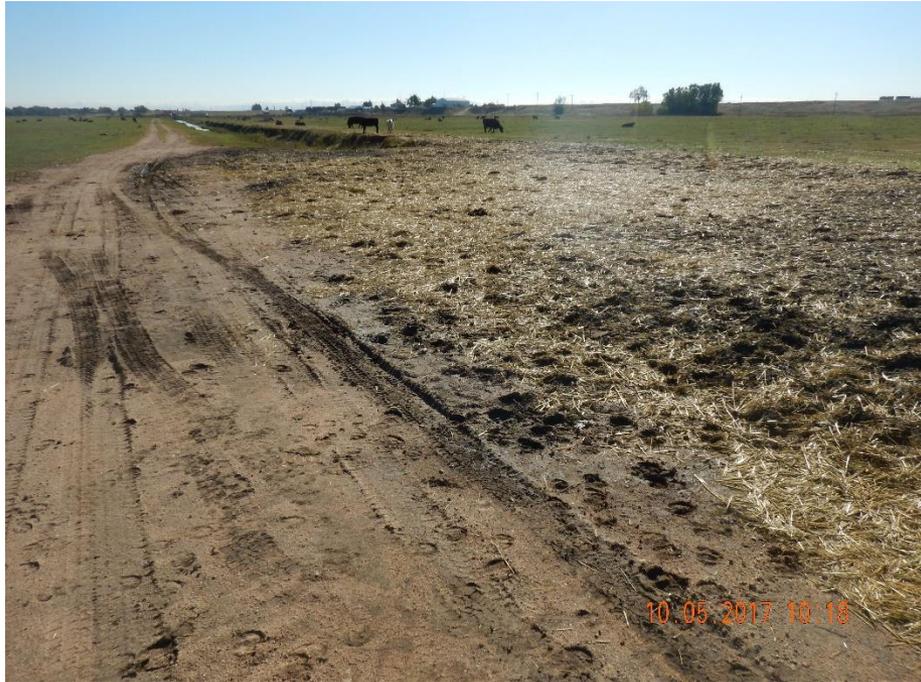
Photo 1: Photo taken from the northwest end of the former battery facility, facing southeast. Photo shows areas appear to have been re-seeded and stabilized via crimped straw.

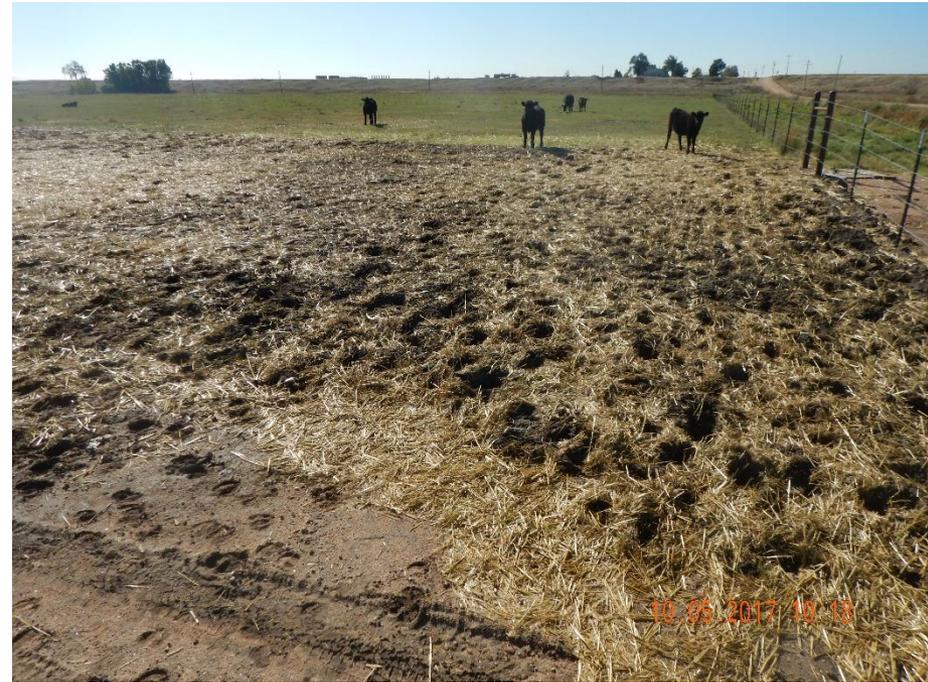
Photo 2: Photo taken from the northwest end of the former battery facility, facing south. Photo shows areas appear to have been re-seeded and stabilized via crimped straw.

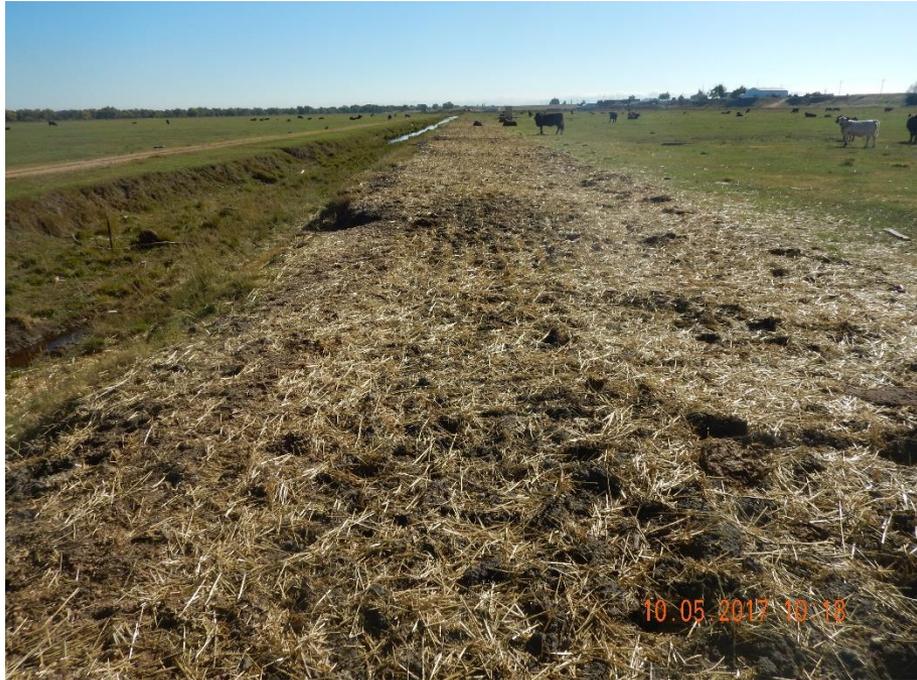
Photo 3: Photo taken from the east end of the former battery location, facing west. Photo shows access road appears to have been re-seeded and stabilized via crimped straw.

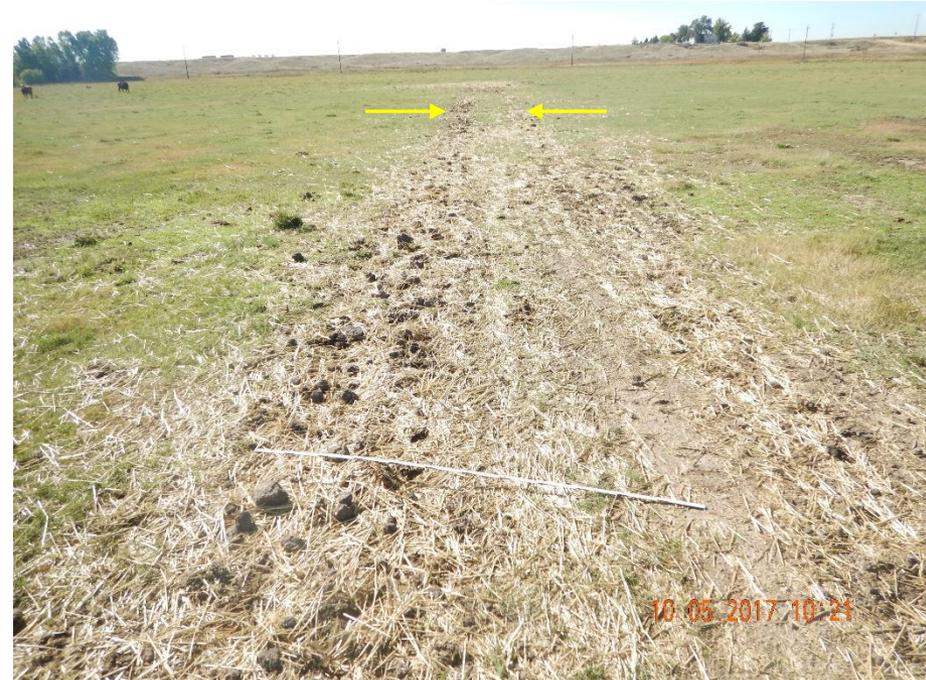
Photo 4: Photo taken north of the well location, facing south. Photo shows well and access road appears to have been reseeded and stabilized via crimped straw. Photo also shows areas of the access road where the ruts remain visible, this suggests the required compaction alleviation may not have been performed per reclamation rules. Reclamation will not pass until the required compaction alleviation of the access road and well have been performed.

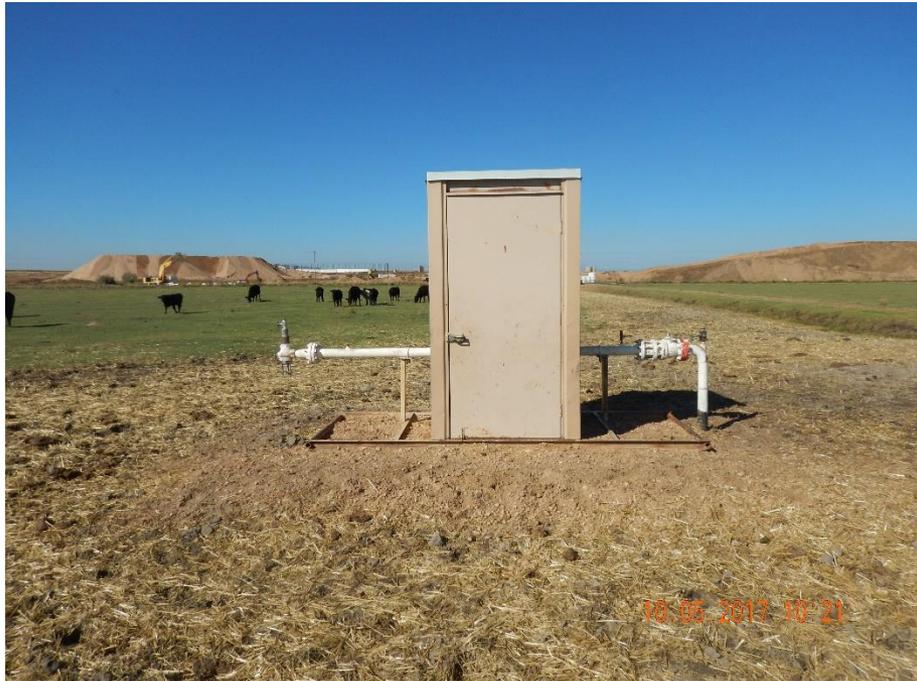
Photo 5: Photo taken north of the well location, facing west. Photo shows meter shed equipment has not been removed.

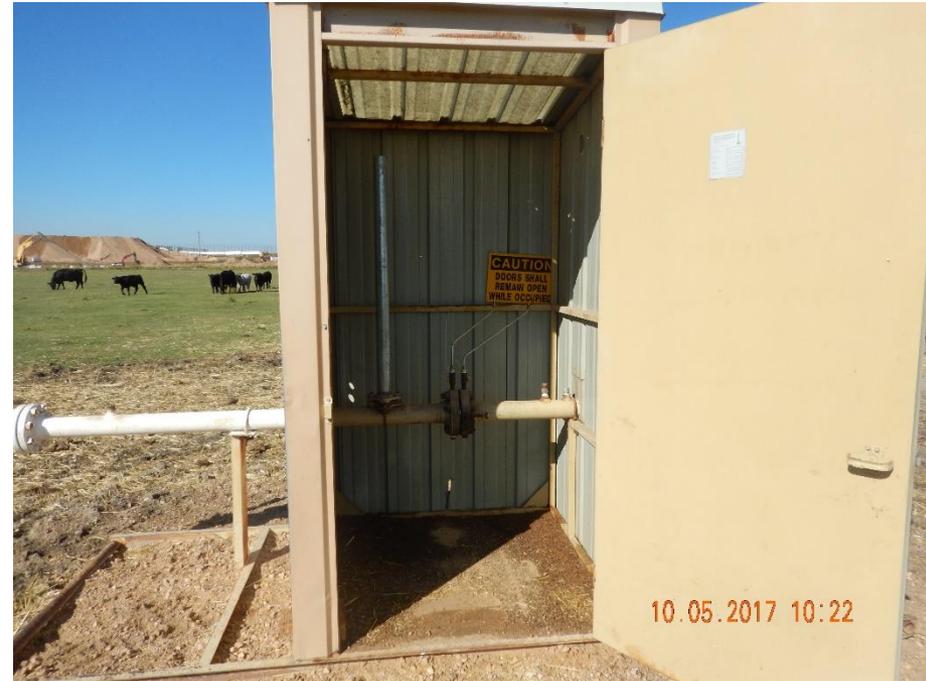
Photo 6: Photo taken from the meter shed, north of the well. Photo shows equipment has been removed from inside the meter shed.
