Reclamation Inspection

Operator: PDC ENERGY INC - #69175

Location ID: 445139

Inspection Photos
Location Name: Cecil's Kersey Farm
Location ID: 445139

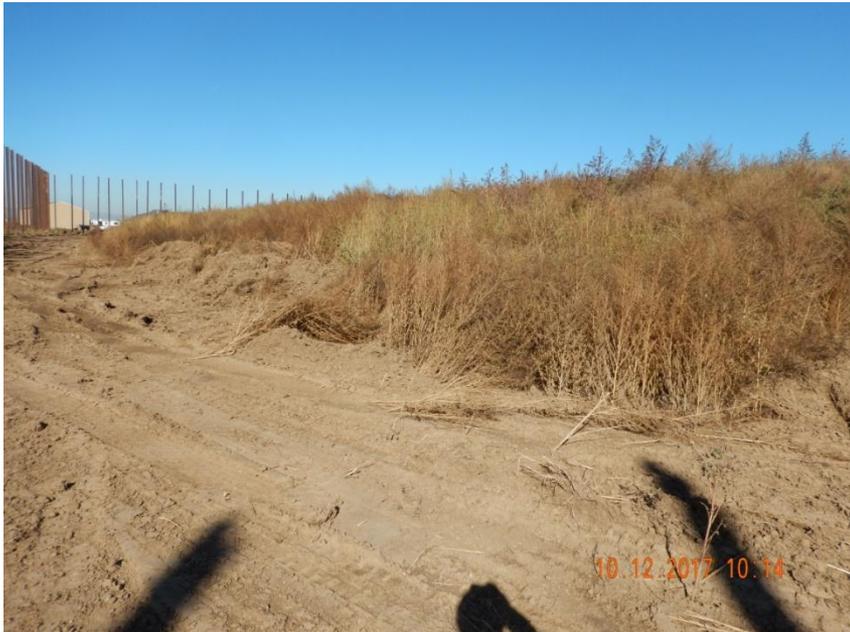
Photo 1. Photo taken from the southeastern location, facing West. Photo illustrates the southern topsoil stockpile is not being protected from weed establishment per Rule 1002.c. Topsoil stockpile has significant weed cover- Russian thistle and Kochia.

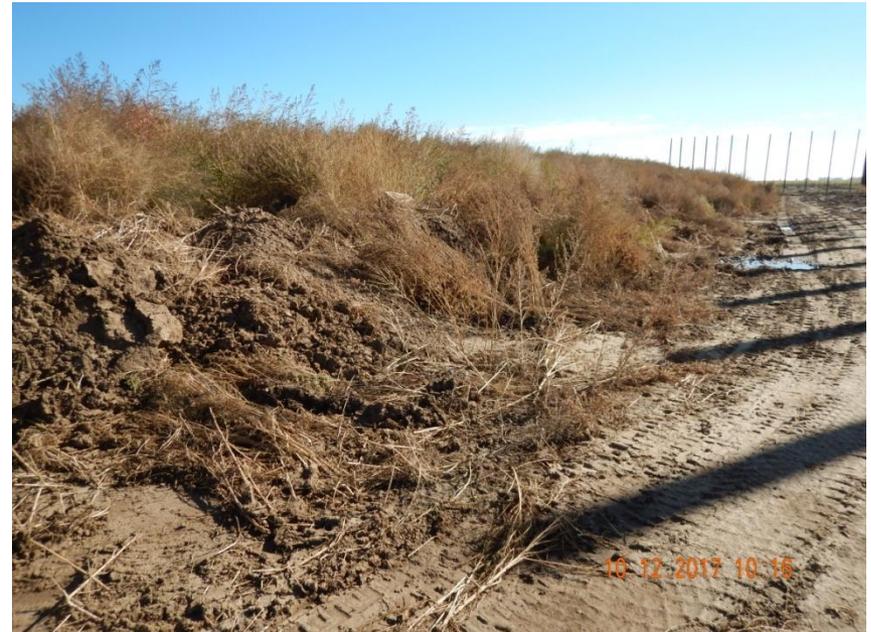
Photo 2. Photo taken from the southwest location, facing East. See comments under Photo 1.

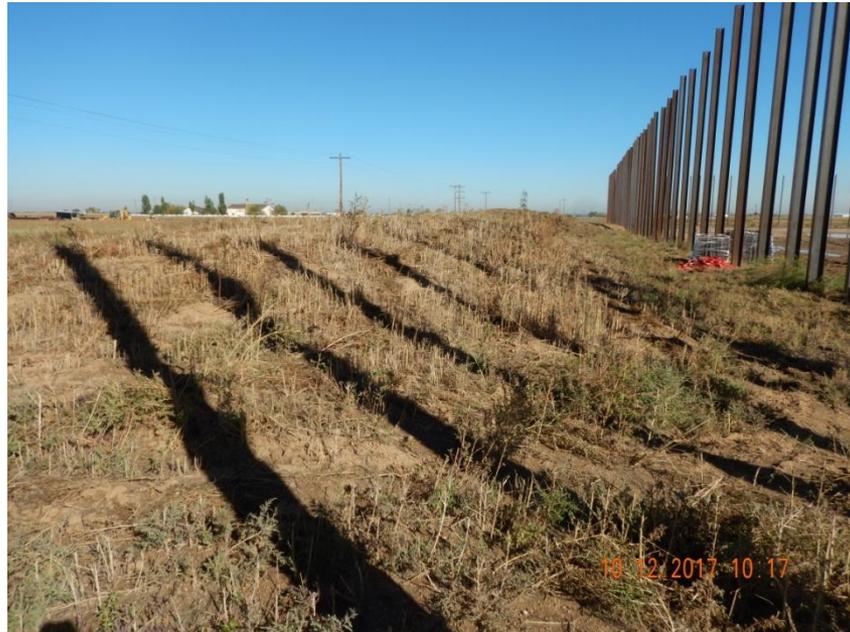
Photo 3. Photo taken from the southwestern location, facing North. Photo illustrates the western topsoil stockpile is not being protected from weed establishment per Rule 1002.c. Topsoil stockpile has significant weed cover- Russian thistle and Kochia.
