# Interim Reclamation and Stormwater Inspection

October 25, 2017

Operator: EXTRACTION OIL & GAS LLC- #10459

Location ID: 427157

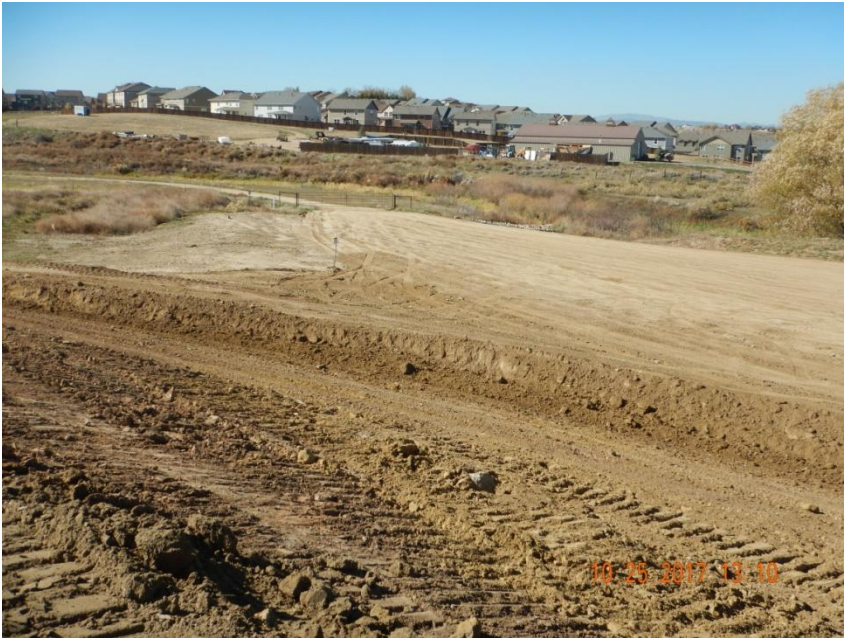
**Photo 1.** Photo taken from the north stockpile located on the middle tier, facing Northwest. Northwestern area appears to have been re-graded to direct stormwater flows east towards the sediment basin.

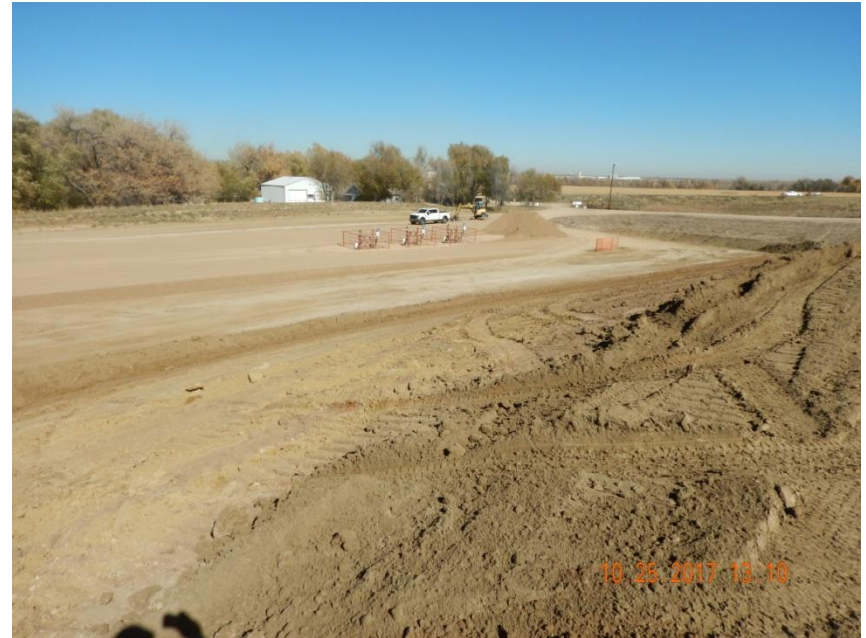
**Photo 2.** Photo taken from the north stockpile located on the middle tier, facing Northeast. Stormwater construction work in process along the northern location.

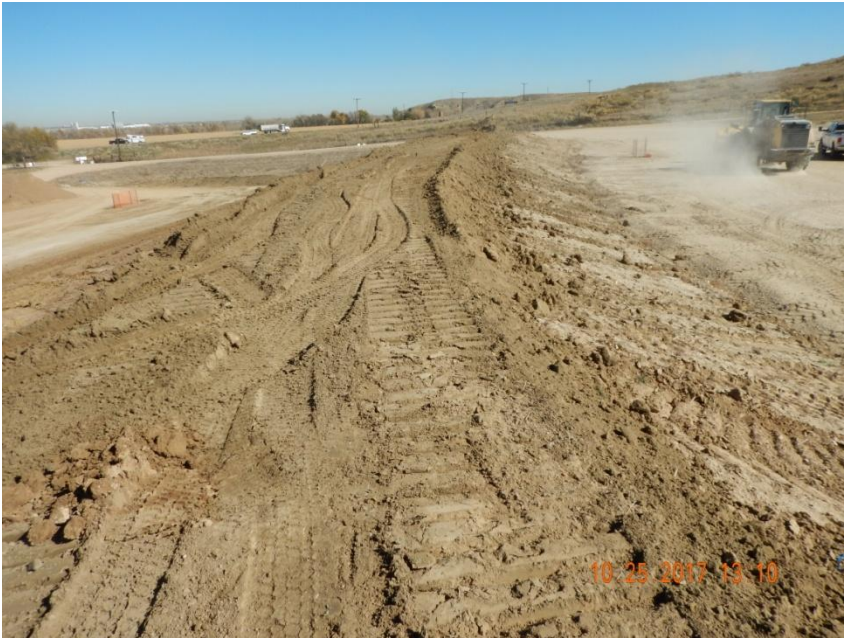
**Photo 3.** Photo taken from the north stockpile located on the middle tier, facing East. Material from the sediment basin is being spread onto the north stockpile and other stormwater erosion areas.

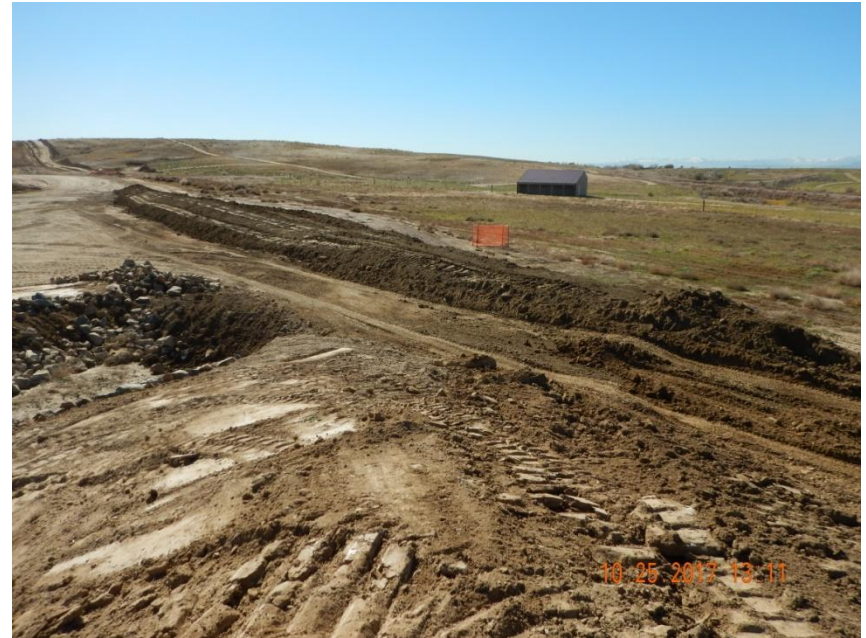
**Photo 4.** Photo taken from the north stockpile located on the middle tier, facing West. Stormwater construction work in process along the western location. Appears a berm is being constructed and the western access road has been removed.
