Inspection Photos
Location Name: Bunn 1-35
API #: 05-123-10978
Location ID: 319270

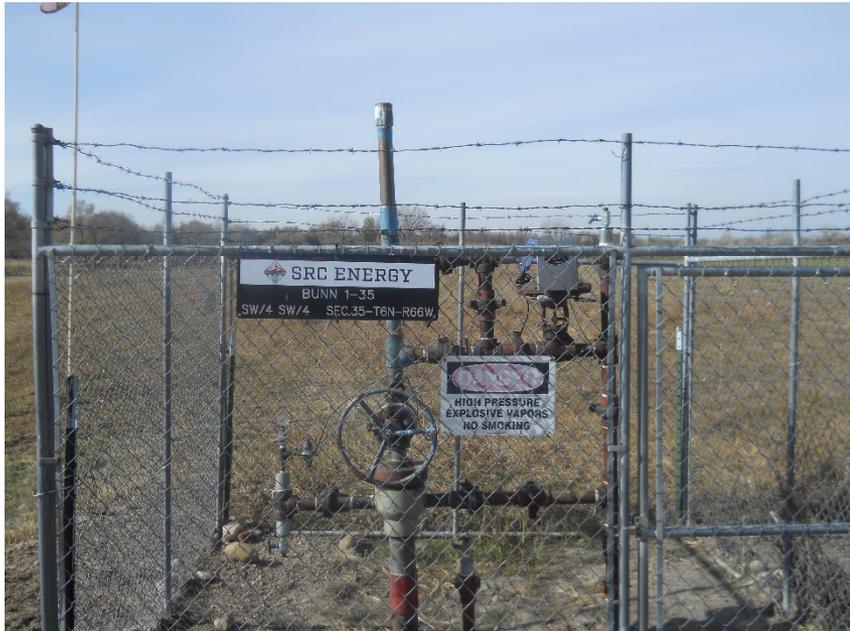
Wellhead looking west

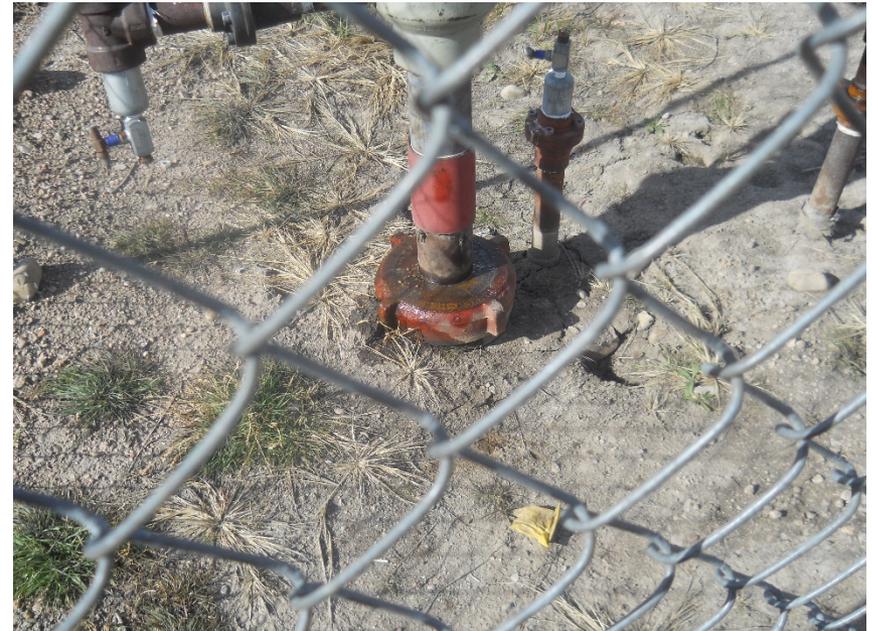
Stained soil around wellhead needs to be cleaned up. Appears that wellhead packing is leaking or has leaked at some point
