Inspection Photos

Operator: DIAMOND OPERATING, INC. - 24320

Location ID: 317281

Inspection Doc. Number: 682502765

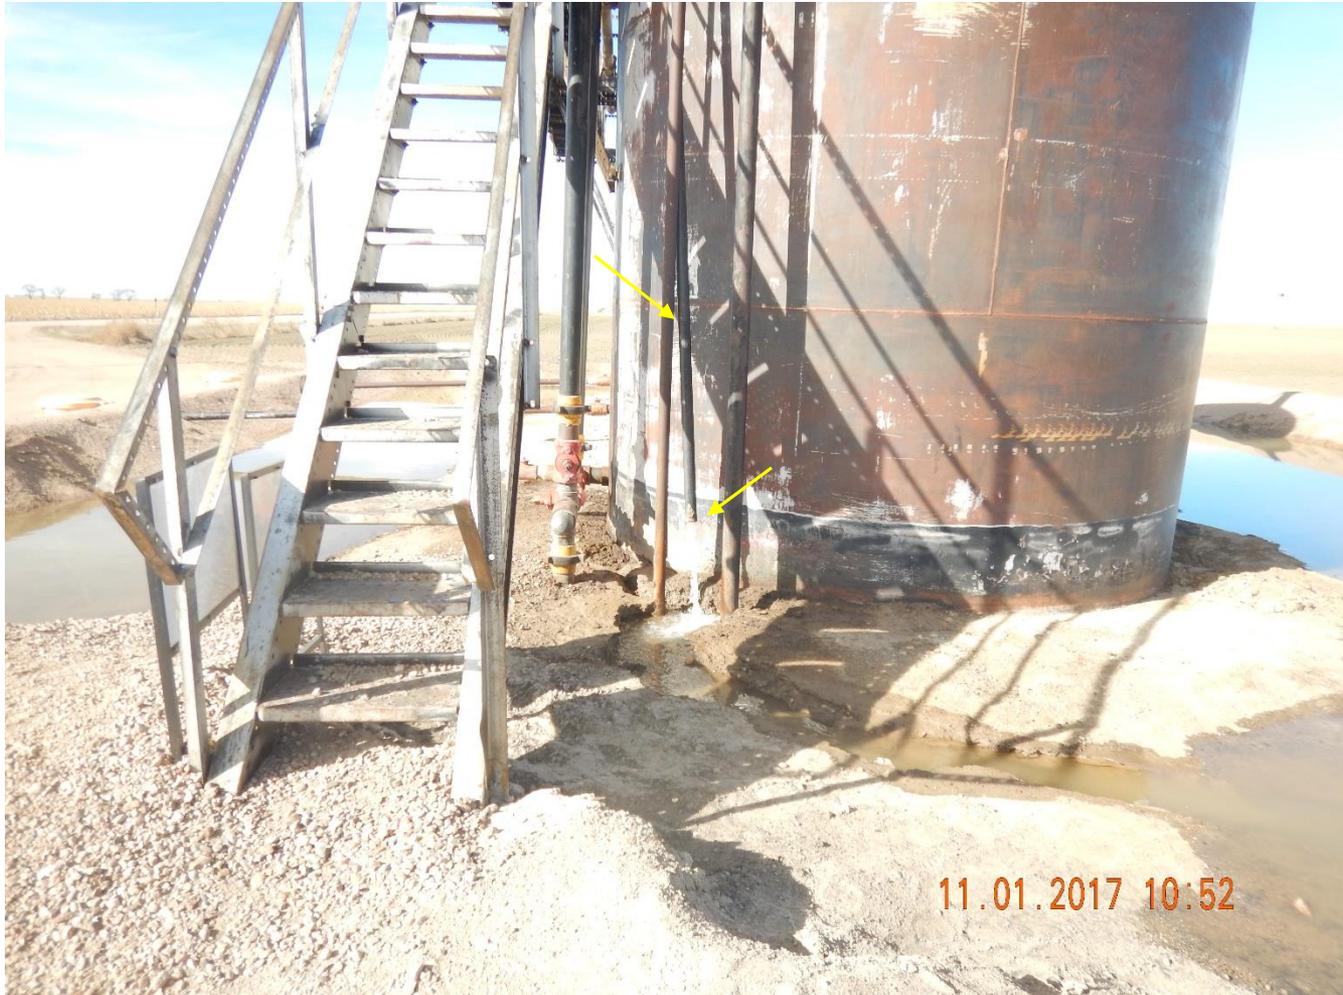
Photo 2: Photo taken from the east side of the produced water tank. Photo shows produced water is being discharged via the overflow-siphon line and into the containment berm.

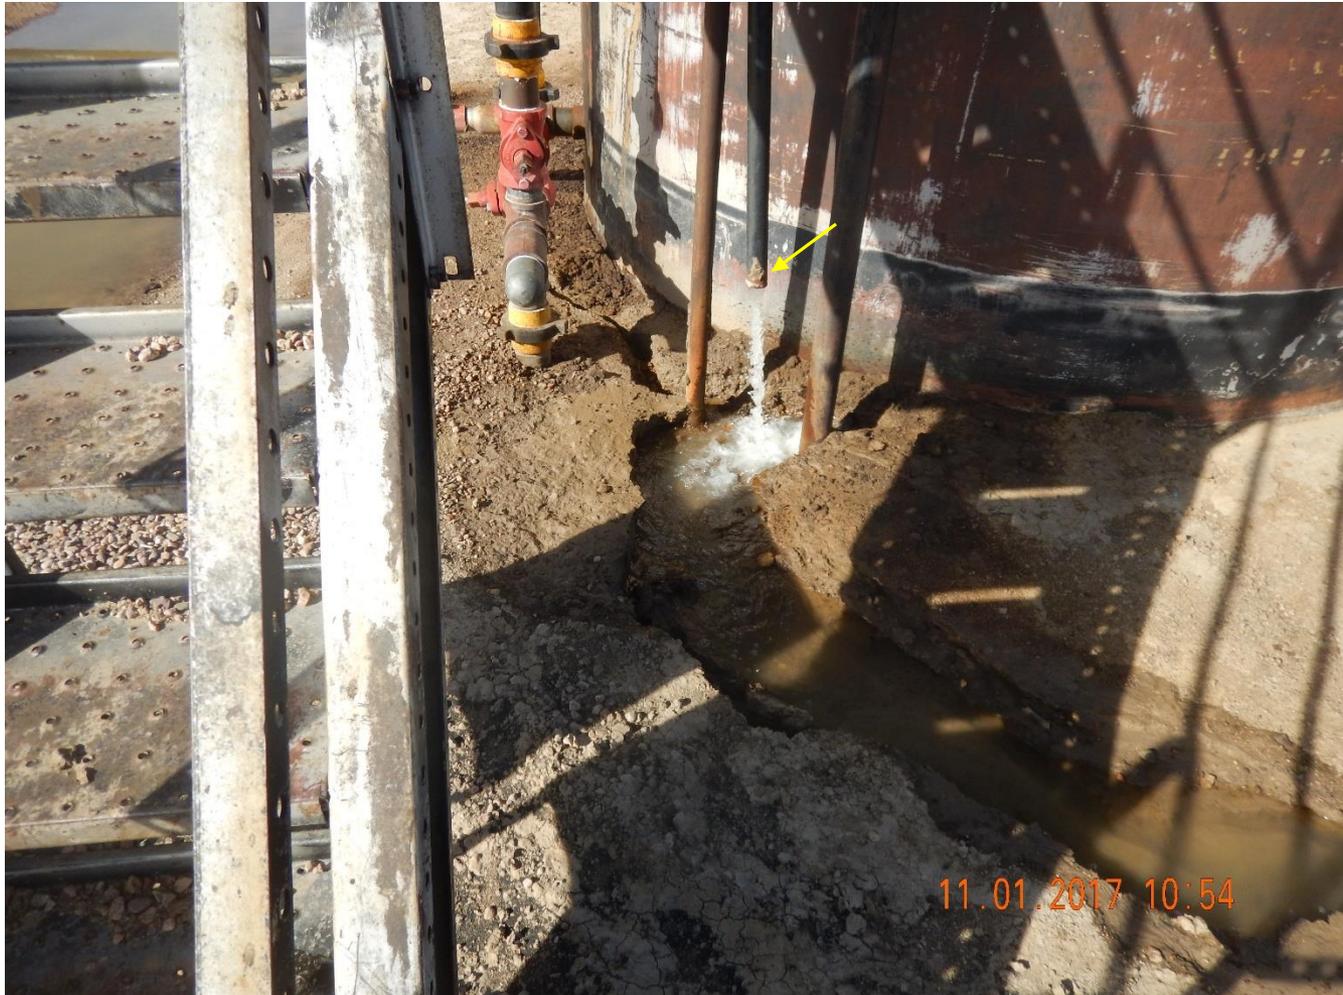
Photo 3: Photo taken from the east side of the produced water tank. Photo shows produced water is being discharged via the overflow-siphon line and into the containment berm.

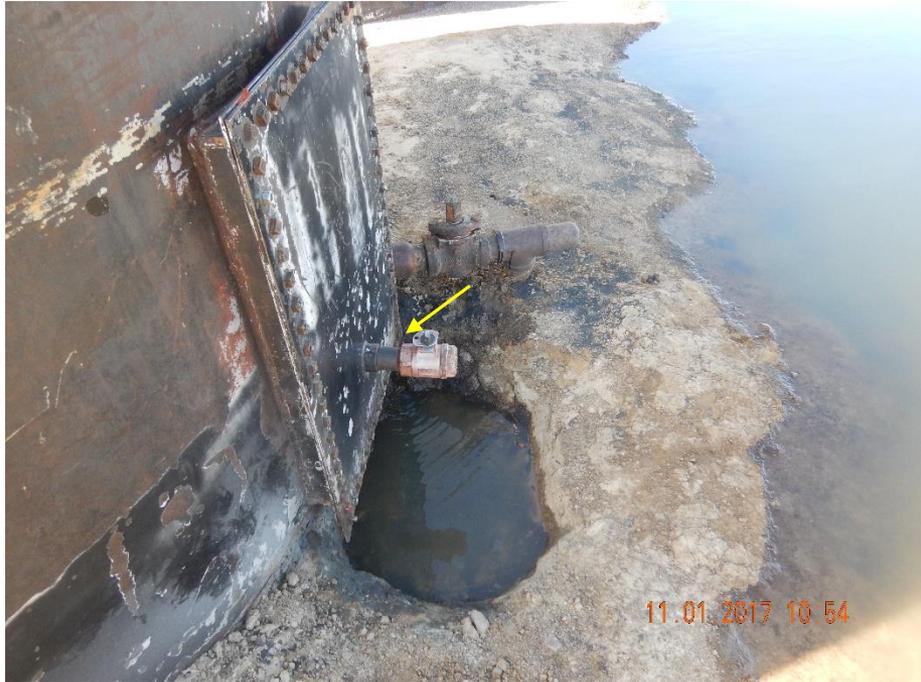
Photo 4: Photo taken from the north end of the produced water tank. Photo shows a leak occurring at the base of the manifold. This will require repair.

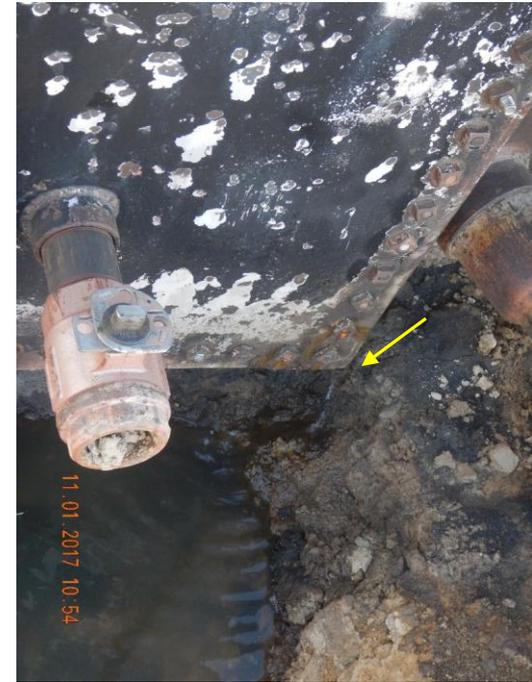
Photo 5: Photo taken from the north end of the produced water tank. Photo shows a leak occurring at the base of the manifold. This will require repair.

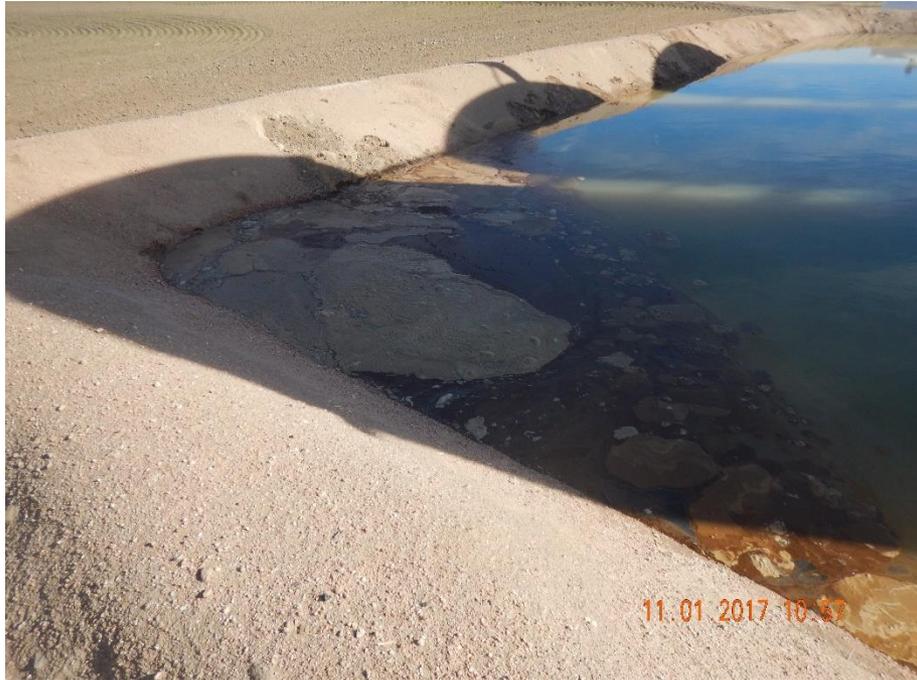
Photo 6: Photo taken from the west end of the battery. Photo shows produced water discharged into the containment berm. Photo also shows oil residue.

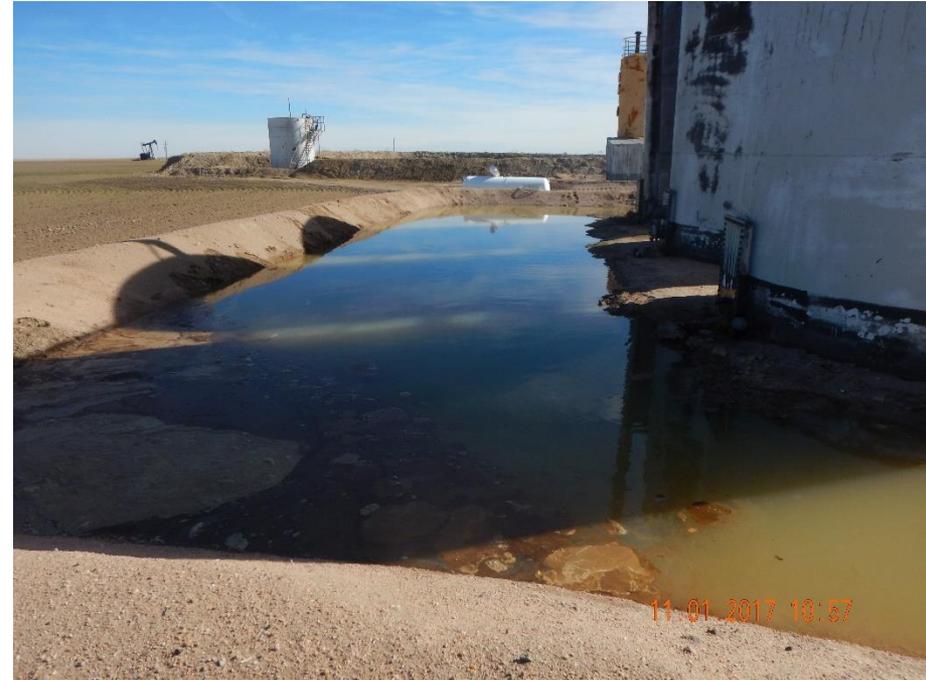
Photo 7: Photo taken from the west end of the battery. Photo shows produced water discharged into the containment berm. Photo also shows oil residue.

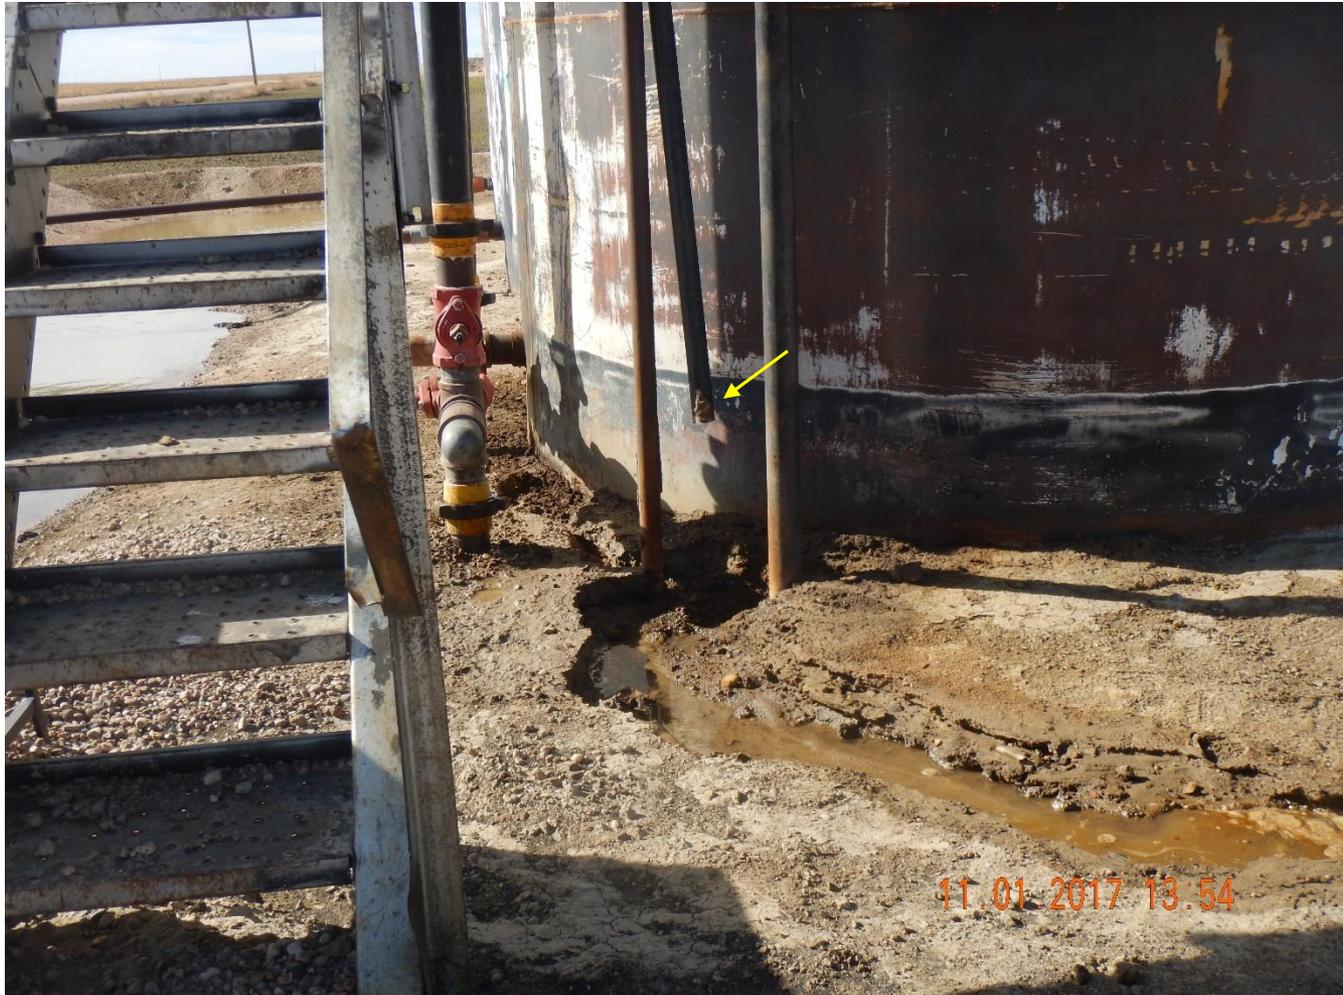
Photo 8: Photo taken from the east side of the produced water tank. Inspector met with pumper on site. Pumper was able to shut in the wells and stop the discharge. Photo shows discharge has been stopped.
