# Final Reclamation Inspection

November 2, 2017

Operator: SUNDANCE ENERGY INC - 10340

Location ID: 429637

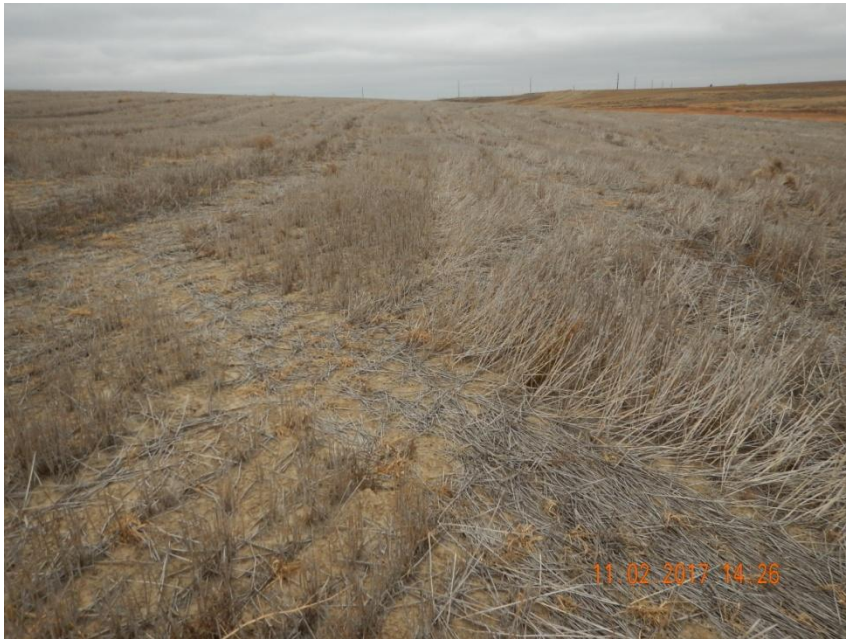
**Photo 1.** Photo taken on November 2, 2017 from the south central BRA, facing East. Wheat stubble from the 2016 harvest appeared to have uniform establishment and density reflective of reference crop area levels, indicating the BRA has met Rule 1004 standards. See photo 2 illustrating a reference area.

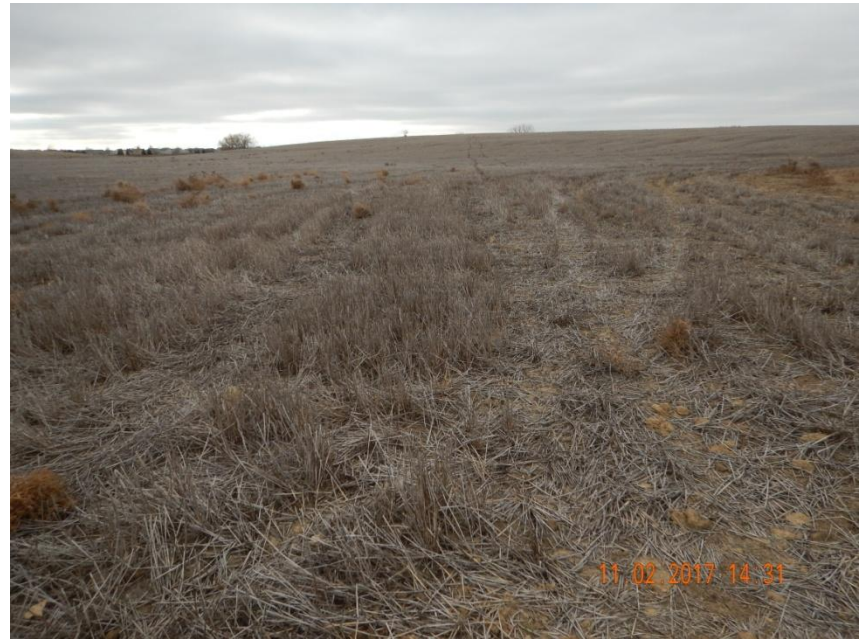
**Photo 2.** Reference photo taken on November 2, 2017 from the wheat field southwest of the BRA, facing West. Wheat stubble in reference crop areas appear to be reflective of the BRA, indicating the BRA has met Rule 1004 standards.

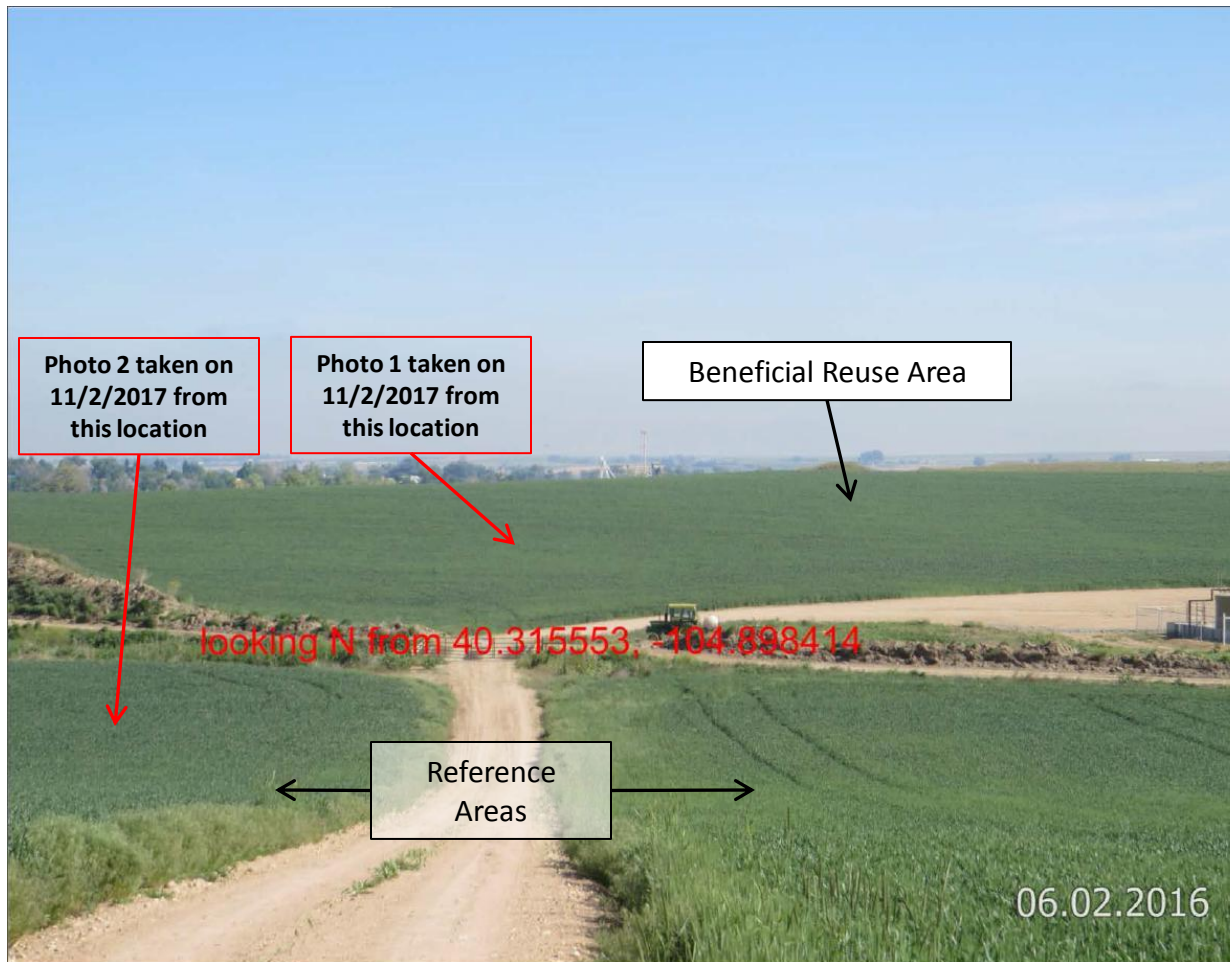
**Photo 3.** Photo taken on June 2, 2016 by COGCC staff from 40.315553, -104.898414, facing North. The photo illustrates the western half of the Sundance Beneficial Reuse Area (BRA) which is the northernmost wheat field. Based off this photo, it appears the BRA was reflective of reference crop area levels, indicating the BRA has met Rule 1004 standards.

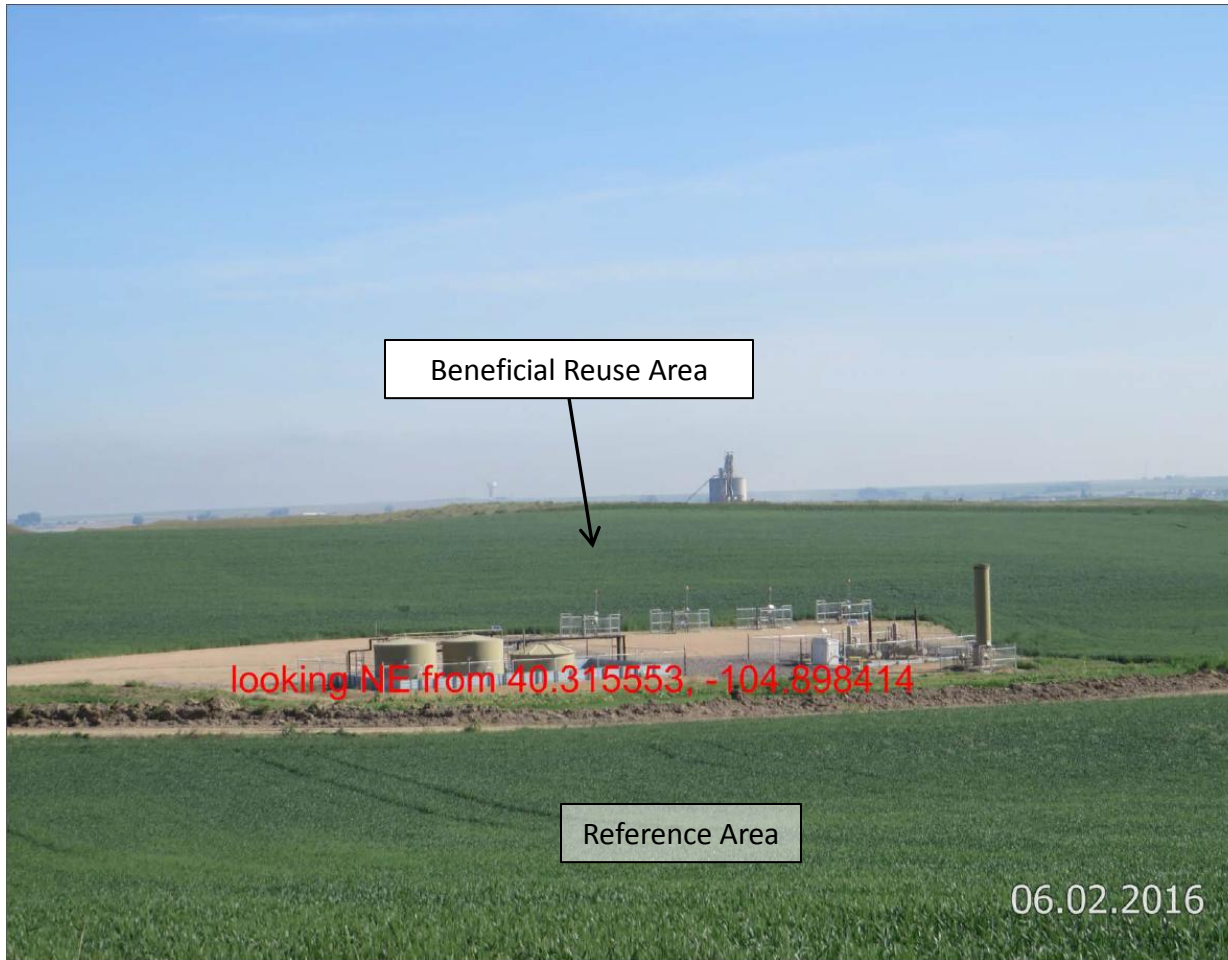
**Photo 4.** Photo taken on June 2, 2016 by COGCC staff from the previously mentioned coordinates, facing Northeast. The photo illustrates the eastern half of the Sundance Beneficial Reuse Area (BRA) which is the northernmost wheat field. Based off this photo, it appears the BRA was reflective of reference crop area levels, indicating the BRA has met Rule 1004 standards.
