Stormwater Inspection

Operator: K P KAUFFMAN COMPANY INC - 46290

Location ID: 320780

Inspection Photos
Location Name: RRR&S
Location ID: 320780

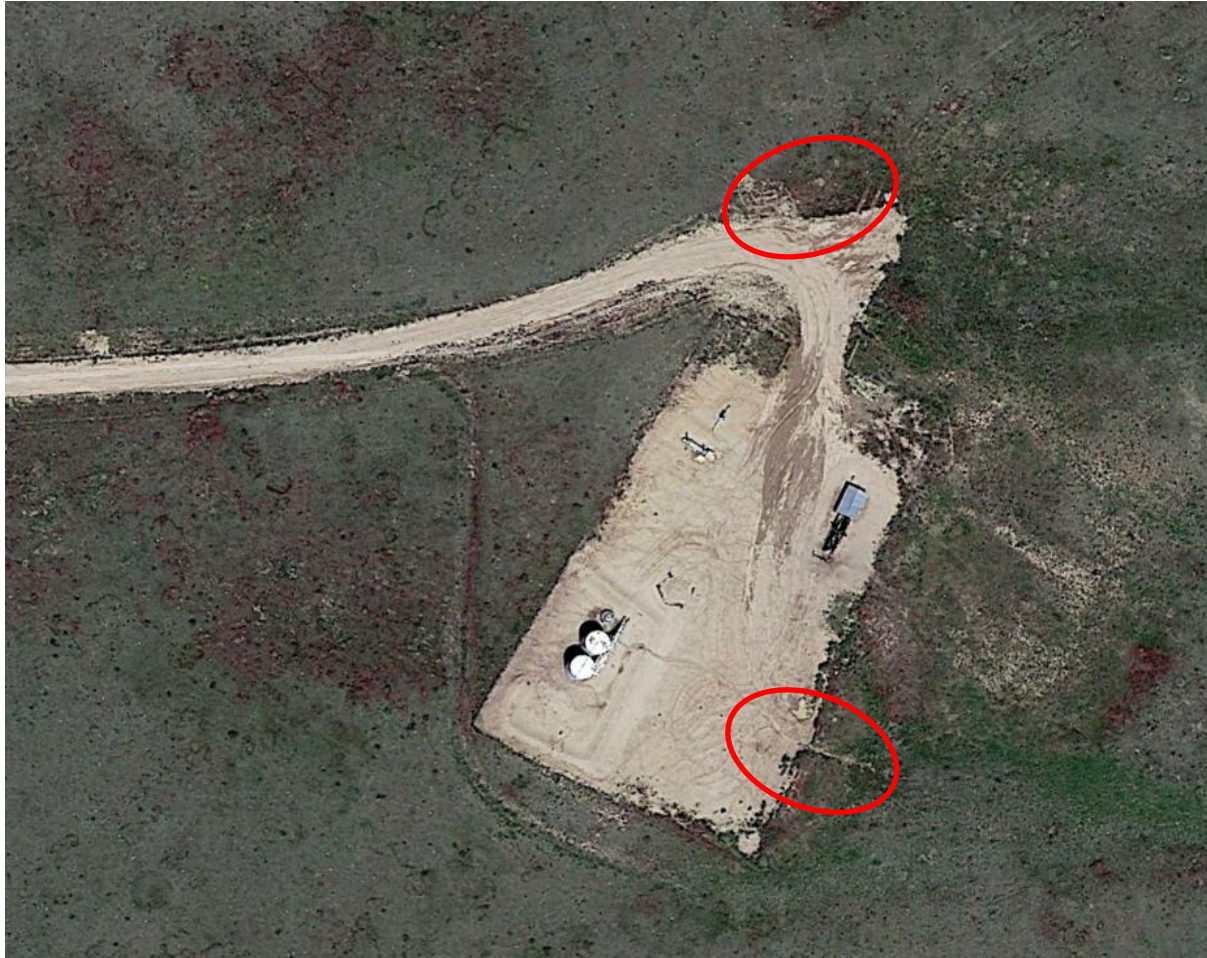
Google Earth aerial imagery taken 6/14/2016 illustrating well location during operations. Two points of discharge were observed during the August 11, 2017 inspection along a portion of the access road and along the southeastern well location (highlighted in the red circles).

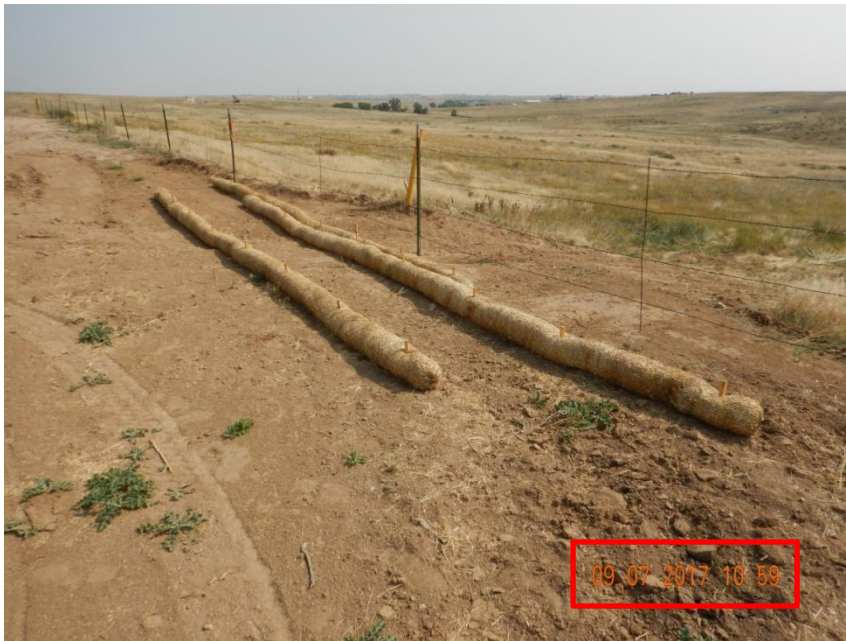
Photo 1. Photo taken September 7, 2017 from the eastern location where there was a previous gully erosion event, facing Northeast. Appears to Operator has repaired the erosion. Operator has installed wattle BMPs but BMP has not been properly installed and is not a sufficient BMP.

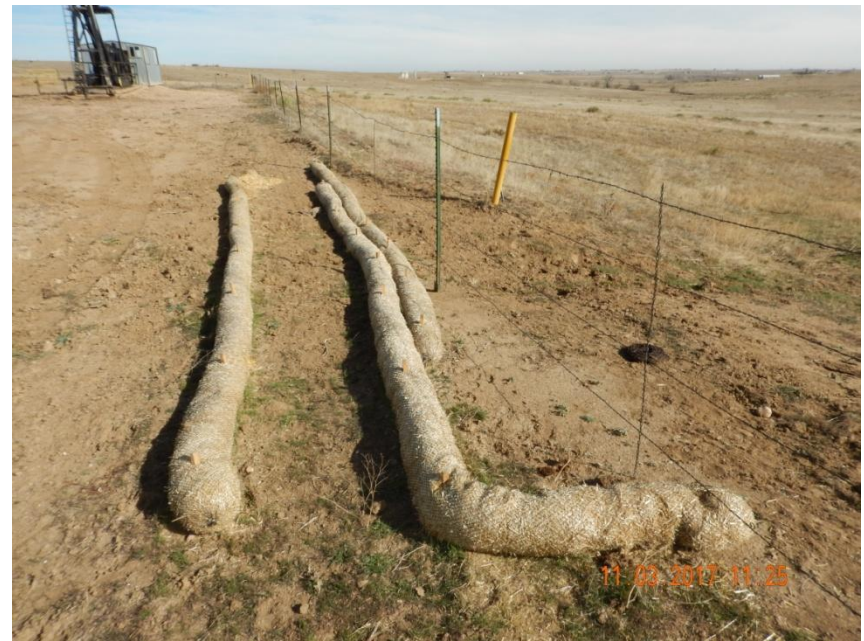
Photo 2. Photo taken November 3, 2017 from the previous photo location, facing North. Operator has not performed any further work to install sufficient BMPs. Portions of the wattle BMP have been damaged due to cattle.

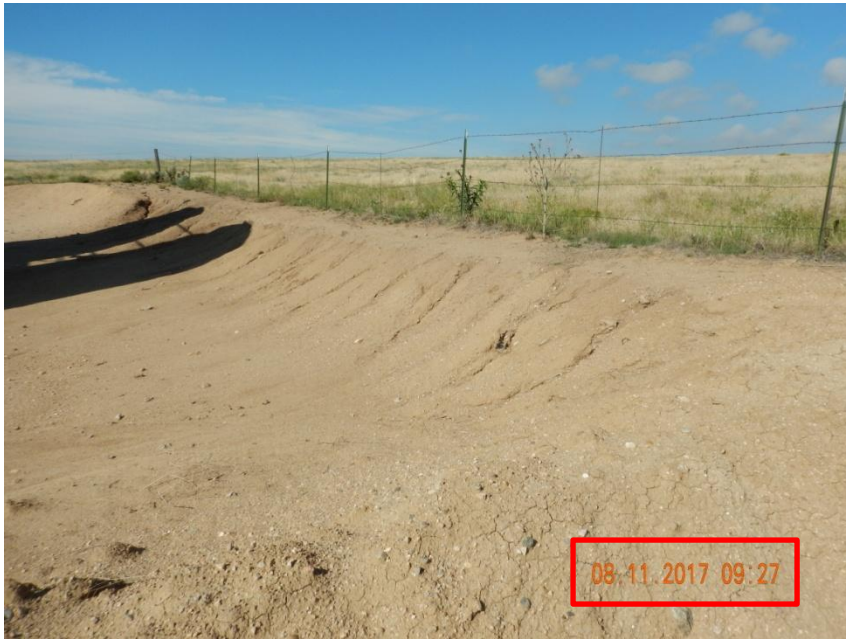
Photo 3. Photo taken August 11, 2017 from the western location, facing Southwest. Rill erosion occurring throughout the cut slope contributing to sediment discharge off location. Cut slope needs to be stabilized to prevent erosion and stabilize the production area.

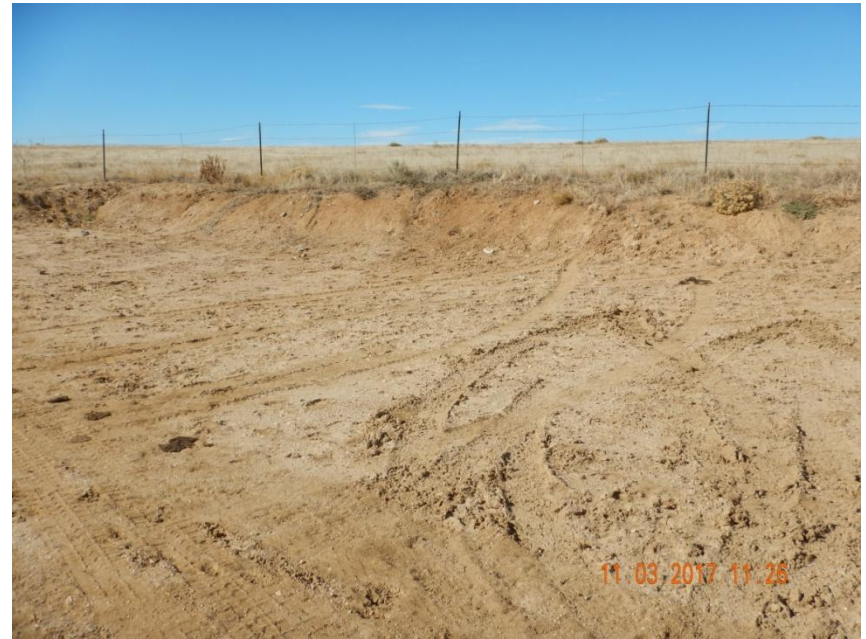
Photo 4. Photo taken November 3, 2017 from the previous photo location, facing Southwest. Does not appear the Operator has made repairs to the rill erosion along the cut slope. Does not appear the Operator has installed a BMP to prevent erosion and stabilize the production area.

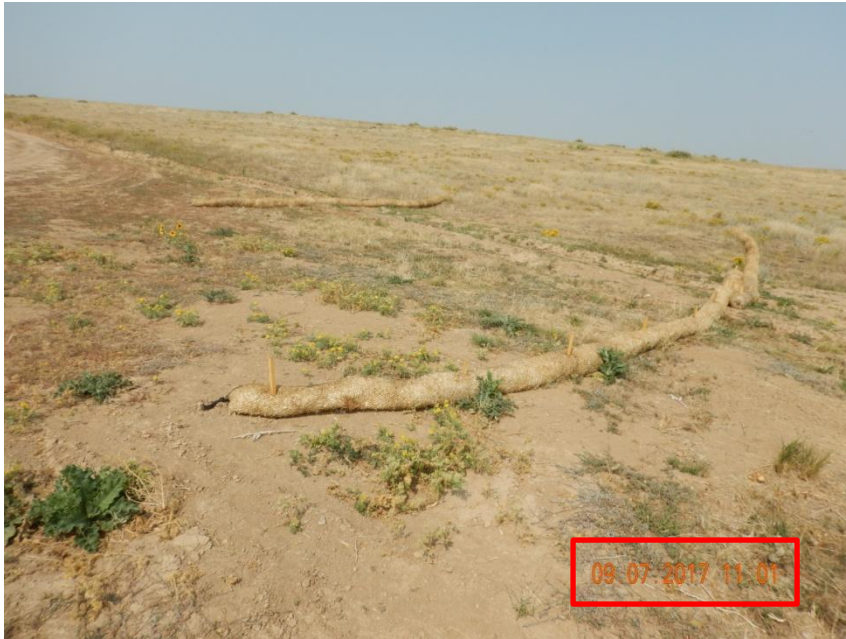
Photo 5. Photo taken September 7, 2017 from the second discharge point off the main access road, facing North. Operator has installed wattle BMPs but BMP has not been properly installed and is not a sufficient BMP.

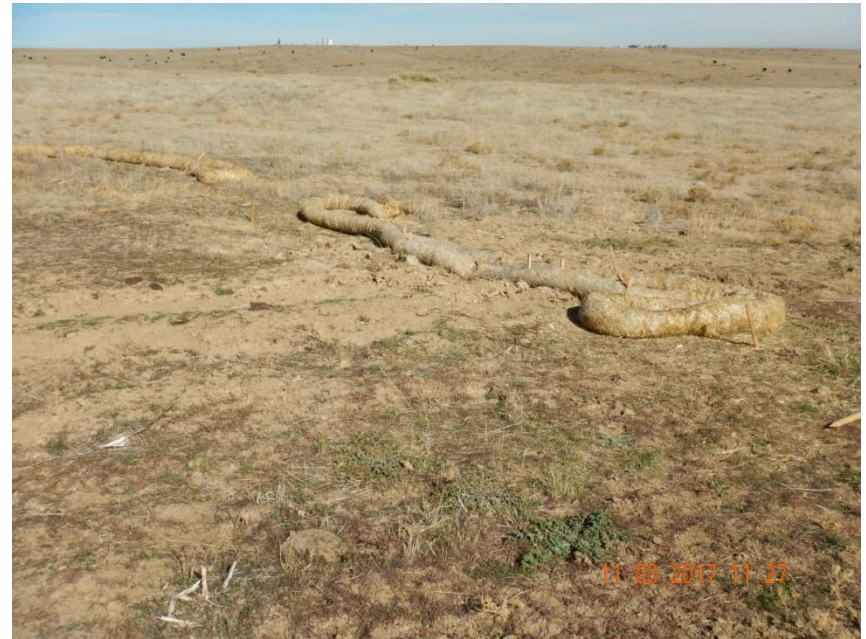
Photo 6. Photo taken November 3, 2017 from the previous photo location, facing North. Operator has not performed any further work to install sufficient BMPs. The wattle BMP has been damaged due to cattle and is not in proper functioning condition.
