Stormwater Inspection

Operator: PETROSHARE CORPORATION- 10454

Location ID: 322194

Location Name: NORDMAN TRUST #41-20

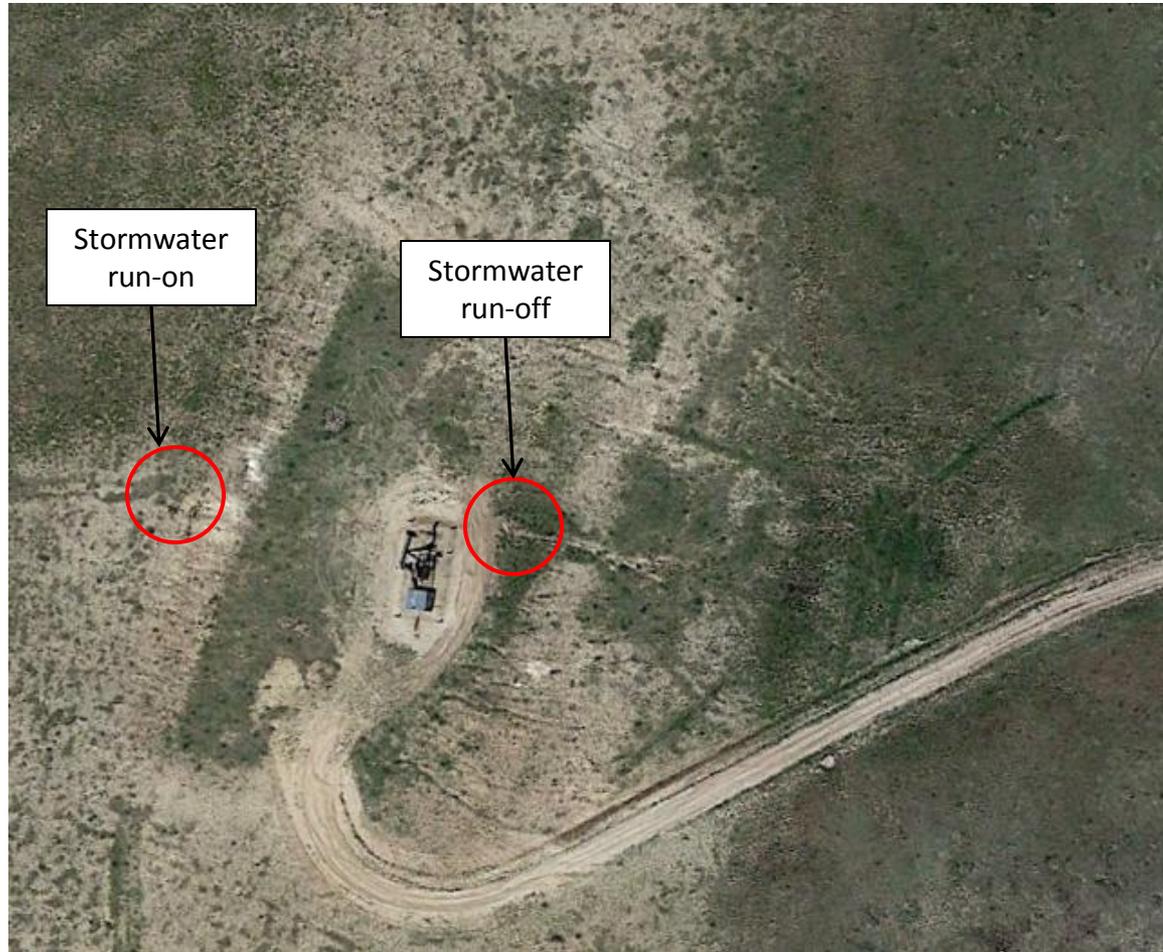
Google Earth aerial imagery taken 6/14/2016 illustrating well location during operations. A point of discharge was observed during the November 3, 2017 inspection along the northeastern well pad (highlighted in the red circle). A portion of the western cut slope has stormwater run-on which is causing degradation to the location. Also, erosion issues were also observed along the access road. See the following photos for more detail.

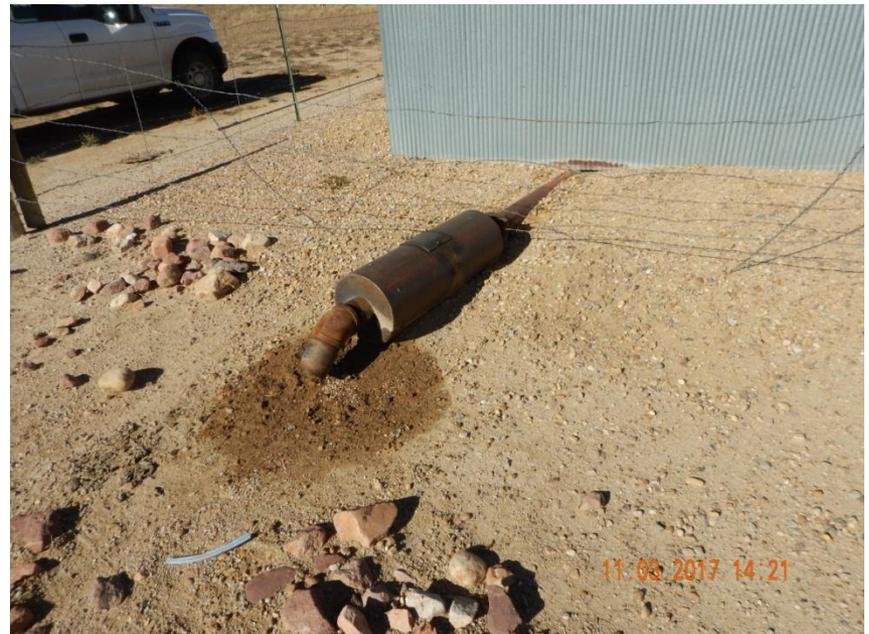
Photo 2. Photo taken from the well location, facing North. Remove or remediate stained soil per Rule 906.a.

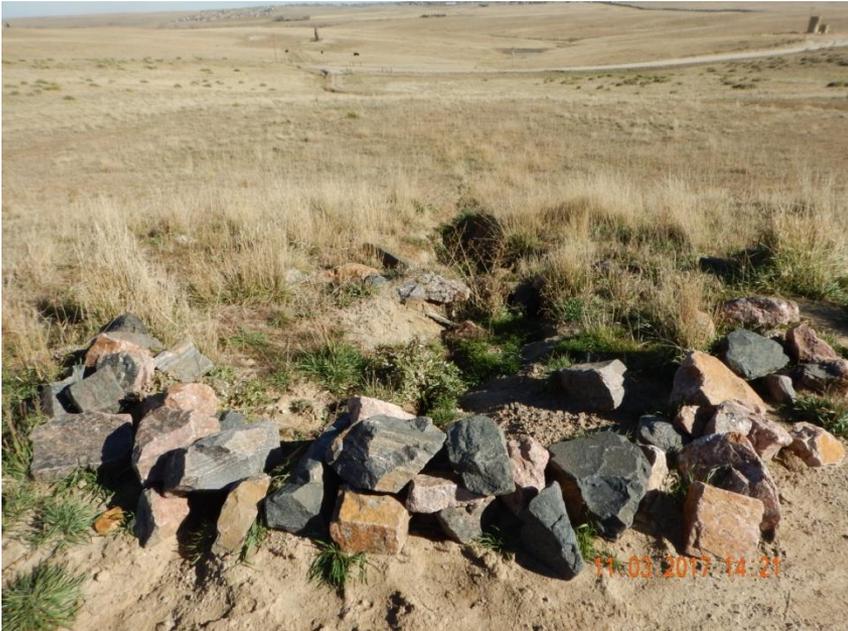
Photo 3. Photo taken from the northeast well pad, facing East. Rip-rap has been installed but does not appear to be a sufficient BMP as active gully erosion is evident. Operator needs to repair gully erosion and install sufficient BMPs.

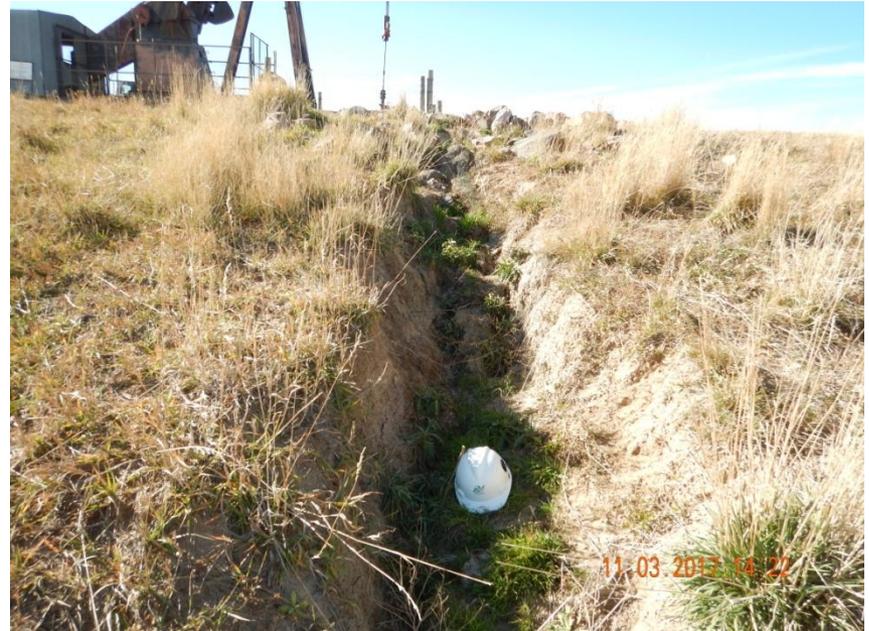
Photo 4. Photo taken downgradient from the gully erosion, facing West. See comments under Photo 3.

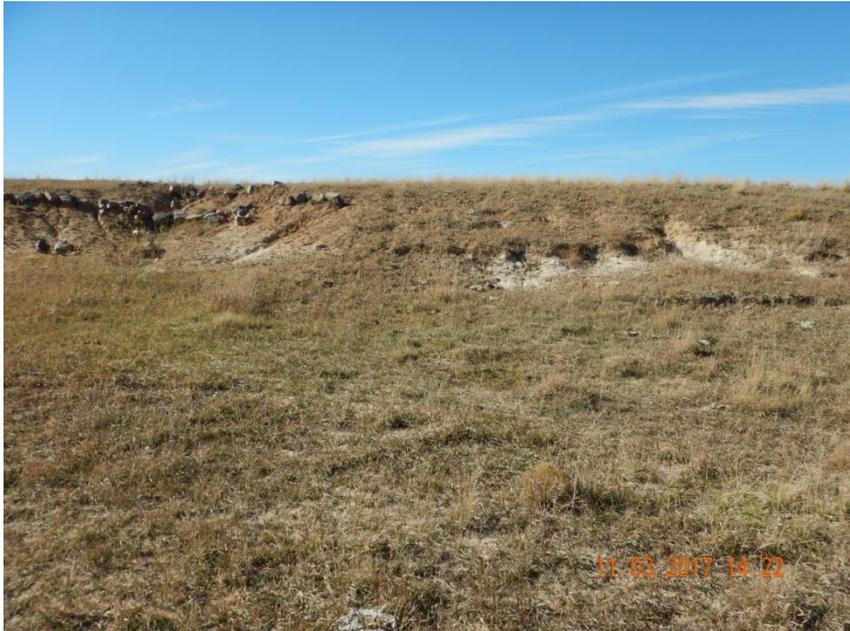
Photo 5. Photo taken from the western well pad location, facing West. Appears stormwater run-on onto the location is causing gully erosion along the western cut slope which is causing degradation to the location. Operator needs to repair gully erosion and install sufficient BMPs.

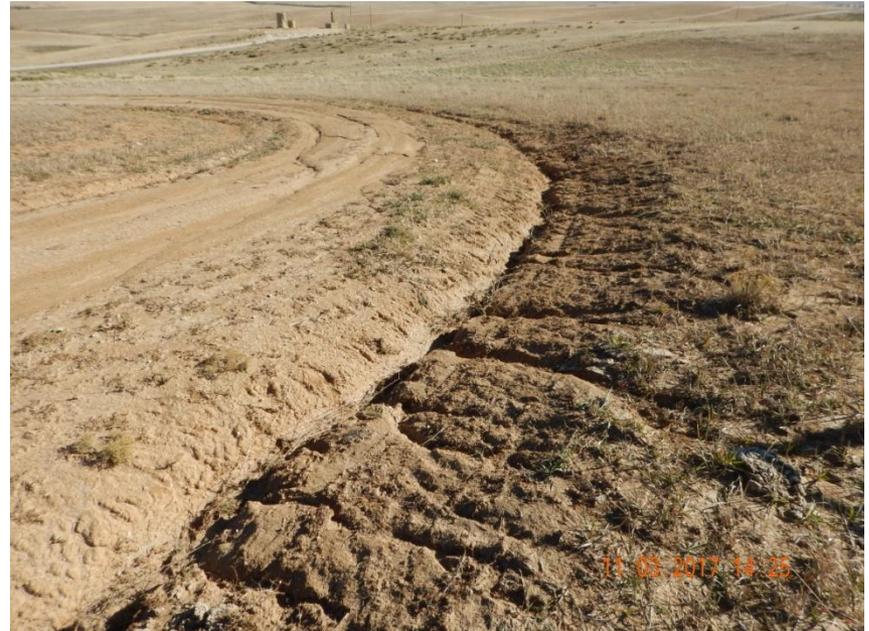
Photo 6. Photo taken from a portion of the access road, facing East. Rill erosion forming into gully erosion is evident along the access road. Operator needs to repair erosion and install sufficient BMPs.
