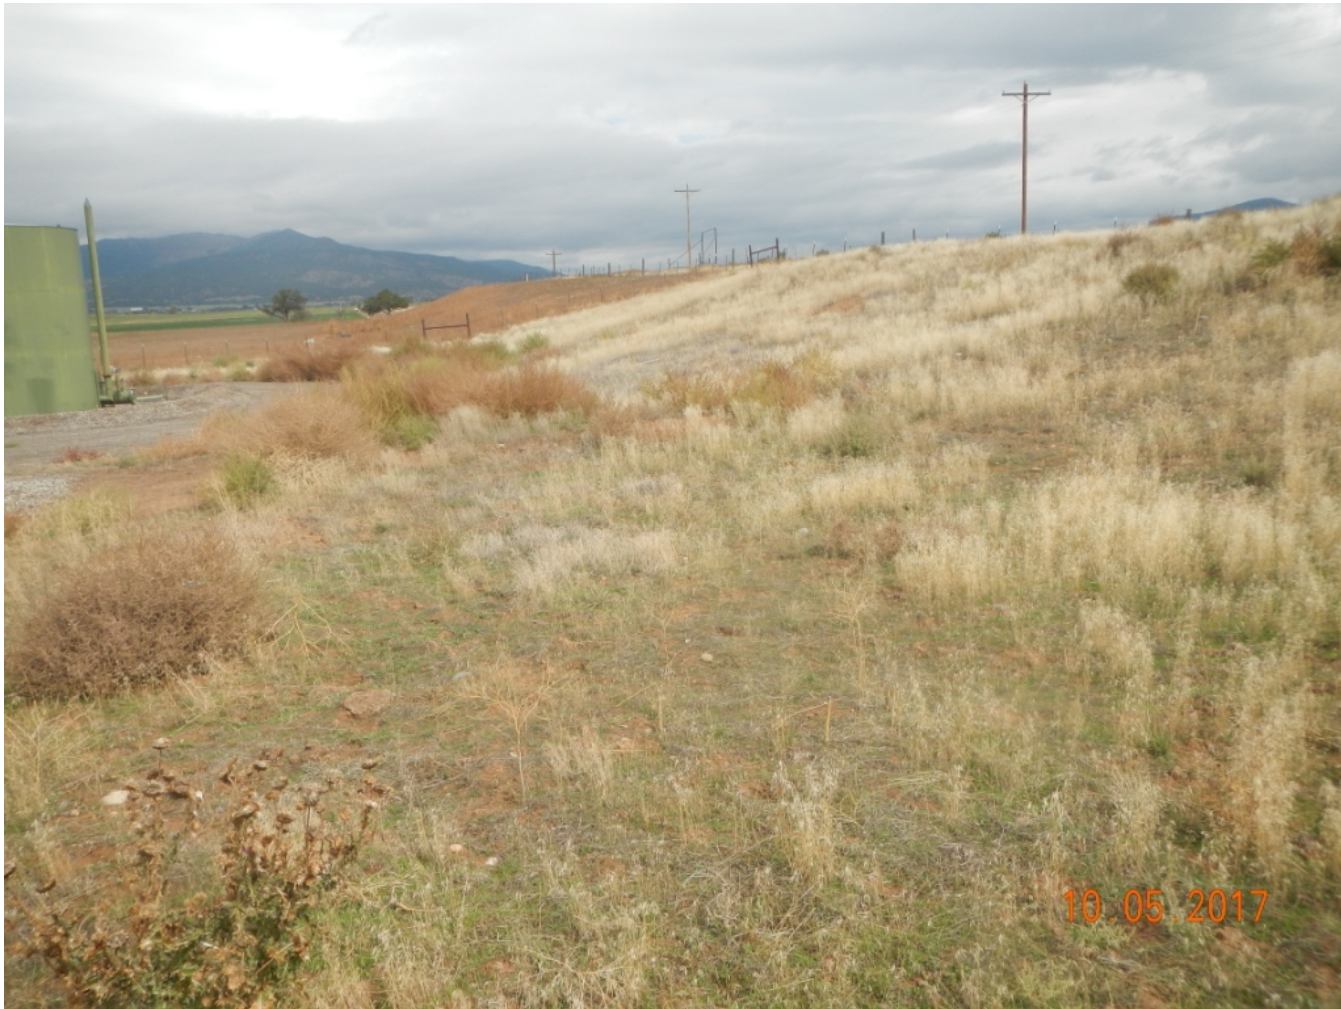
Photo 2. View of the eastern portion of the project area from the southeastern corner facing northward. Revegetation is progressing but largely weedy with cheatgrass (*Bromus tectorum*) and Russian thistle (*Salsola tragus*).

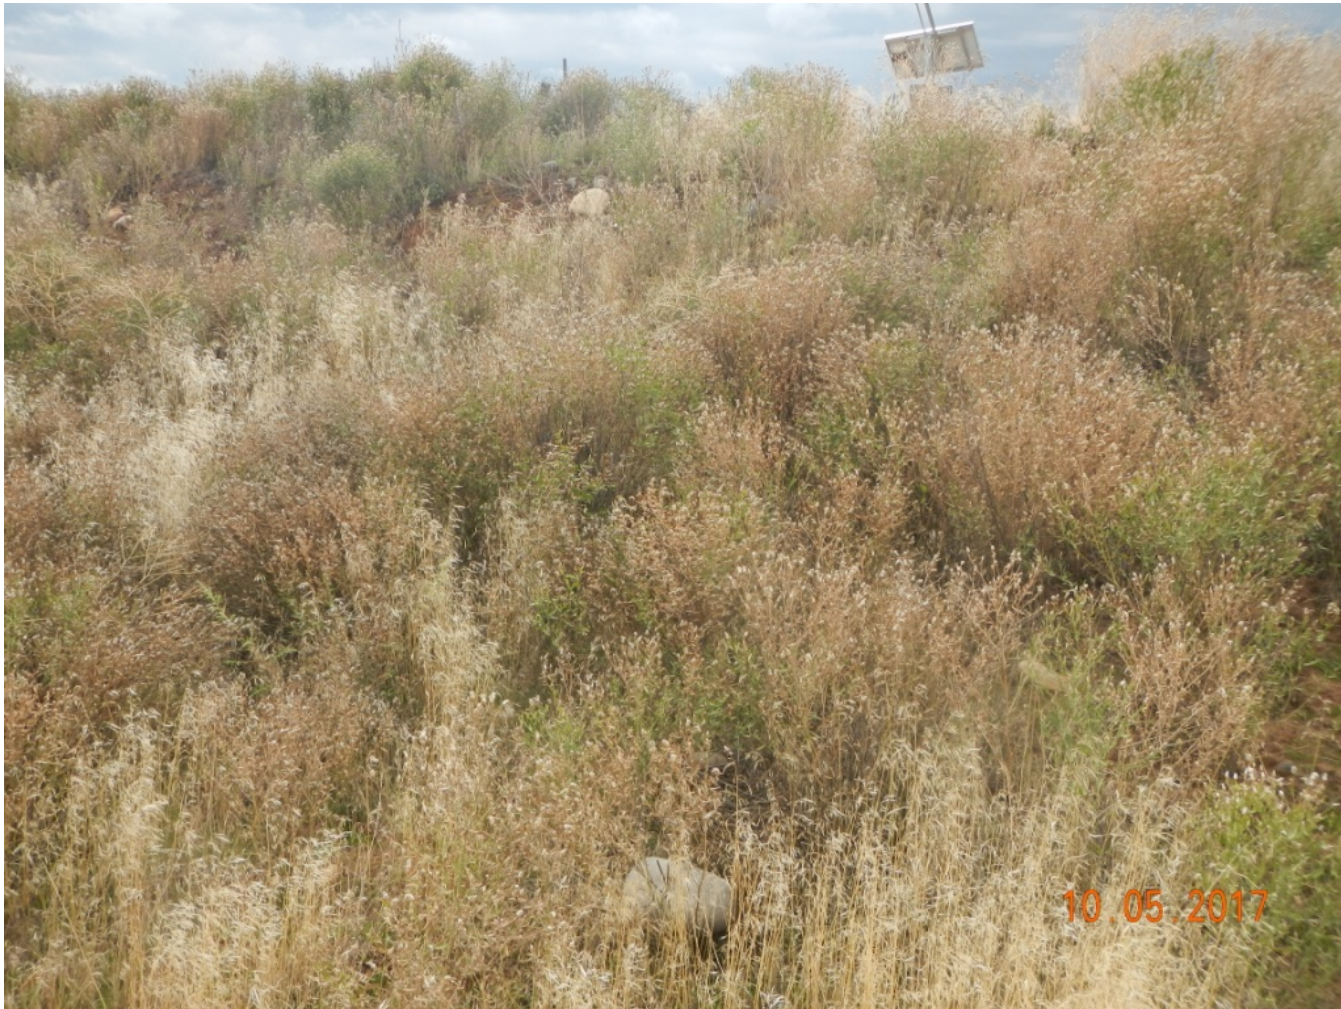
Photo 4. View of Russian knapweeds (*Acroptilon repens*) in the southern portion of the project area. Approximately 2000 individuals observed.

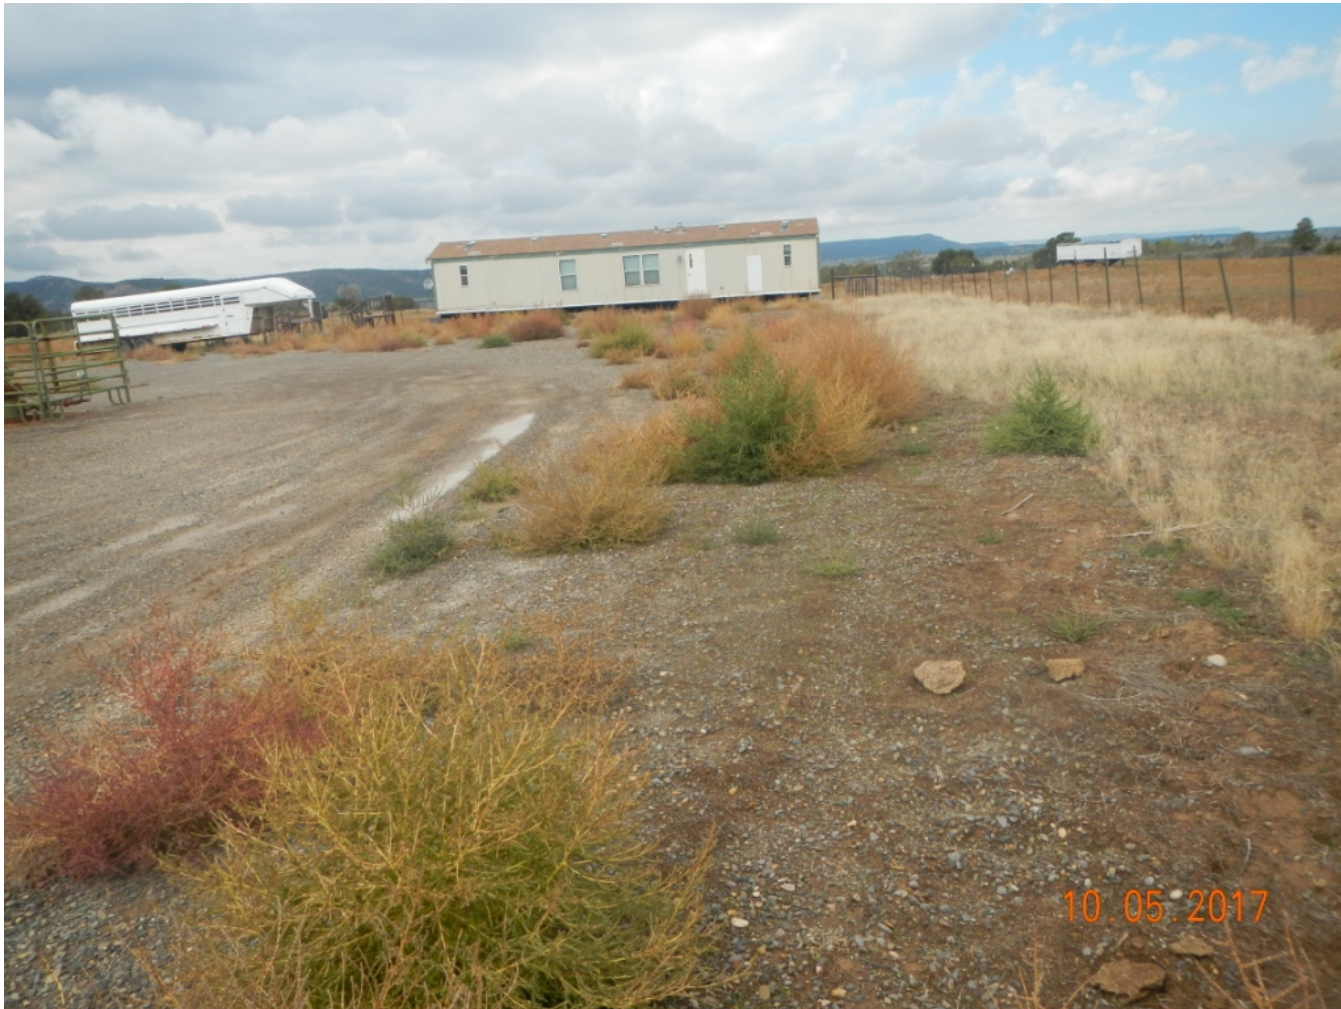
Photo 5. View of the northern portion of the project area from the northeastern corner facing westward. What appears to be surface owner trailers are stored in the western portion of the project area.
