Inspection Photos

Operator: GRAND MESA OPERATING CO - 35080

Location ID: 452771

Inspection Doc. Number: 682502779

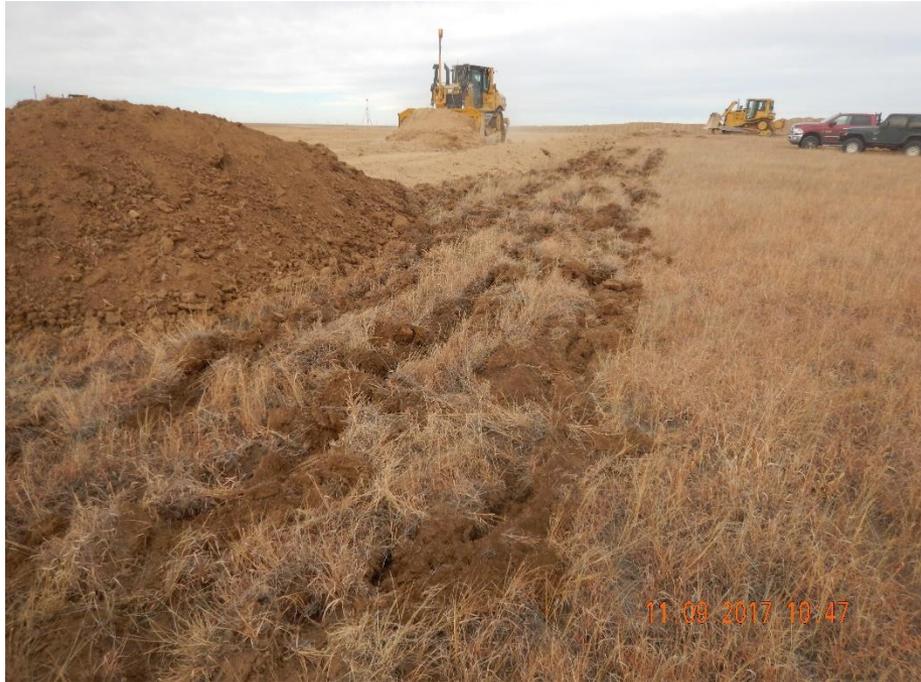
Photo 1: Photo taken from the southeast end of the location, facing north. Operator installed surface roughening as a stormwater and sediment control BMP around the perimeter of the location. BMP had been installed prior to construction activities.

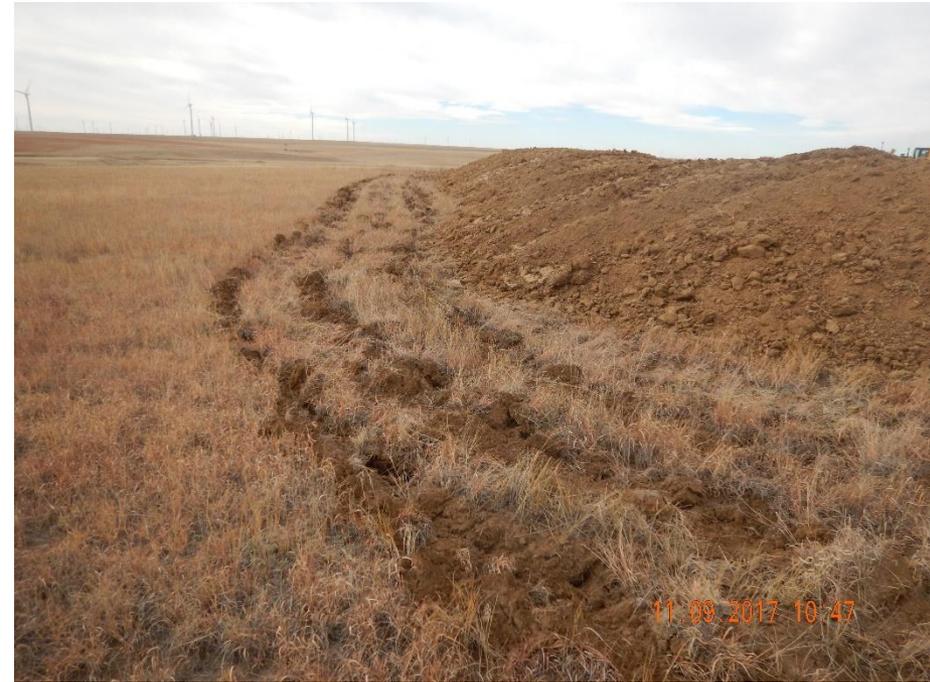
Photo 2: Photo taken from the southeast end of the location, facing west. Operator installed surface roughening as a stormwater and sediment control BMP around the perimeter of the location. BMP had been installed prior to construction activities.

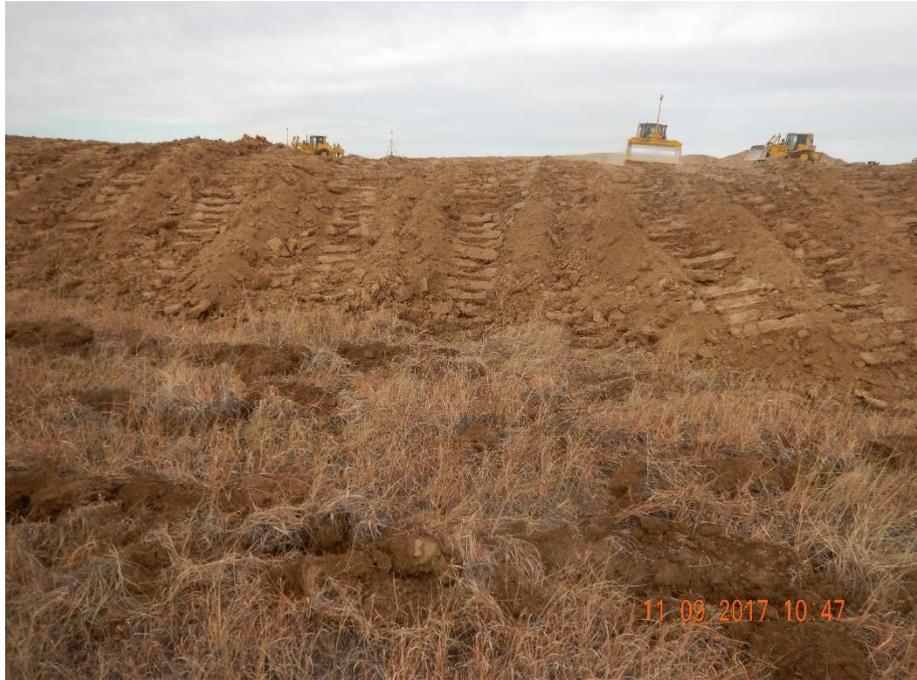
Photo 3: Photo taken from the north end of the location. Photo shows topsoil salvage and stabilization in process.

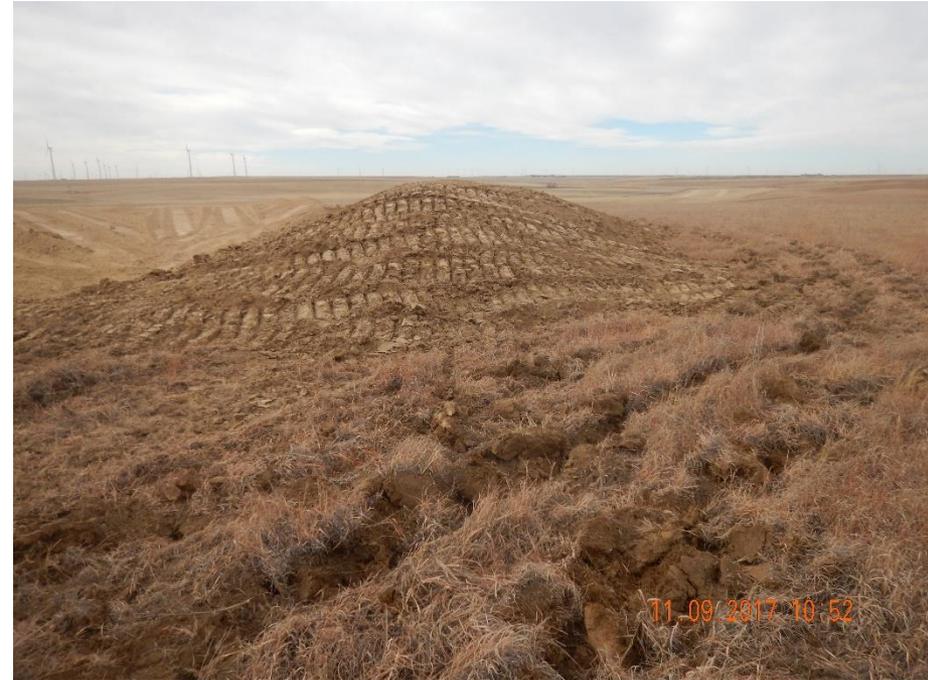
Photo 4: Photo taken from the north end of the location, facing west. Photo shows topsoil salvage and stabilization in process.
