Inspection Photos

Operator: NOBLE ENERGY INC - 100322

Location ID: 329000

Inspection Doc. Number: 682502803

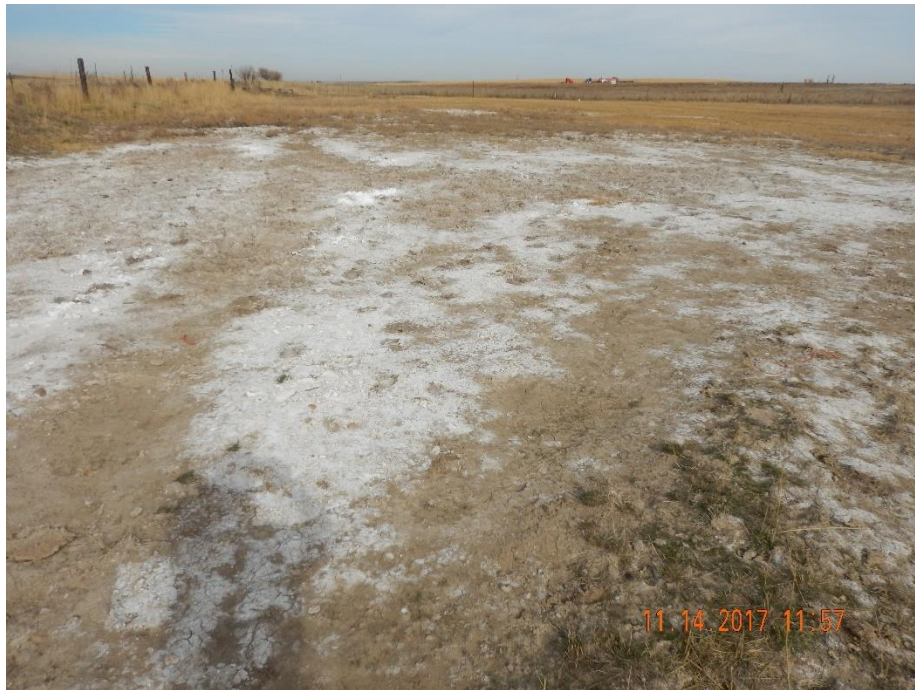
Photo 1: Photo taken from the well location, facing north. Previous inspection required operator to perform additional reclamation at the well location. Photo shows location remains predominantly unvegetated and exposed soil. Unable to find evidence that additional reclamation activities have been conducted per the corrective actions.

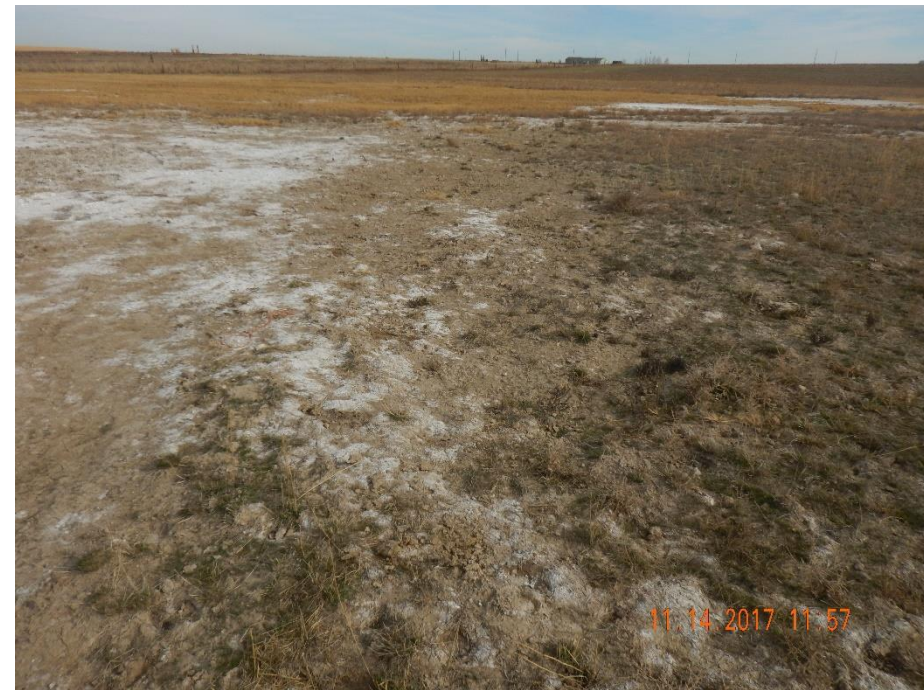
Photo 2: Photo taken from the well location, facing northeast. See comments under photo 1

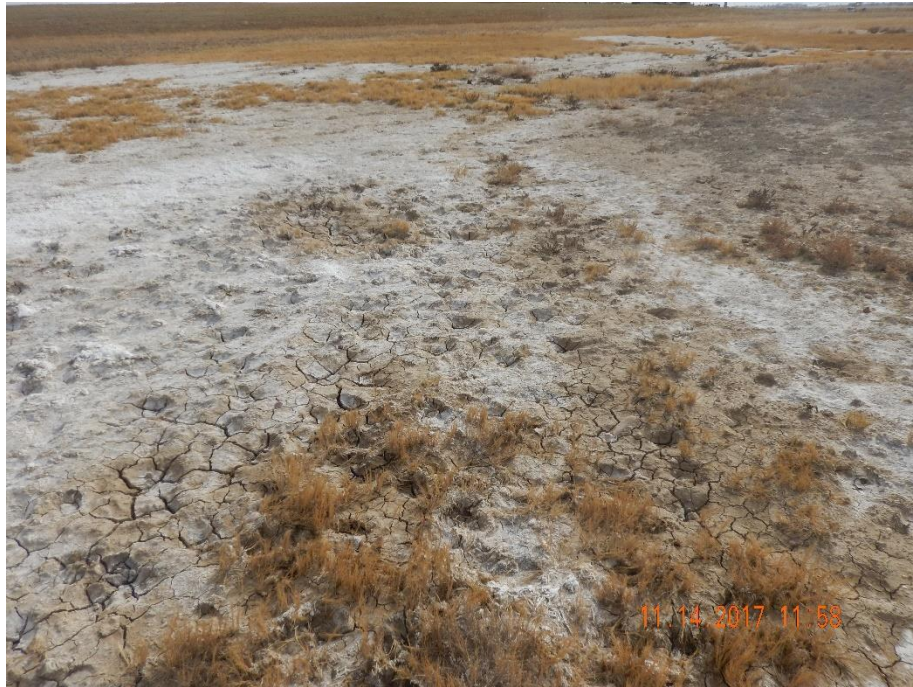
Photo 3: Photo taken from the north end of the location, facing southeast. See comments under photo 1

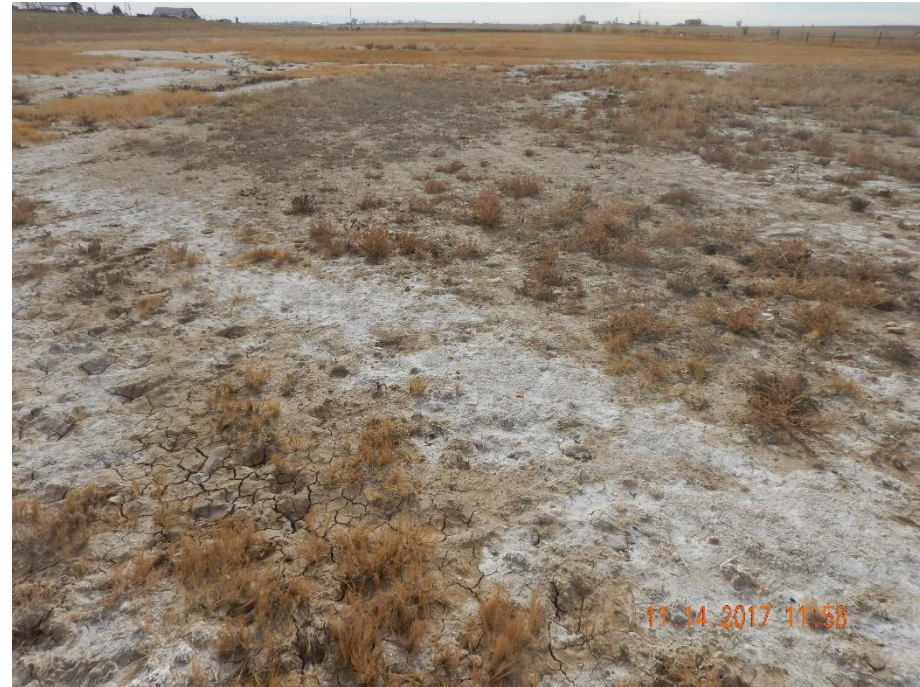
Photo 4: Photo taken from the north end of the location, facing south. See comments under photo 1

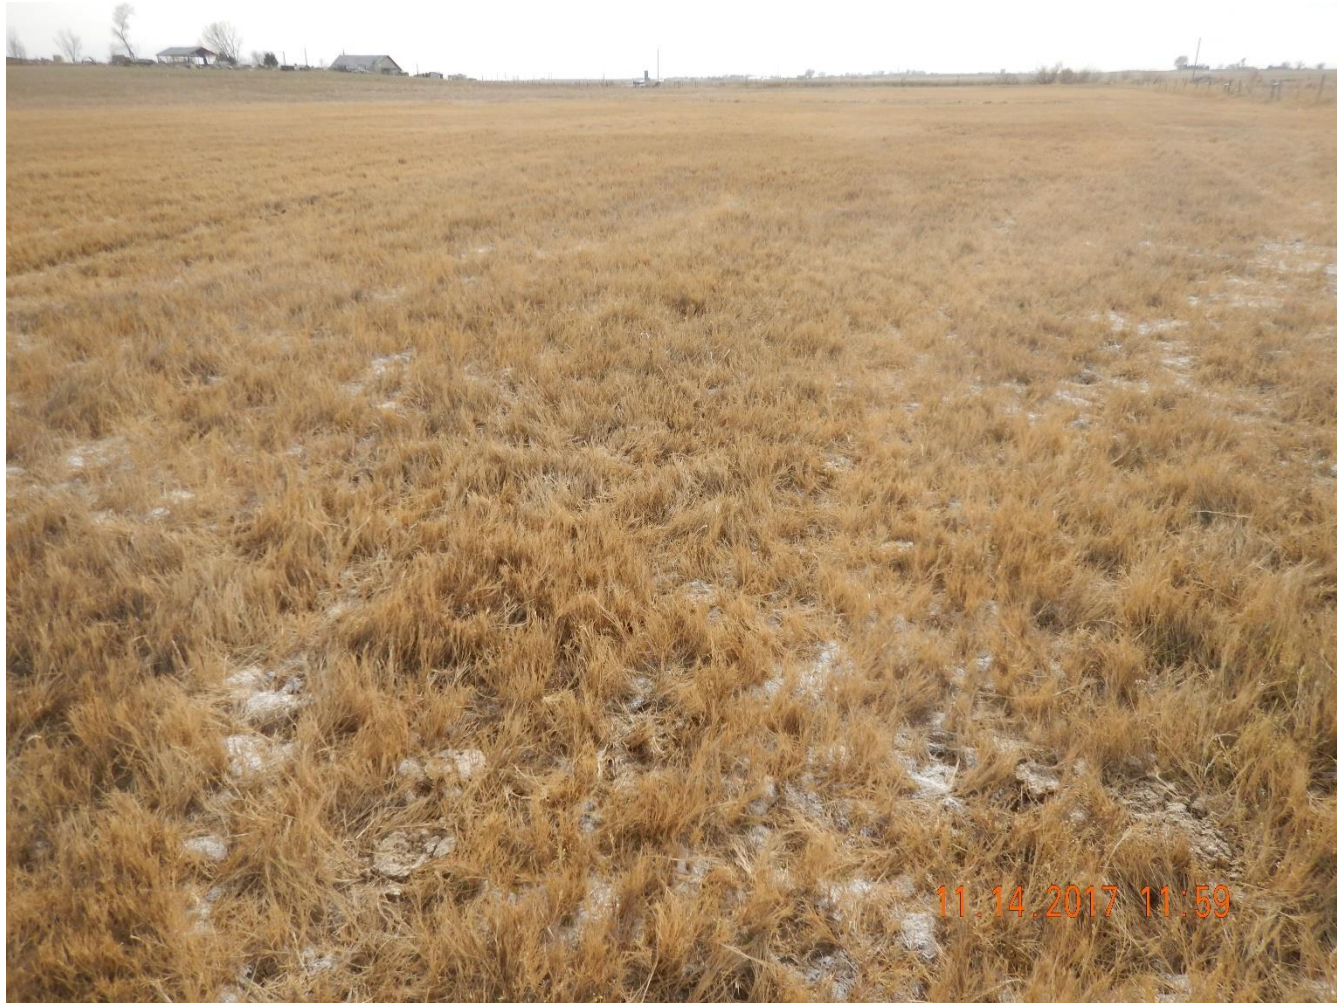
Photo 5: Photo shows vegetation over the adjacent reference area. Photo shows disturbance area is not reflective of the reference.

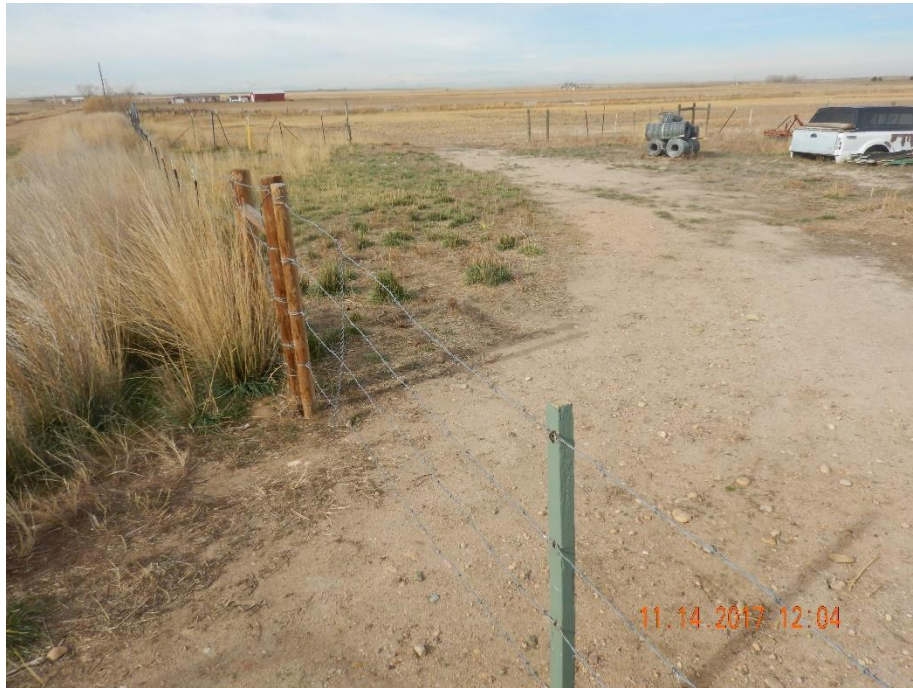
Photo 6: Photo taken from the south end of the former battery facilities location, facing northwest. Photo shows battery location has not been reclaimed to its designated final land use. No 502.b variance to not reclaim the location has been submitted or approved by the operator.

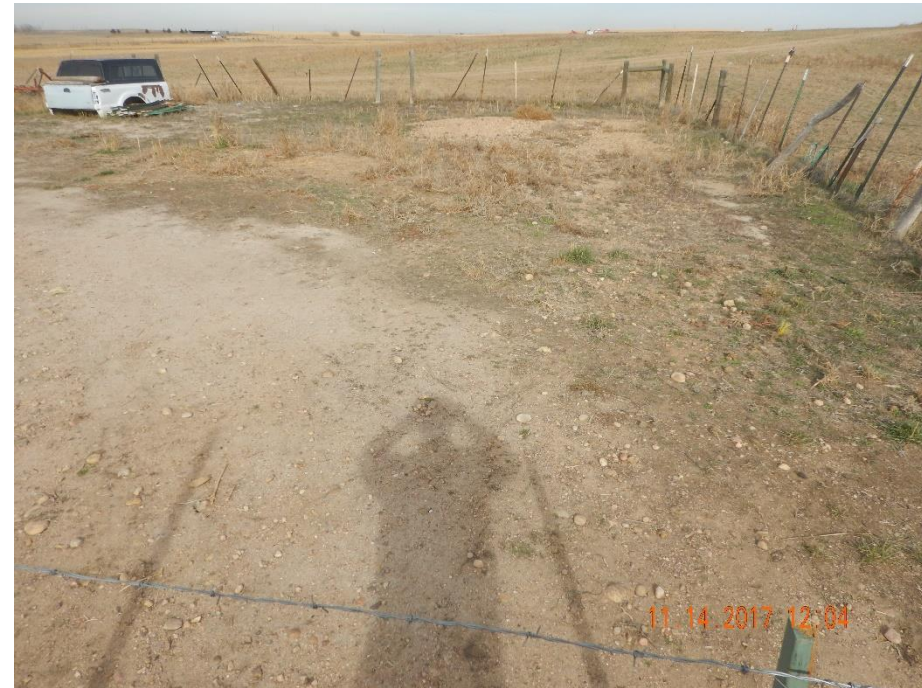
Photo 7: : Photo taken from the south end of the former battery facilities location, facing north. See comments under photo 6.
