# Inspection Photos

Operator: NOBLE ENERGY INC - 100322

Location ID: 323695

Inspection Doc. Number: 682502881

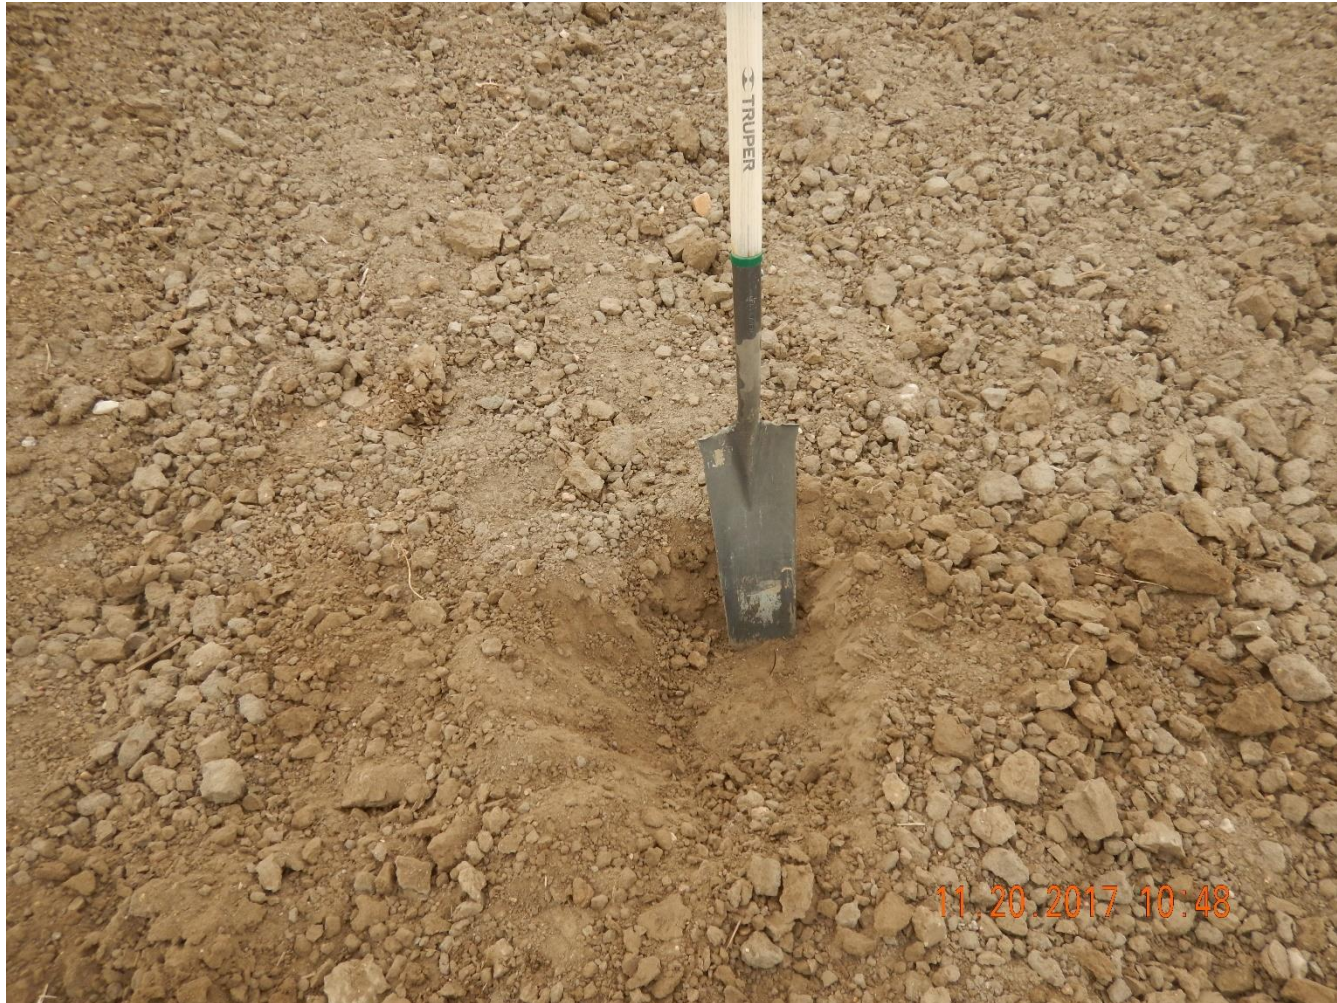
**Photo 1:** Photo taken from the battery location. Photo shows inspector conducted a compaction test pit. Photo shows inspector was able to penetrate the soil ~6 inches subsurface before finding a zone of compaction in the soil.

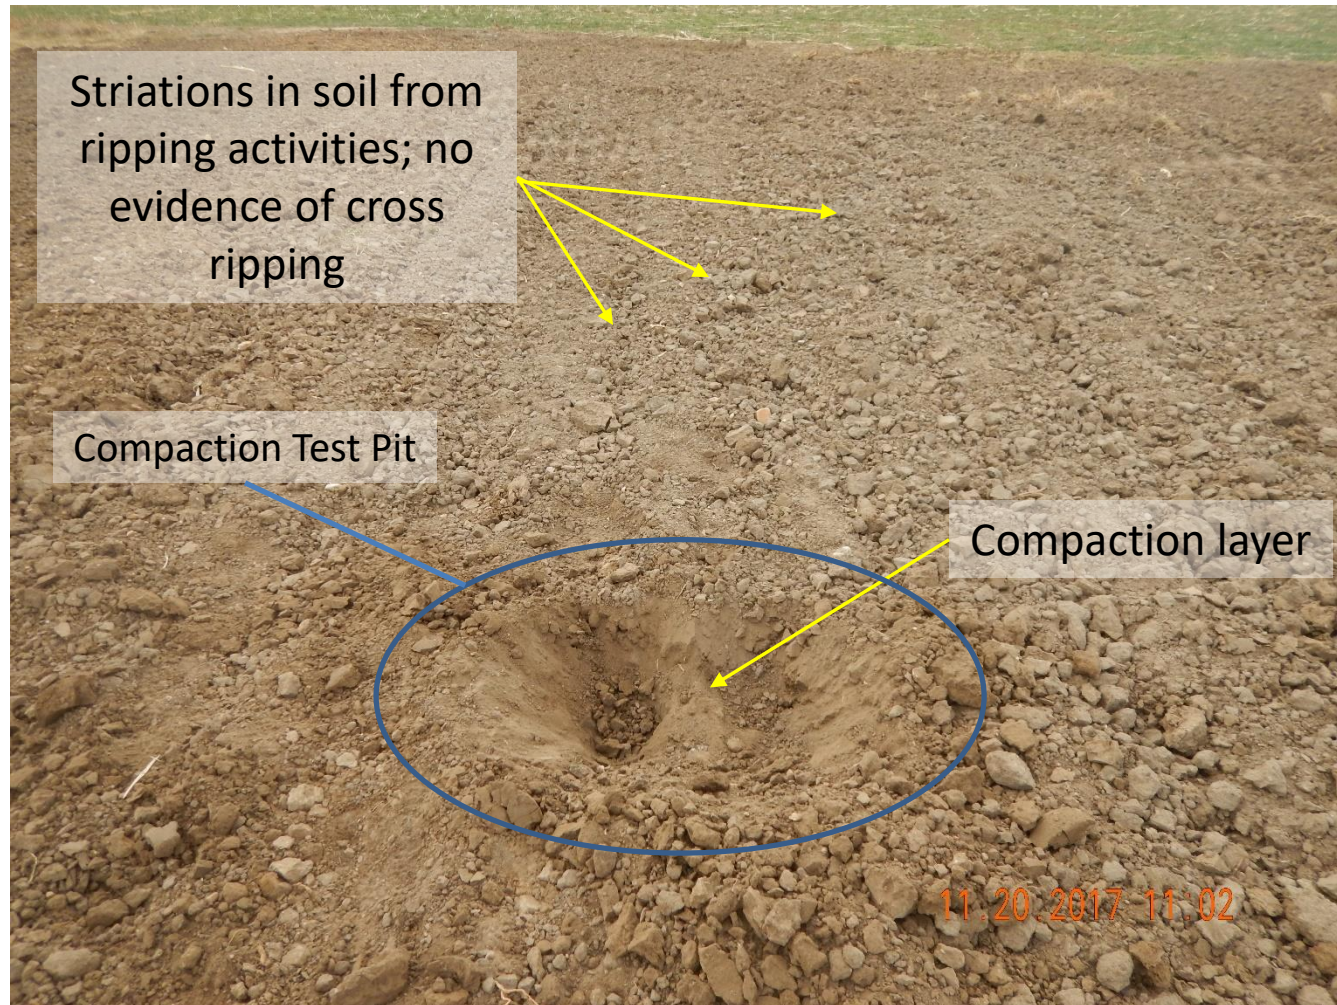
**Photo 2:** Photo taken from the former battery location. Photo shows operator appears to have brought topsoil onto the location and ripped area in one direction. Photo shows a compaction test pit dug by the inspector showing areas where compaction concerns remain. Photo also shows location has only been ripped in one direction, not cross ripped per reclamation requirements. 1003.c requires cross-ripping on areas compacted by oil and gas operations to a depth of eighteen (18) inches

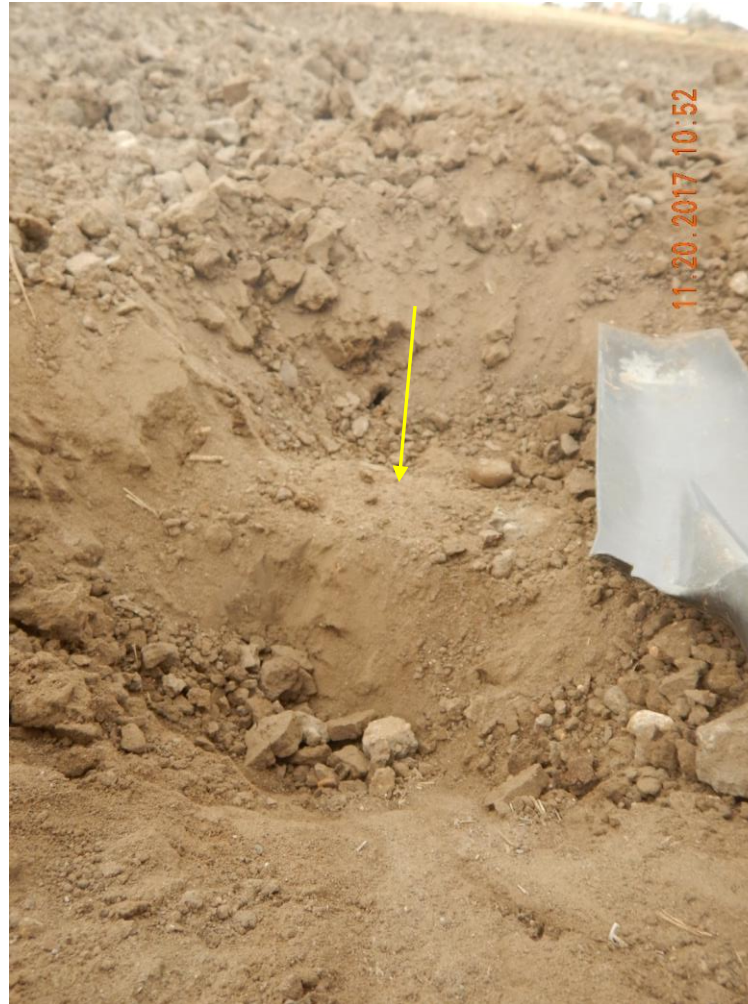
**Photo 3:** Close up photo of the compaction test pit dug by the inspector seen in photo 2. Photo shows the compaction zone found in the soil approximately 6 inches sub-surface.
