# Inspection Photos

Operator: FOUNTAINHEAD RESOURCES LTD -  
30658

Location ID: 322701

Inspection Doc. Number: 682502889  
Weld County, CO

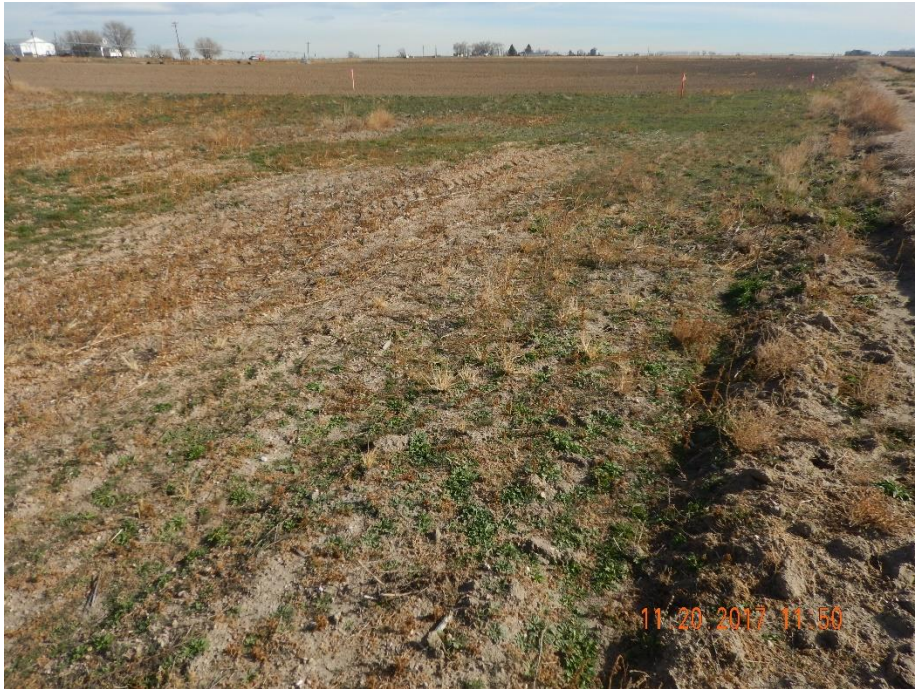
**Photo 1:** Photo taken from the well location, facing east. Previous inspection required operator to perform additional reclamation activities. Unable to find evidence that additional reclamation has been conducted. Green vegetation seen in photos predominantly undesirable weedy plant species.

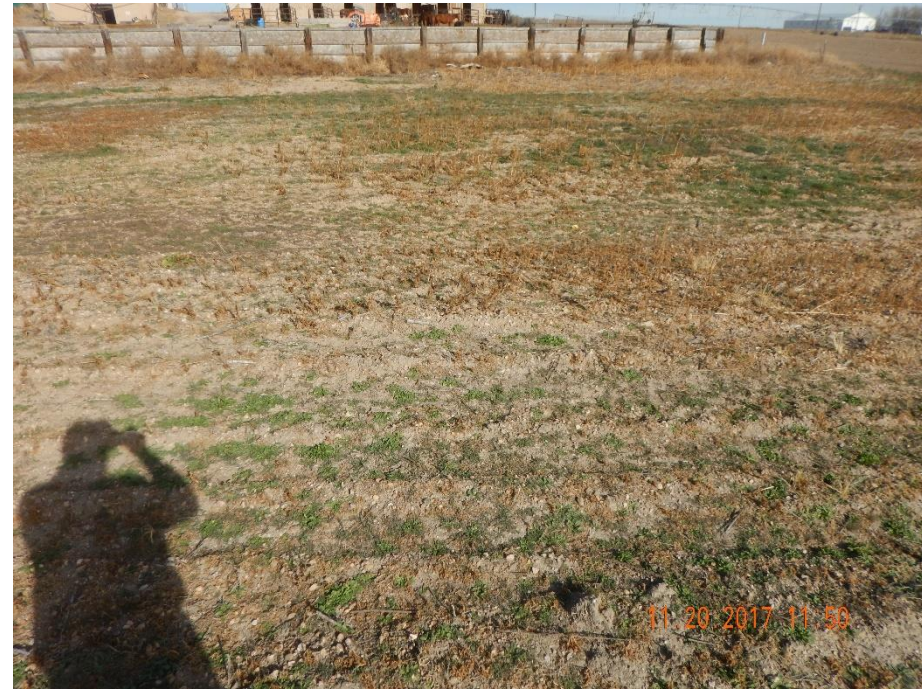
**Photo 2:** Photo taken from the well location, facing north. See comments under photo 1.

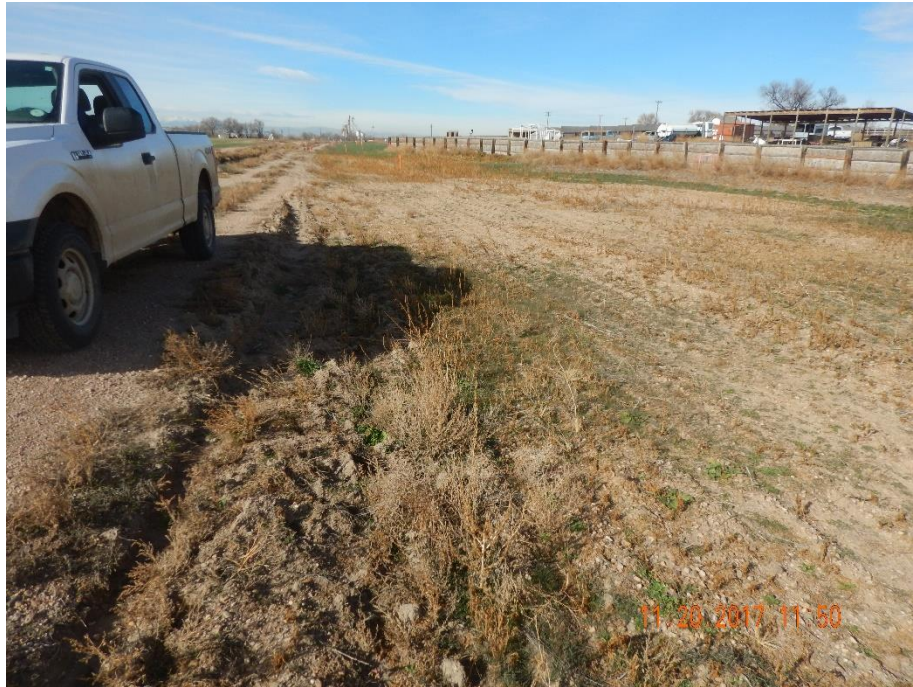
**Photo 3:** Photo taken from the well location, facing west. See comments under photo 1.

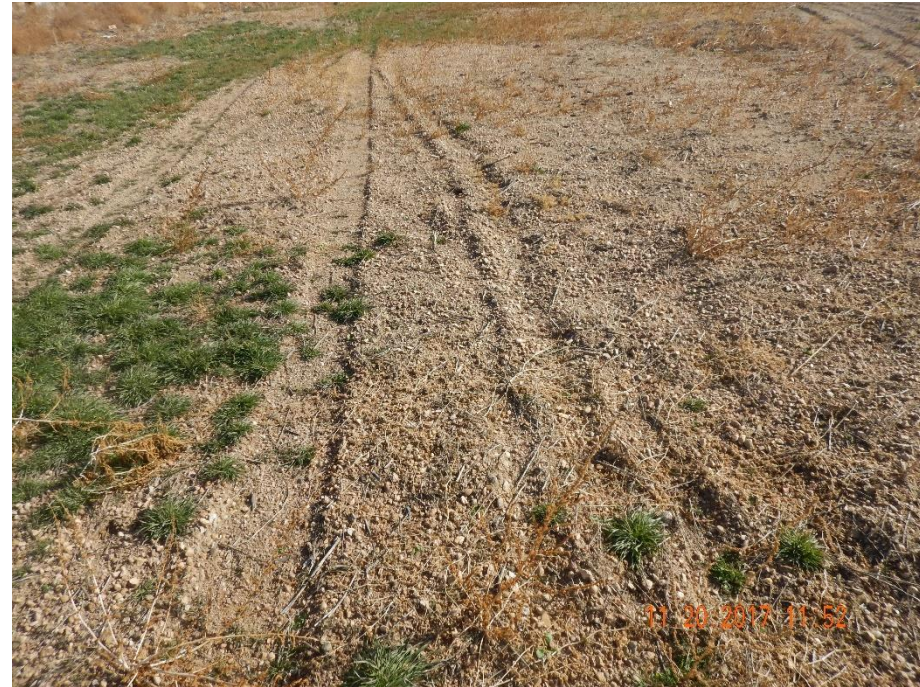
**Photo 4:** Photo taken from the well location. Photo shows gravel remains on location. This should have been removed during reclamation.
