COLORADO
Oil & Gas Conservation
Commission
Department of Natural Resources

Inspection Photos: Black Hills Federal Loc#312741

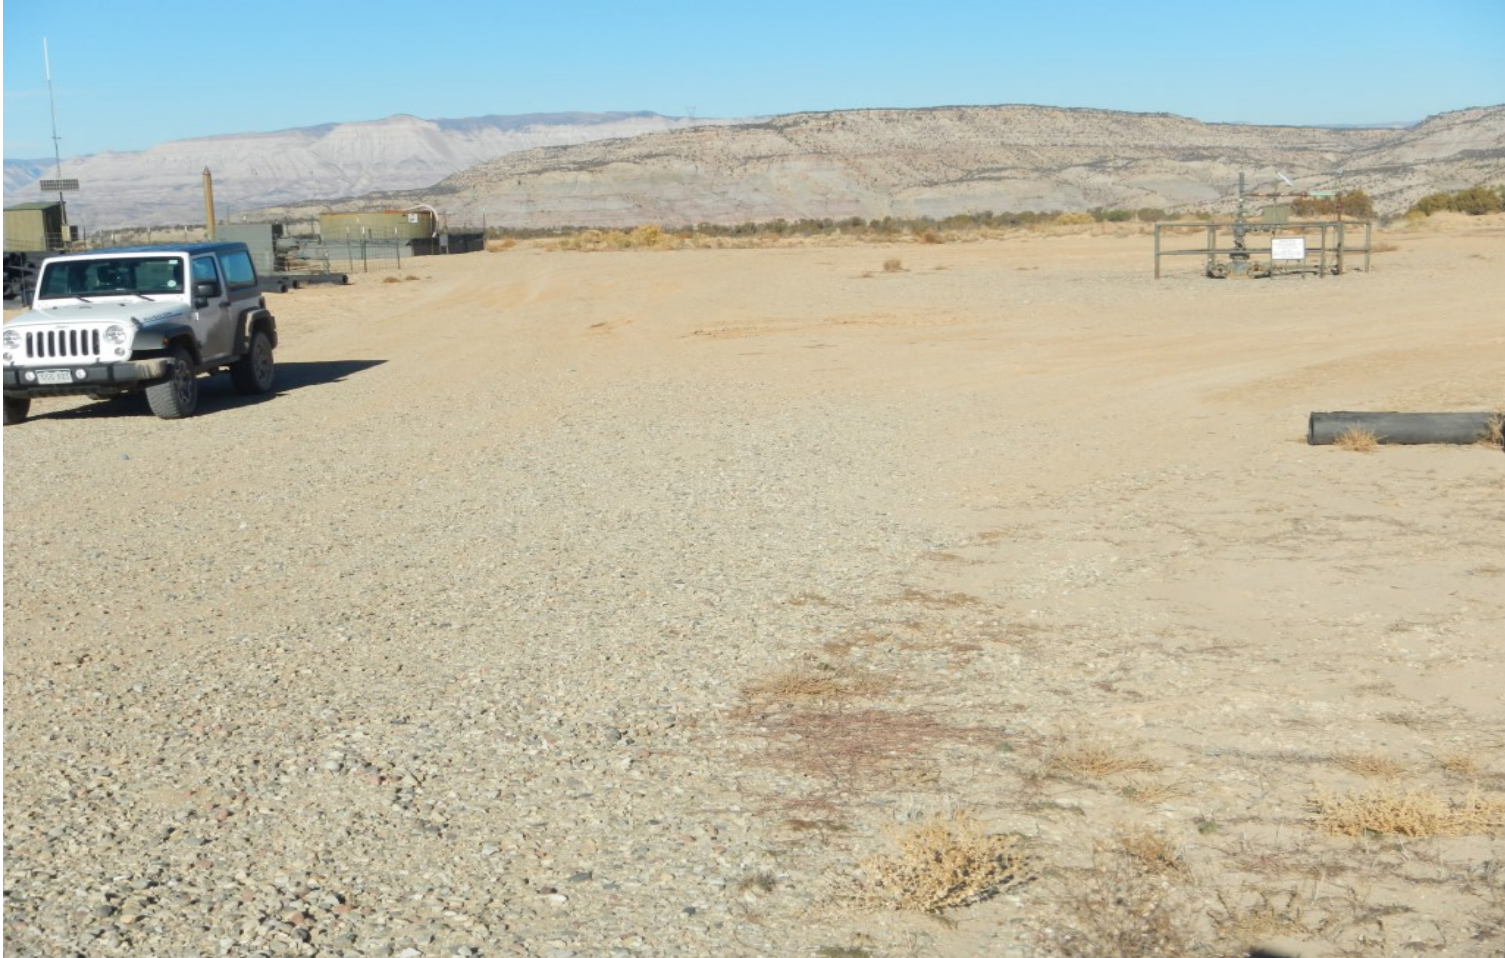
Photo#1:
Overview of Location to North.

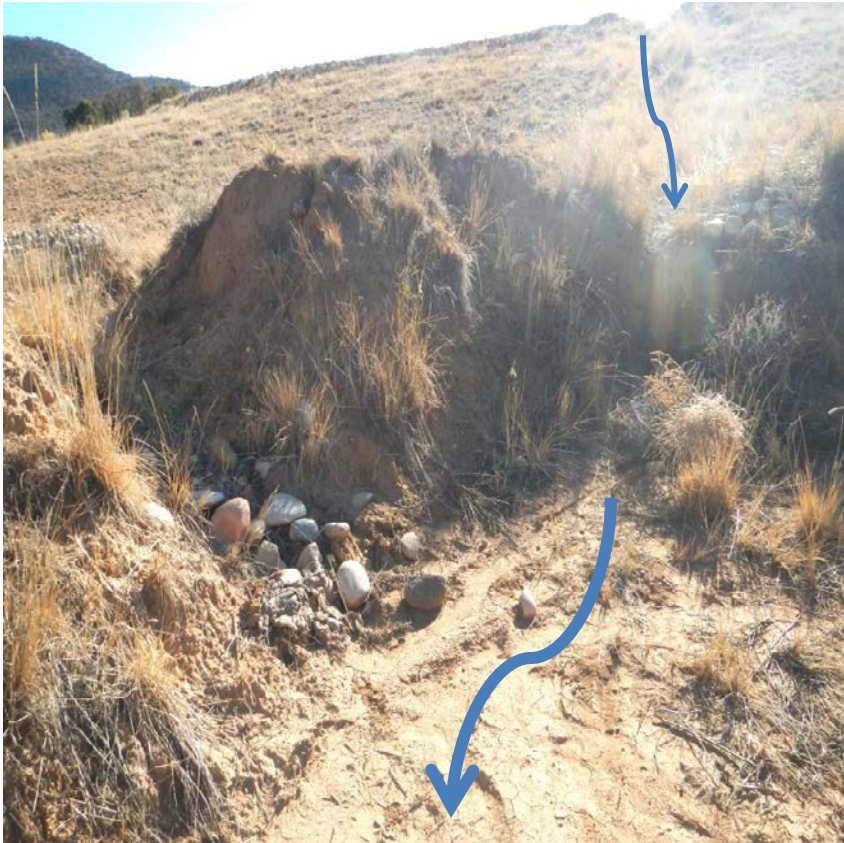
Photo#10: Shows SW Flow from Photo#8 into
Sediment Retention area.

Arrows indicate Stormwater Flow & Sediment Migration.

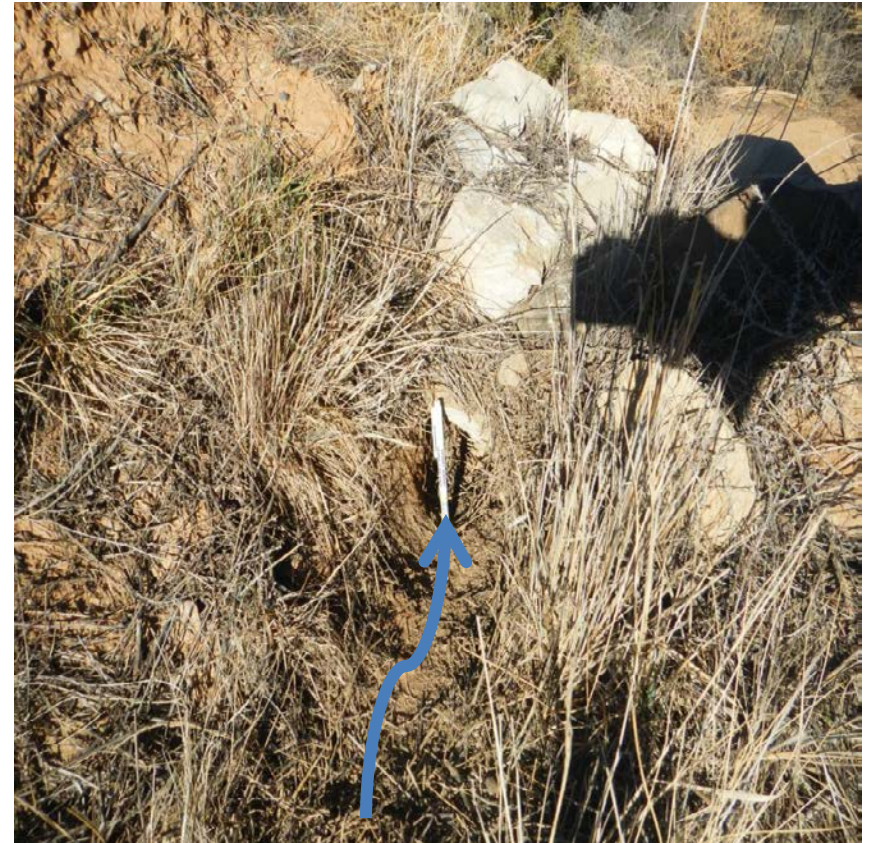
Photo#11: SW exits BMP below Photo#10; undercutting
Rock Armor at Point Pen identifies hole.
