Inspection Photos

12/07/2017

Operator: WESTERN OPERATING COMPANY -
95620

Location ID: 312291

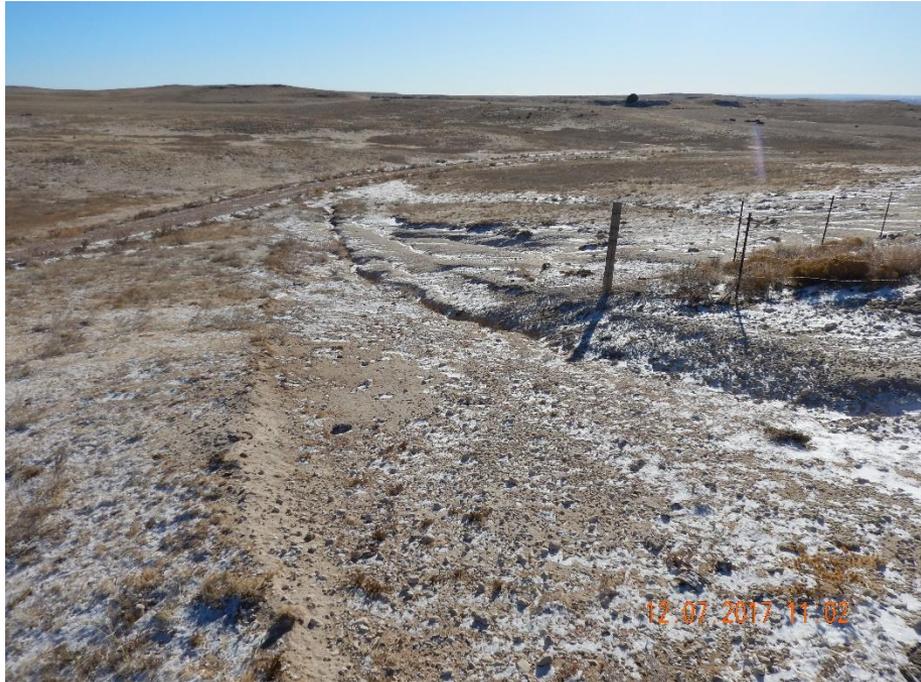
Photo 1: Photo taken from the southeast end of the location, facing southeast. Photo shows areas of erosion degradation. Erosion has not been repaired or stabilized and no BMPs have been installed or maintained per corrective actions.

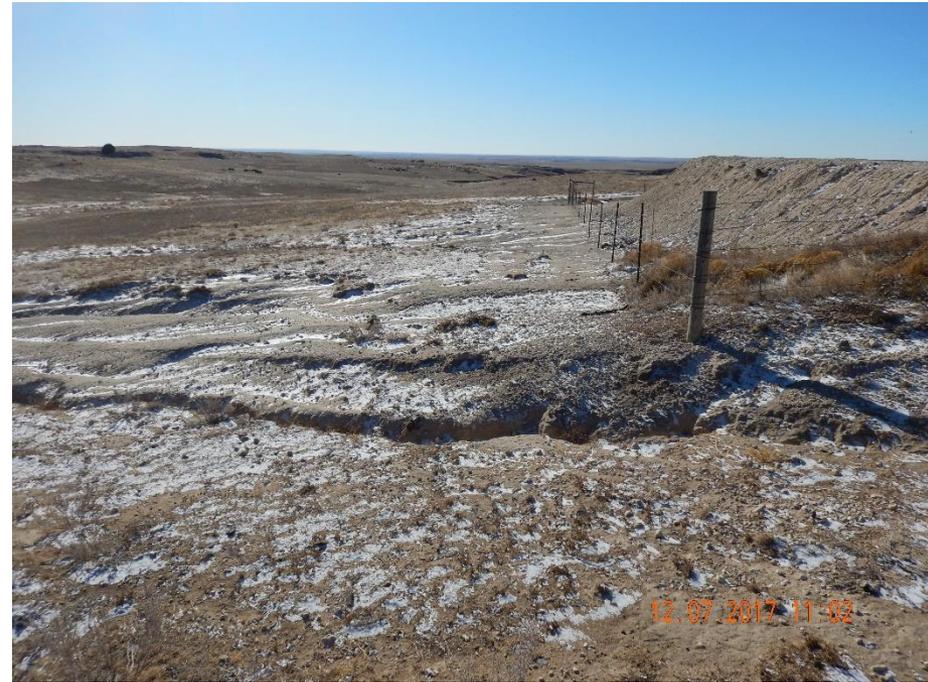
Photo 2: Photo taken from the southeast end of the location (northeast of pit), facing southeast. Photo shows areas of erosion degradation on the adjacent lands due to runoff and salt kill. Photo shows no remediation activities appear to have been conducted, and no stabilization and stormwater BMPs have been installed or maintained per the corrective actions.

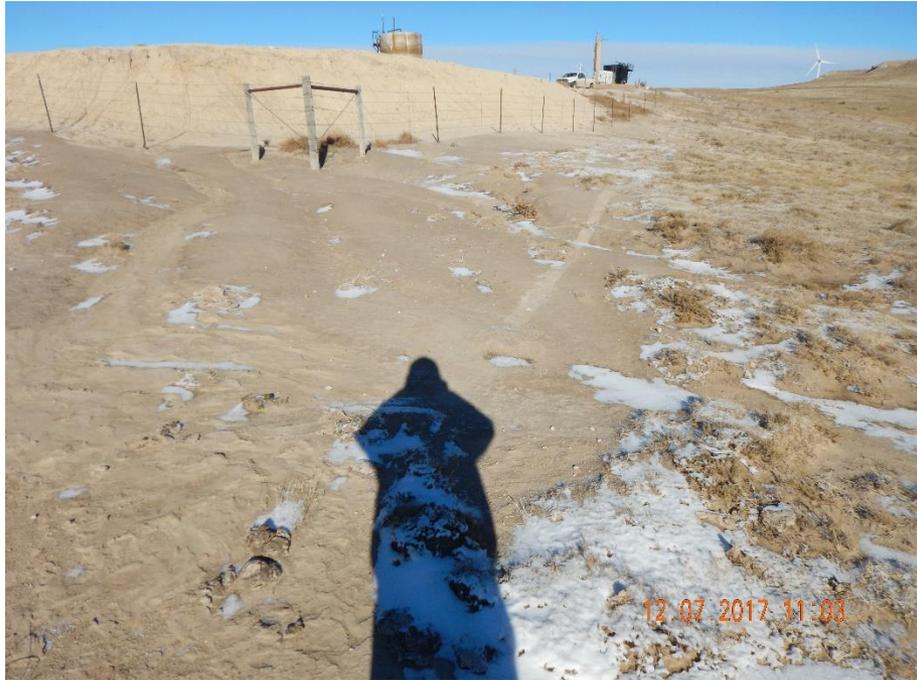
Photo 3: Photo taken from the southeast corner of the pit, facing north. See comments under photo 2.

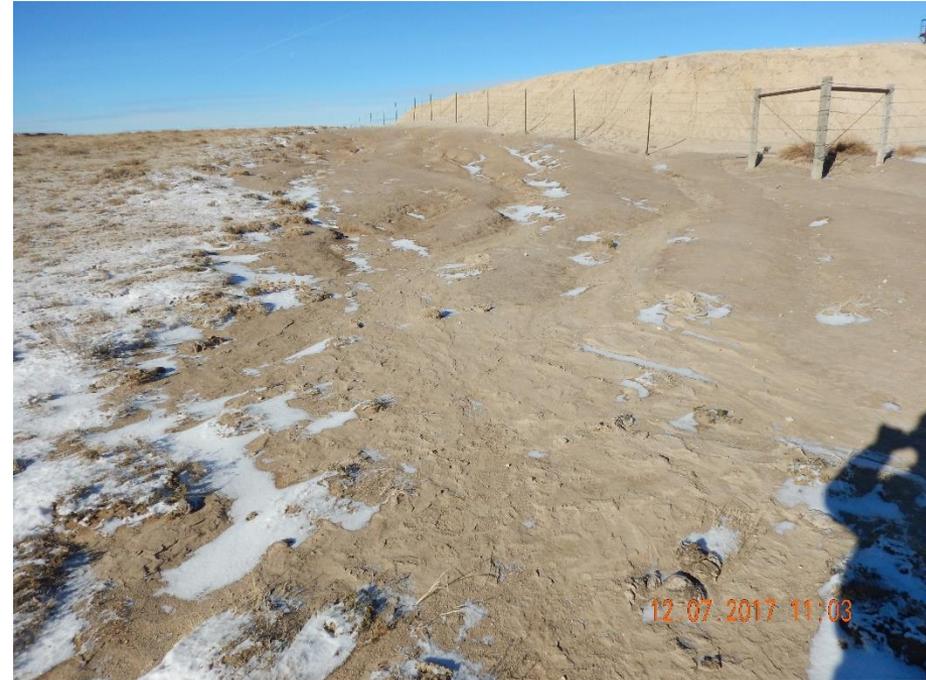
Photo 4: Photo taken from the southeast corner of the pit, facing west. See comments under photo 2.

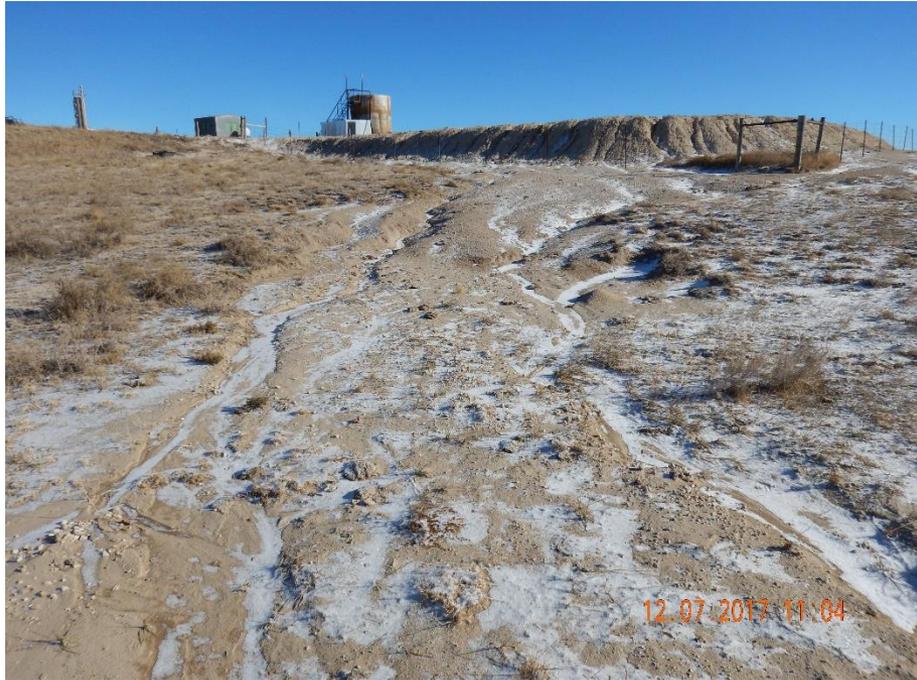
Photo 5: Photo taken from the southwest corner of the pit, facing northeast. See comments under photo 2.

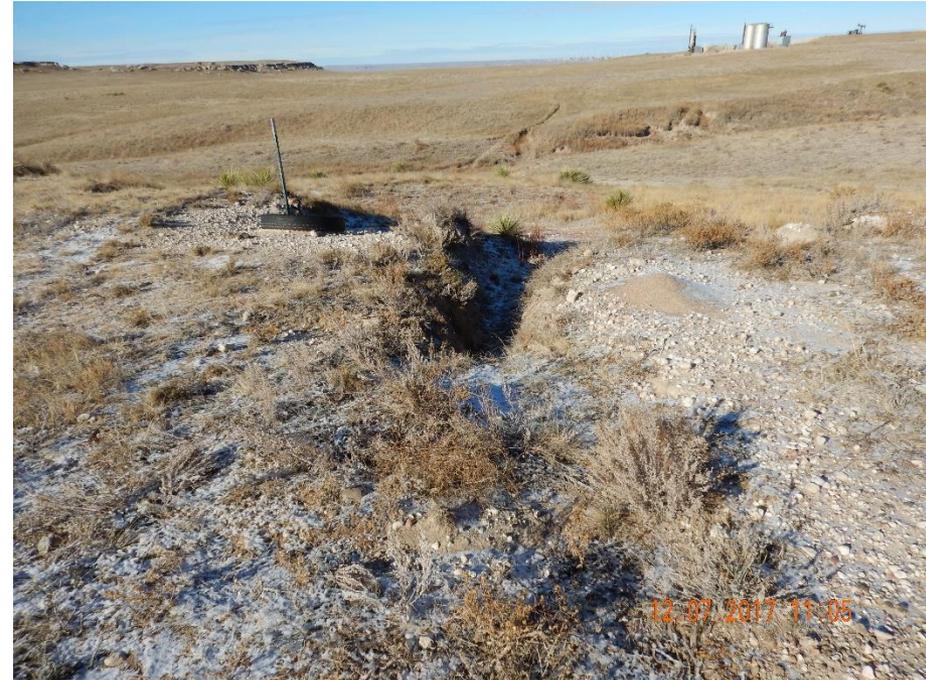
Photo 6: Photo taken from the west end of the location, facing west. Photo shows areas of erosion degradation. Erosion has not been repaired or stabilized and no BMPs have been installed or maintained per corrective actions.
