Inspection Photos

Operator: NOBLE ENERGY INC - 100322

Location ID: 329551

Inspection Doc. Number: 682502958

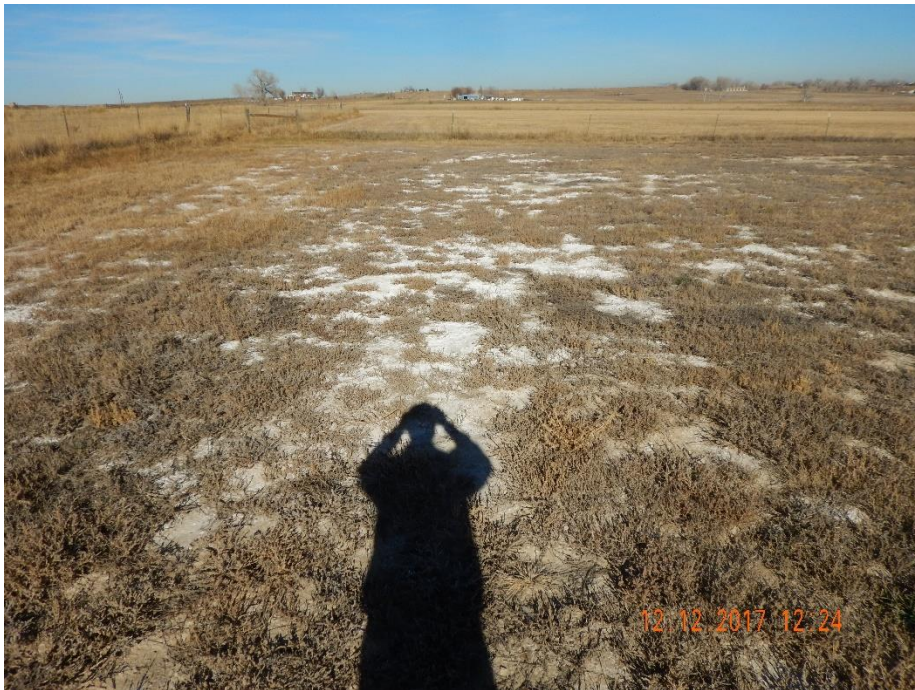
Photo 1: Photo taken from the south end of the well location, facing north. Photo shows vegetation over the reclamation area has not achieved a uniform cover and does not appear to be progressing to 80% cover to that of the reference. Photo also shows no reclamation activities appear to have been conducted per the corrective action.

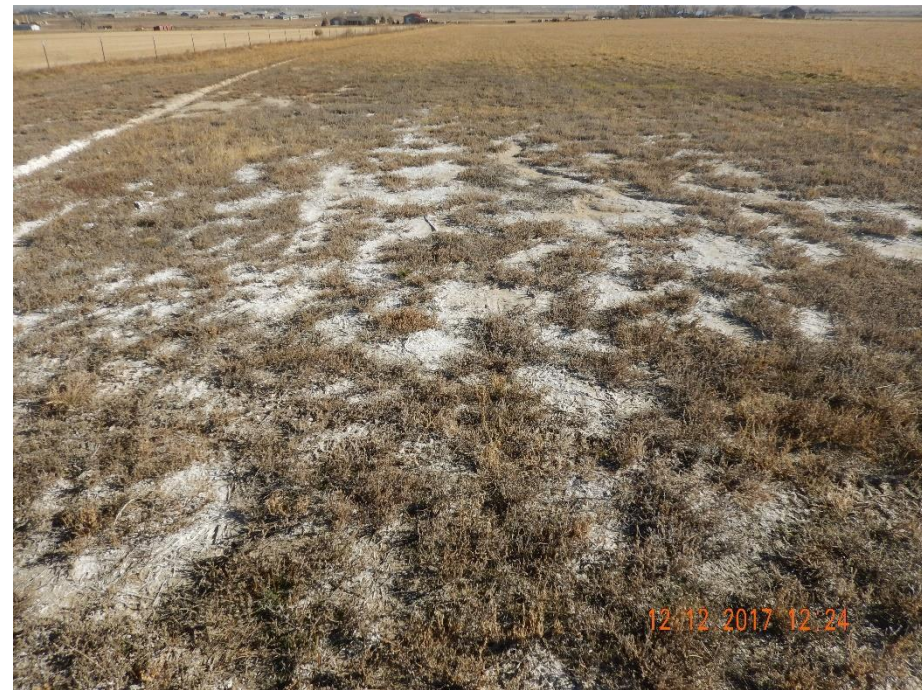
Photo 2: Photo taken from the north end of the well location, facing east. Photo shows vegetation over the reclamation area has not achieved a uniform cover and does not appear to be progressing to 80% cover to that of the reference. Photo also shows no reclamation activities appear to have been conducted per the corrective action.

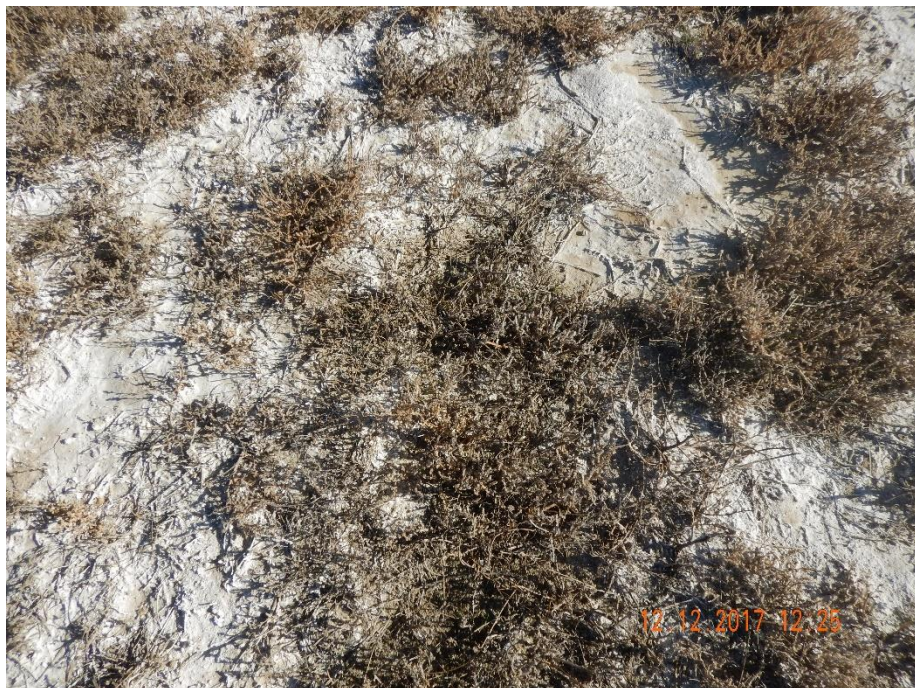
Photo 3: Photo of the disturbance area of the well location. Photo shows vegetation is predominantly undesirable weedy plant species. Photo also shows no reclamation activities appear to have been conducted per the corrective action.

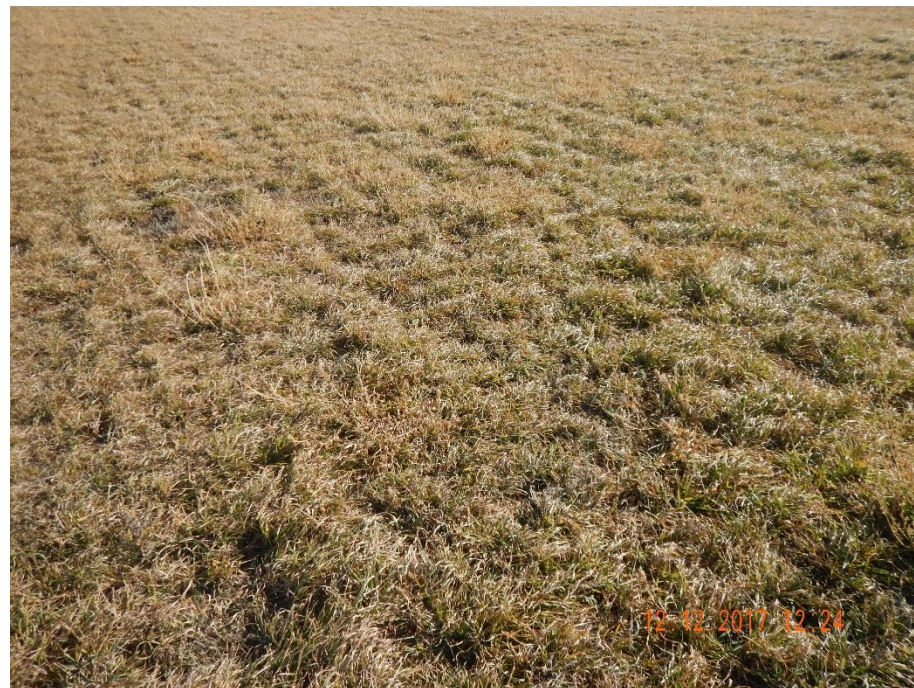
Photo 4: Photo taken from the adjacent reference area. Reference area is a irrigated hay meadow composed predominantly of perennial grass.

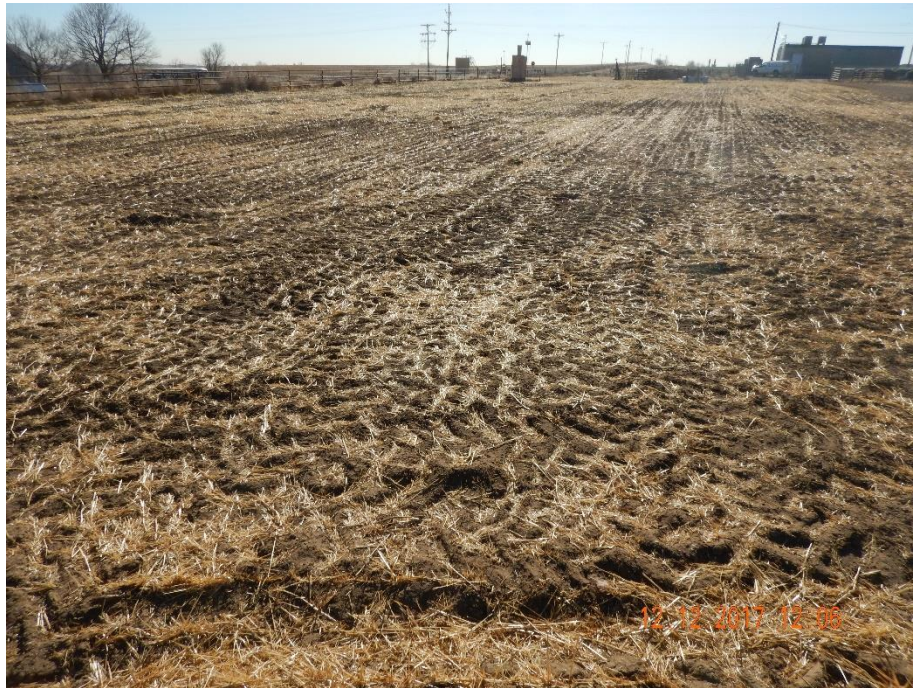
Photo 5: Photo taken from the north end of the former tank battery location, facing south. Photo shows majority of the battery facility appears to have been seeded and crimped with straw for stabilization.

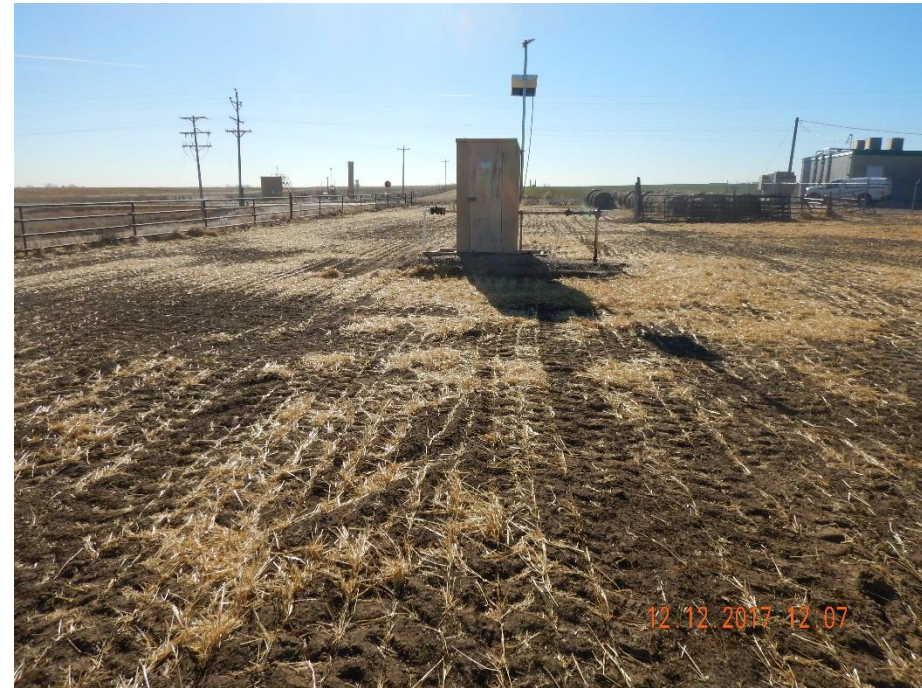
Photo 6: Photo taken from the former tank battery location, facing south. Previous inspections required operator to remove equipment (meter shed) in accordance to 1004.a. Photo shows equipment has not been removed.
