Inspection Photos

Operator: NOBLE ENERGY INC - 100322

Location ID: 327399

Inspection Doc. Number: 682502960

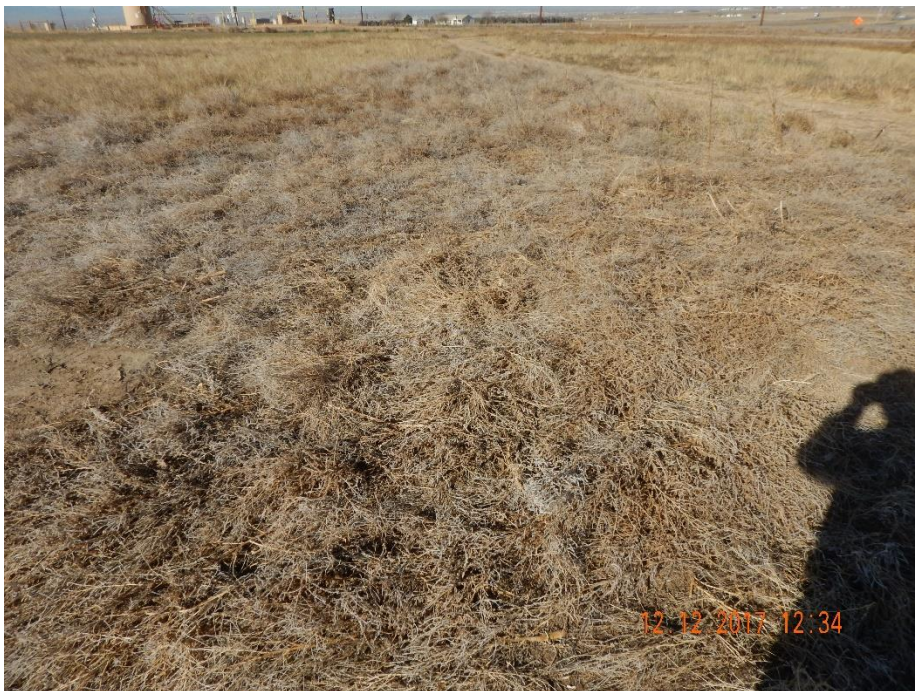
Photo 1: Photo taken from the south end of the well location, facing north. Photo also shows no reclamation activities appear to have been conducted per the corrective action. Photo shows vegetation is predominantly undesirable weedy plant species such as kochia and/or Russian thistle.

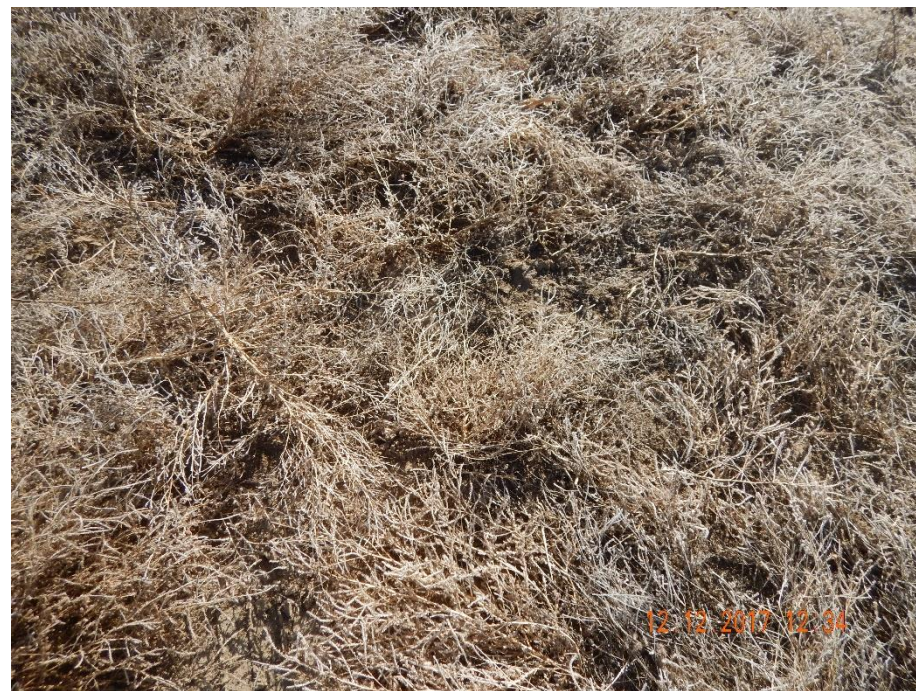
Photo 2: Photo taken from the well location, facing east. Photo shows vegetation over the well location. Vegetation is predominantly undesirable weedy plant species such as kochia and/or Russian thistle. Unable to find evidence that reclamation activities have been conducted at the well location. This corrective action remains applicable.

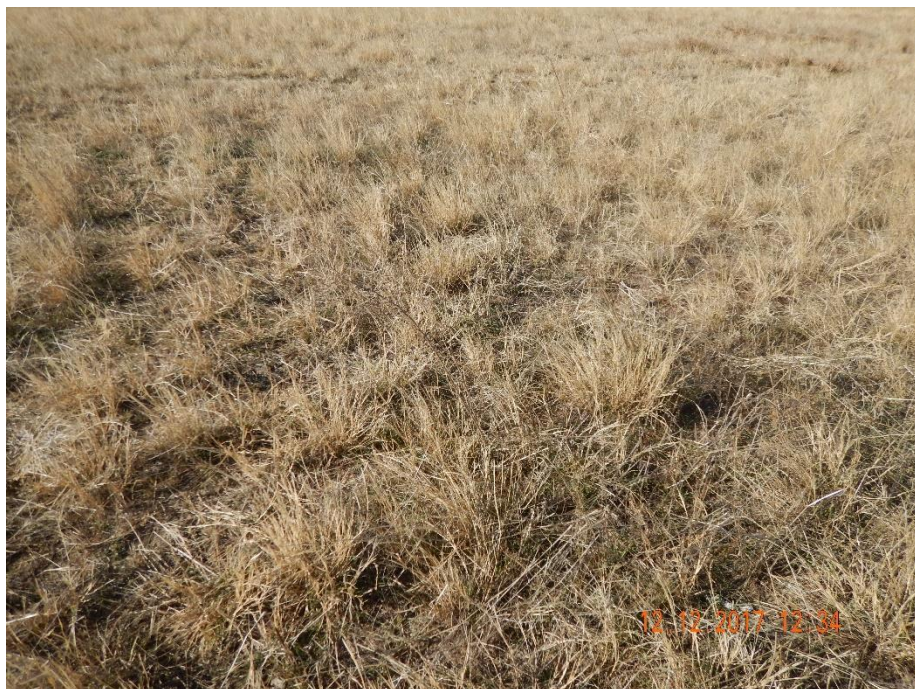
Photo 3: Photo taken from the adjacent reference area of the well location. Vegetation seen here appears to be predominantly desirable perennial vegetation such as sand dropseed.

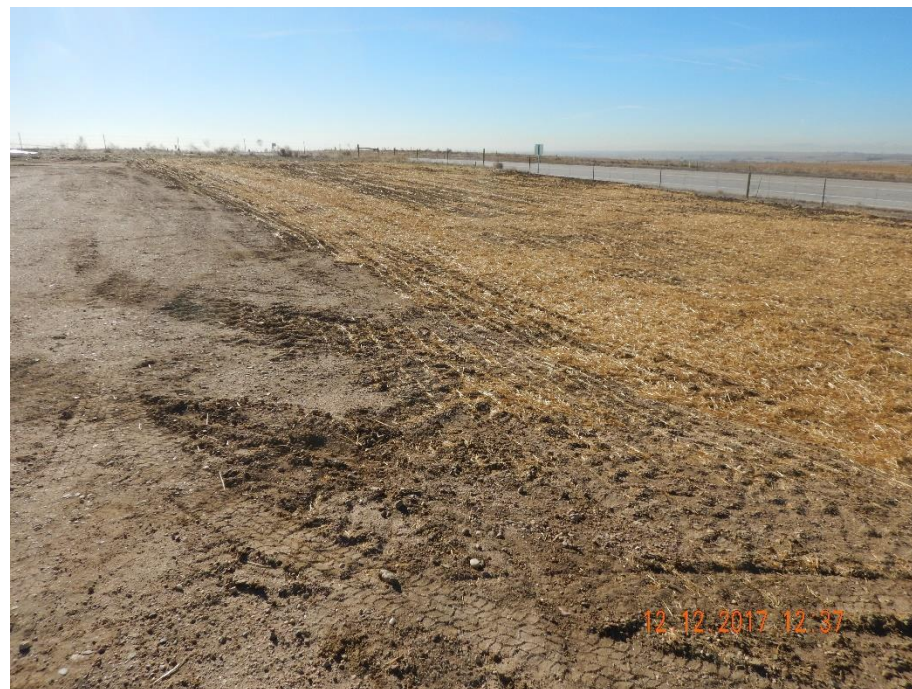
Photo 4: Photo taken from the east end of the former battery facility, facing southwest. Photo shows majority of the battery facility appears to have been seeded and crimped with straw for stabilization.

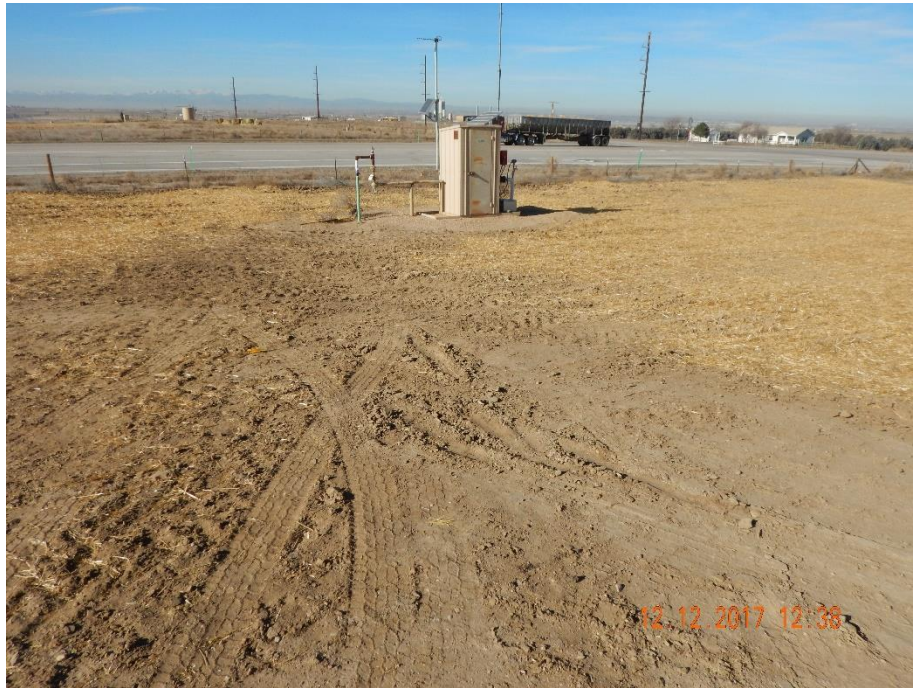
Photo 5: Photo taken from the east end of the former tank battery location, facing northwest. Photo shows majority of the battery facility appears to have been seeded and crimped with straw for stabilization. Photo also shows meter shed equipment has not been removed per the corrective action.

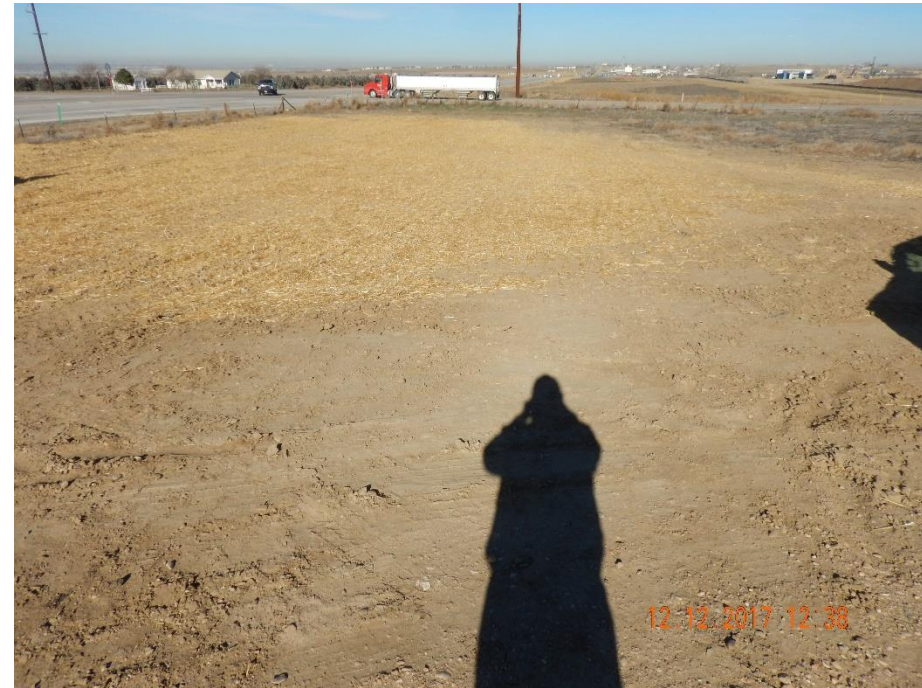
Photo 6: Photo taken from the east end of the former tank battery location, facing north. Photo shows majority of the battery facility appears to have been seeded and crimped with straw for stabilization.
