Inspection Photos

Operator: WESTERN OPERATING COMPANY -
95620

Location ID: 319767

Inspection Doc. Number: 682502972
Adams County, CO

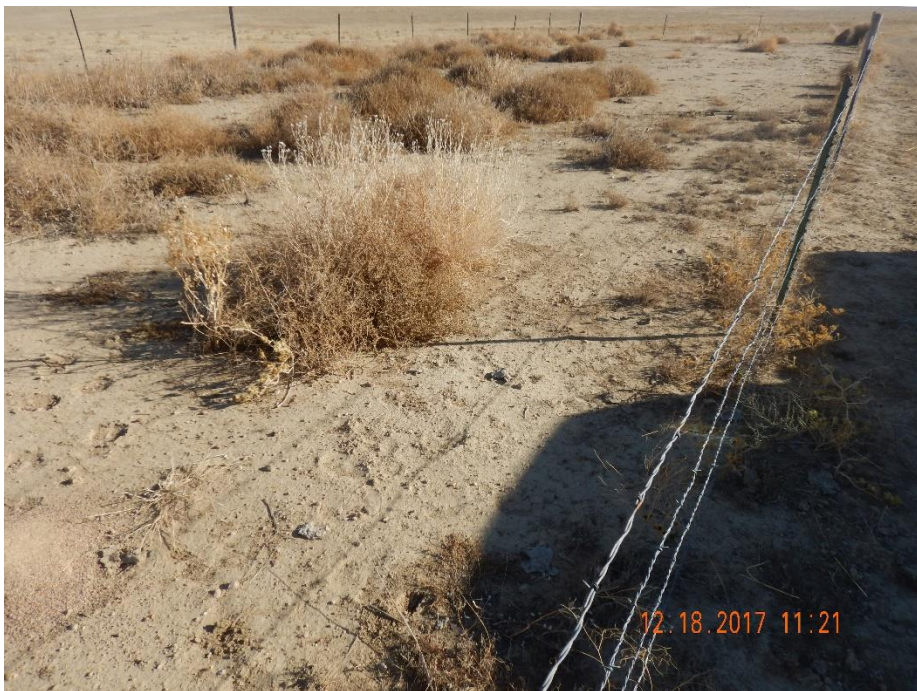
Photo 1: Photo taken from the south end of the former battery facility, facing east. Previous inspections required operator to perform weed management. Photo shows weeds have not been managed or removed per the corrective actions.

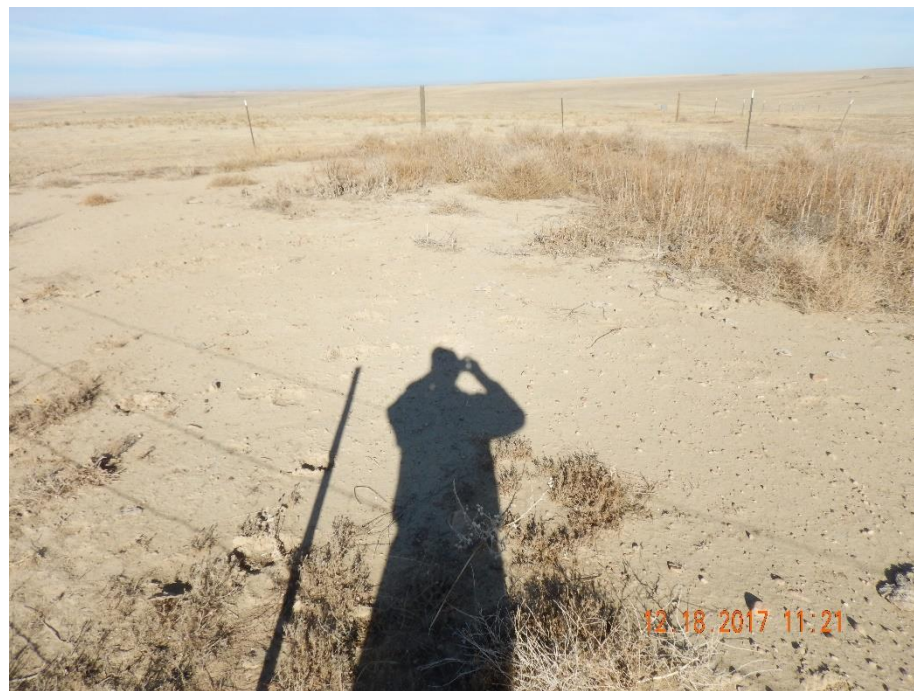
Photo 2: Photo taken from the south end of the former battery facility, facing northwest. Previous inspections required operator to perform weed management. Photo shows weeds have not been managed or removed per the corrective actions.

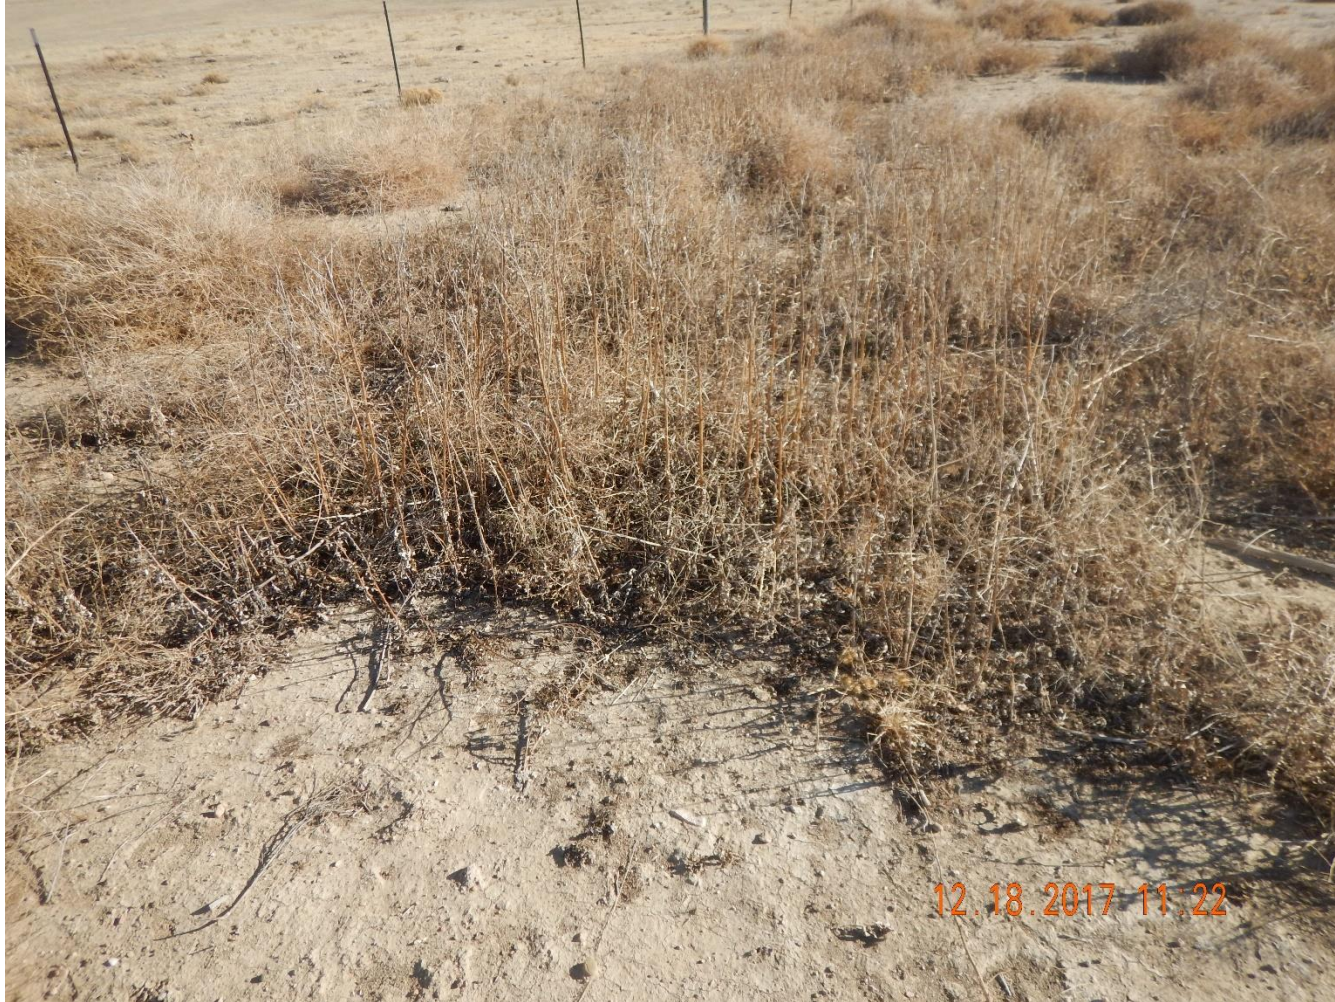
Photo 3: Photo taken from within the former battery facility. Previous inspections documented that Canada thistle (*Cirsium arvense*) was present and required its removal. Canada thistle is a listed noxious weed is required to be managed under COGCC, Colorado State and Adams County requirements. Photo shows stalks of Canada thistle that were previously documented. Photo shows operator has not removed or managed weeds on the location.
