Inspection Photos

Operator: PETRO-CANADA RESOURCES (USA)
INC - 72085

Location ID: 311698

Inspection Doc. Number: 682502984
Adams County, CO

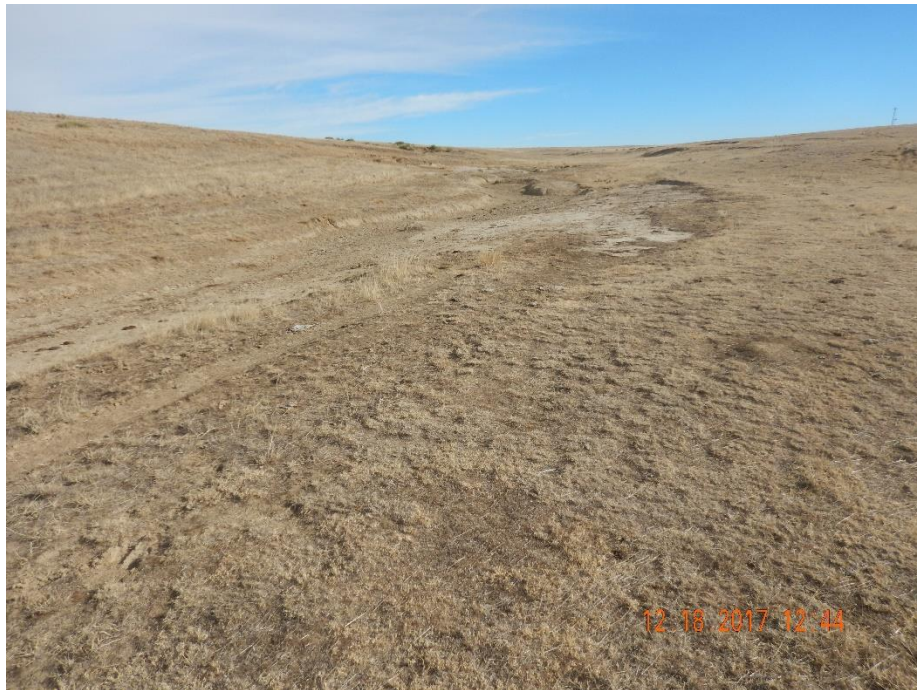
Photo 1: Photo taken from the west of the location, facing east. Previous inspections required operator stabilize the location and drainage to prevent further incision and erosion, and to perform reclamation. Photo shows no reclamation activities appear to have been conducted.

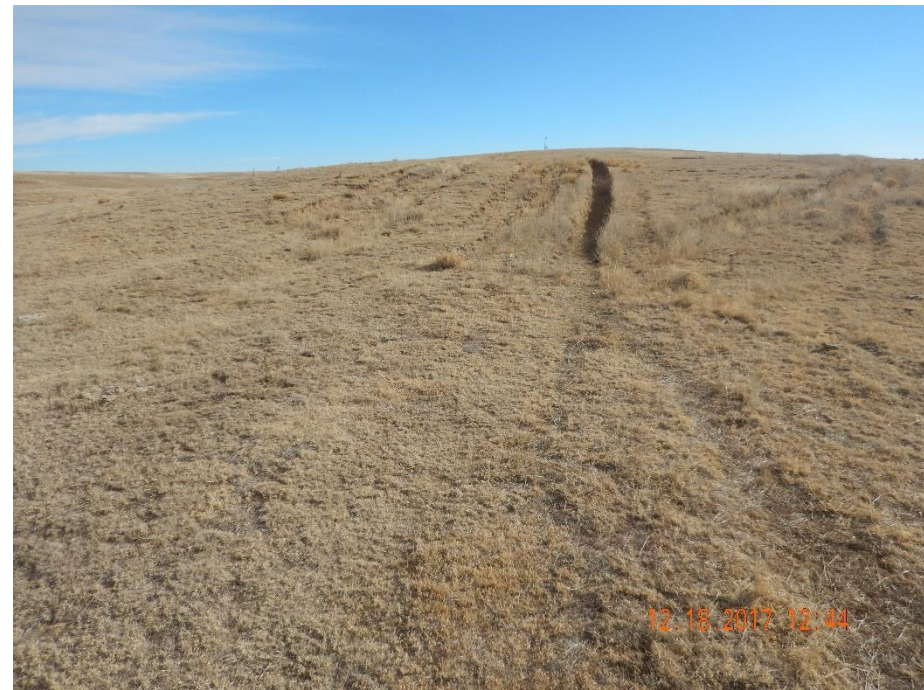
Photo 2: Photo taken from the west of the location. Previous inspections required operator stabilize the location and drainage to prevent further incision and erosion, and to perform reclamation. Photo shows no reclamation activities appear to have been conducted at access road(s).
