Inspection Photos

Operator: DCP MIDSTREAM LP - 4680

Facility ID: 453456

Inspection Doc. Number: 682503000

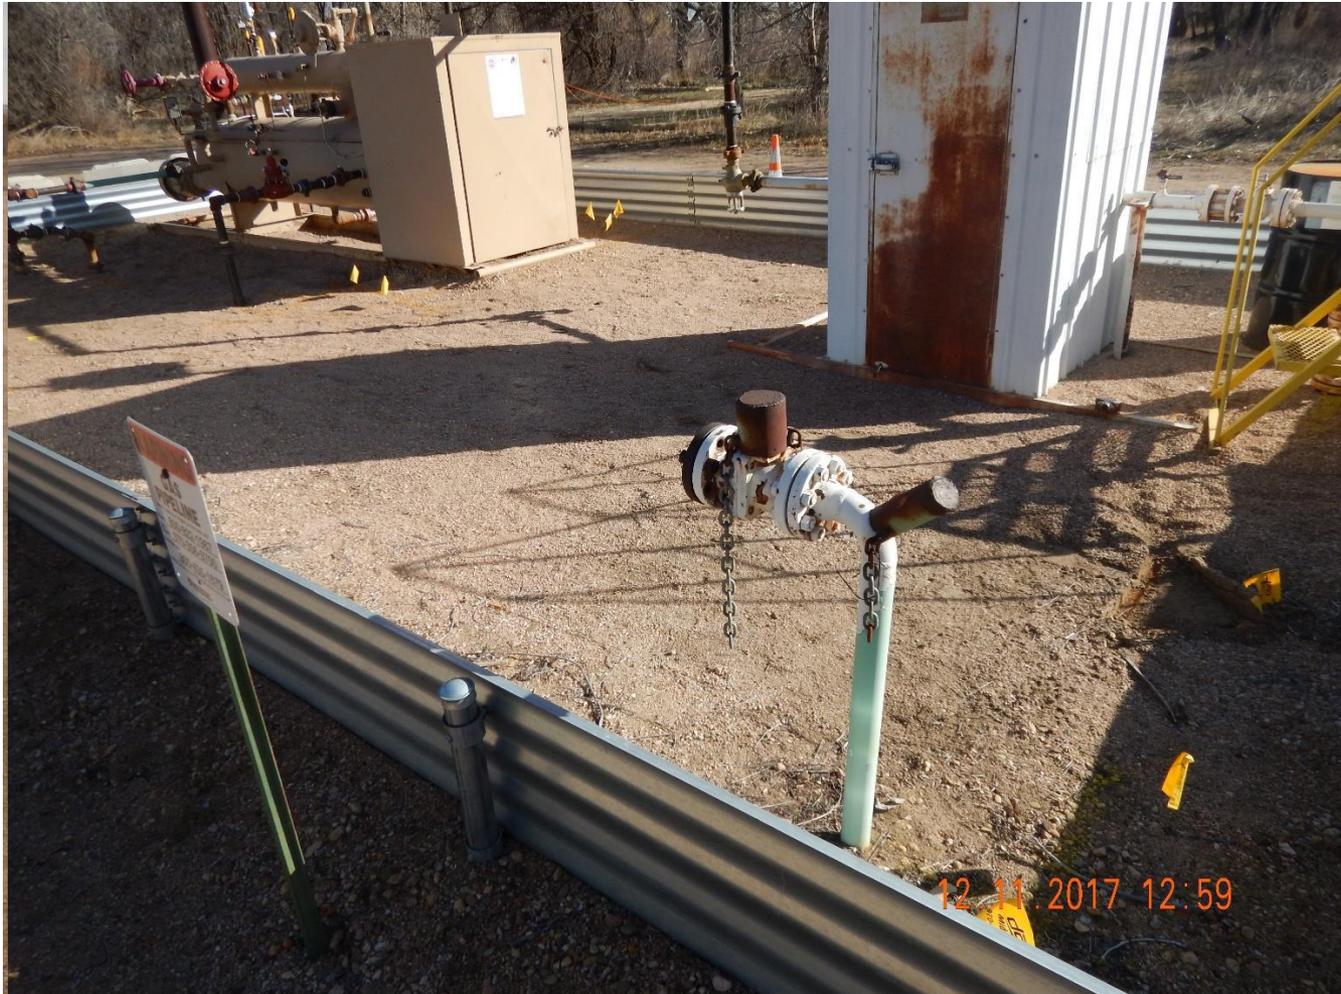
Photo 1: Photo taken from the eastern half of Extraction's Brantner Tank Battery Facility, facing southeast. Photo shows an abandoned pipe riser that has been identified as belonging to DCP. Riser requires removal in accordance to 1004.a.
