Location Name: Wet Canyon Spill COGCC Spill # 453631

Inspection Date: 1/3/2018

COLORADO
Oil & Gas Conservation
Commission
Department of Natural Resources

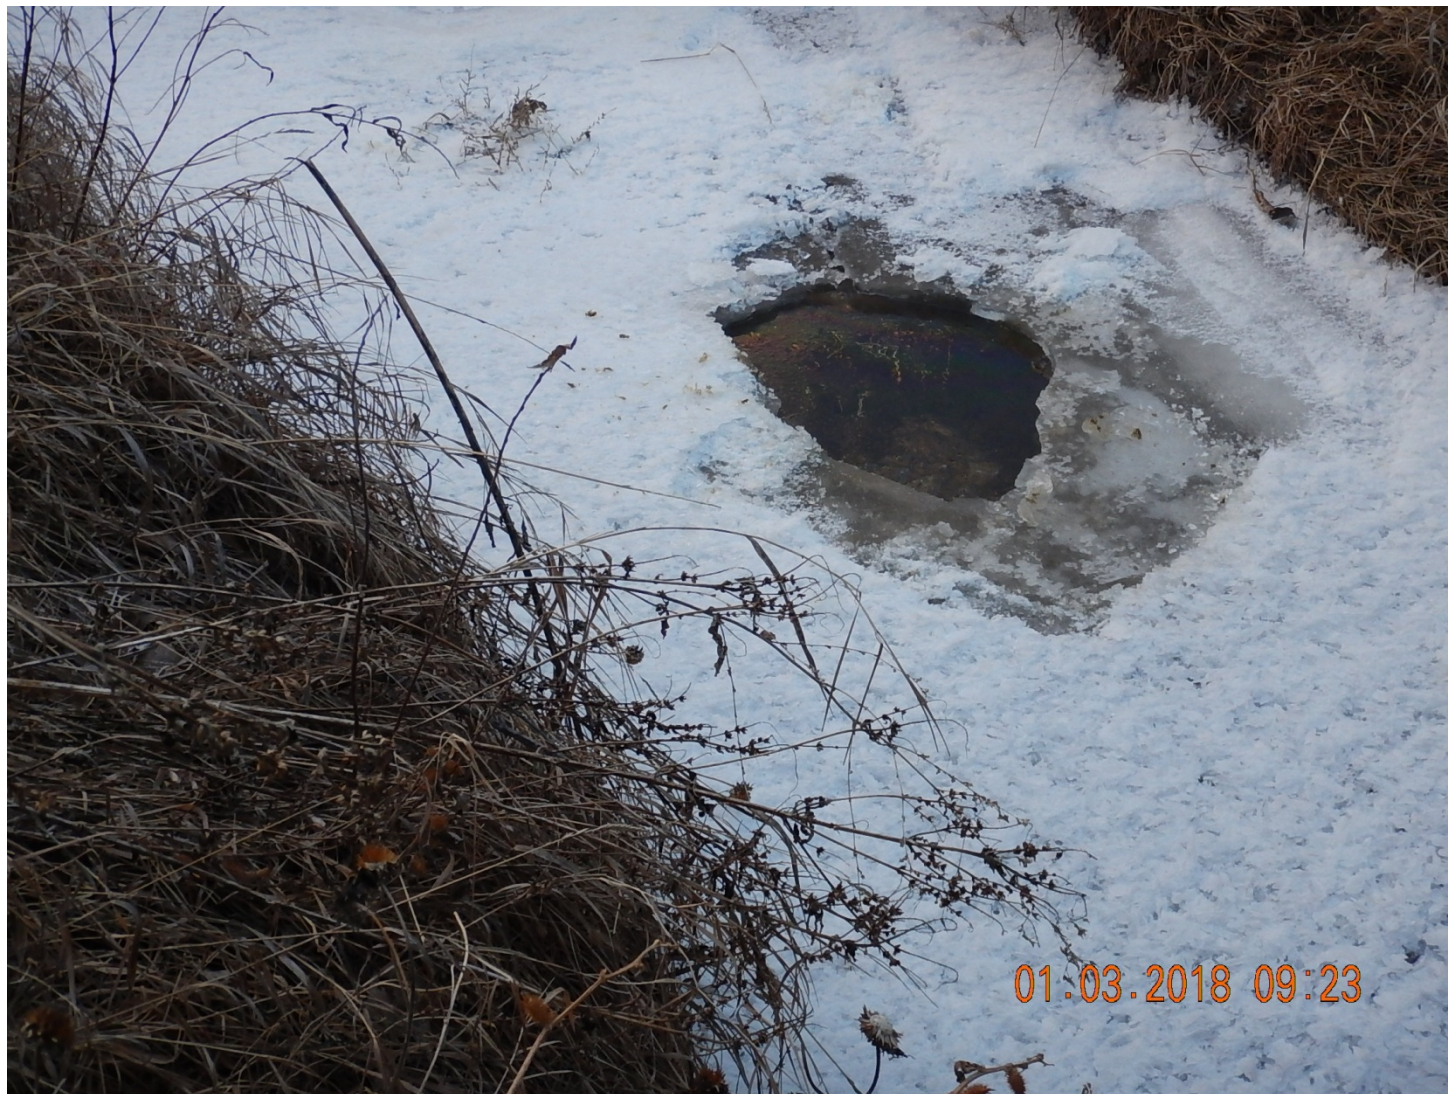
COGCC Sample #1. Surface water sample obtained from Wet Canyon here. Coordinates 37.13234, -104.84719

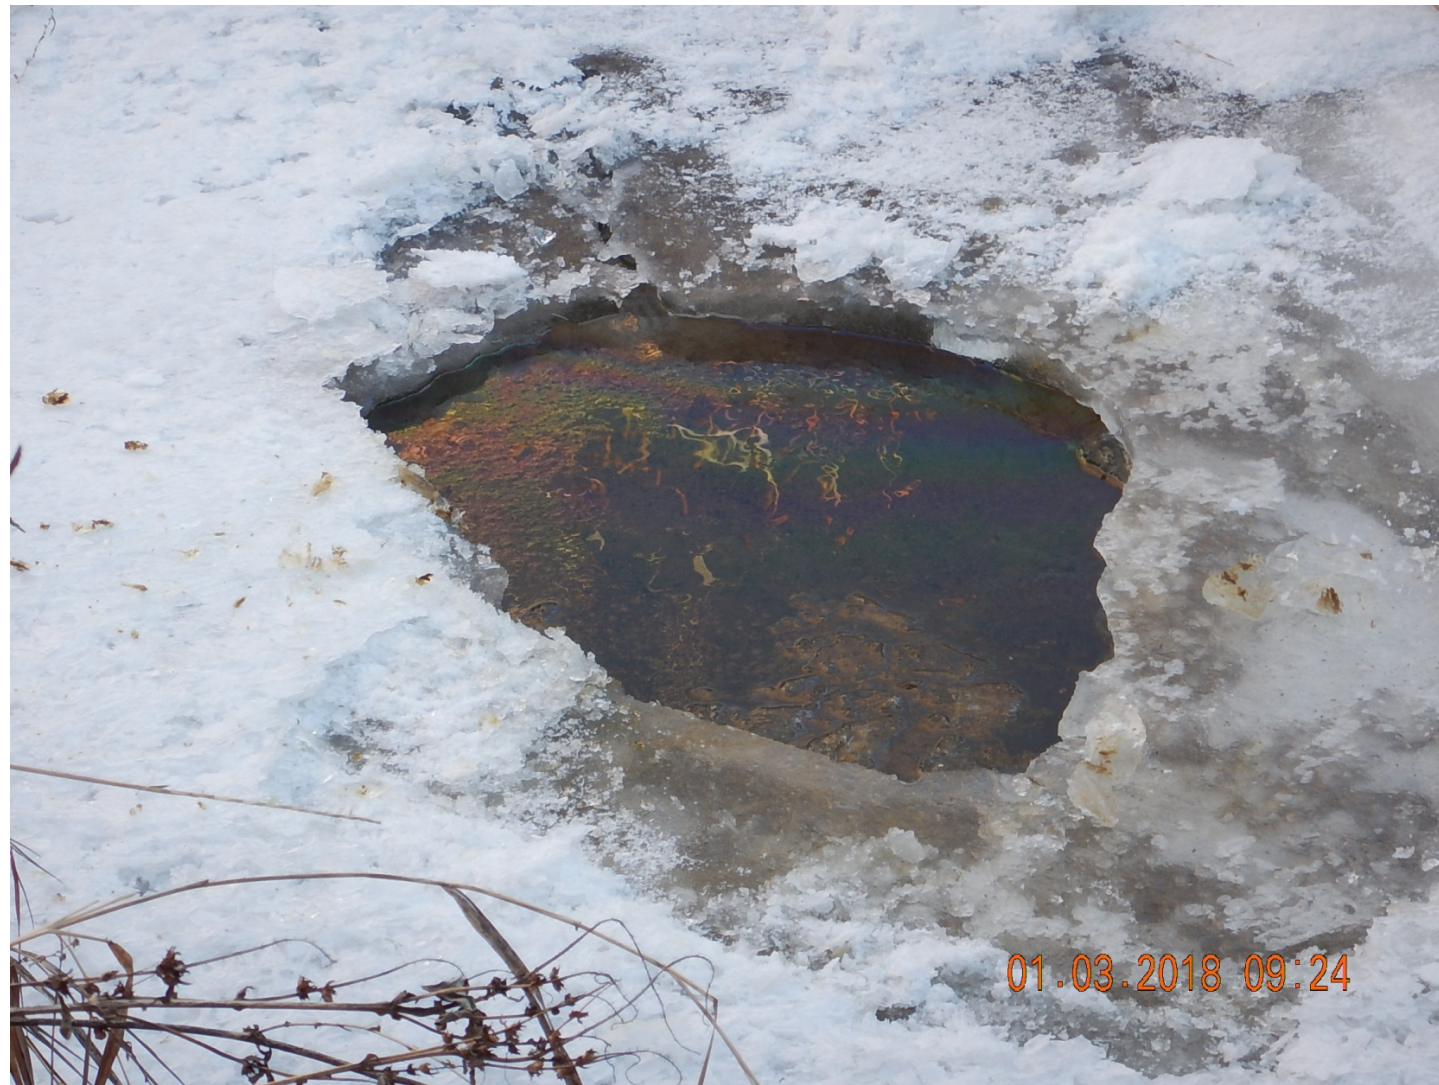
COGCC Sample #1. Surface water sample obtained from Wet Canyon here. Coordinates 37.13234, -104.84719. Very thin oil sheen observed.

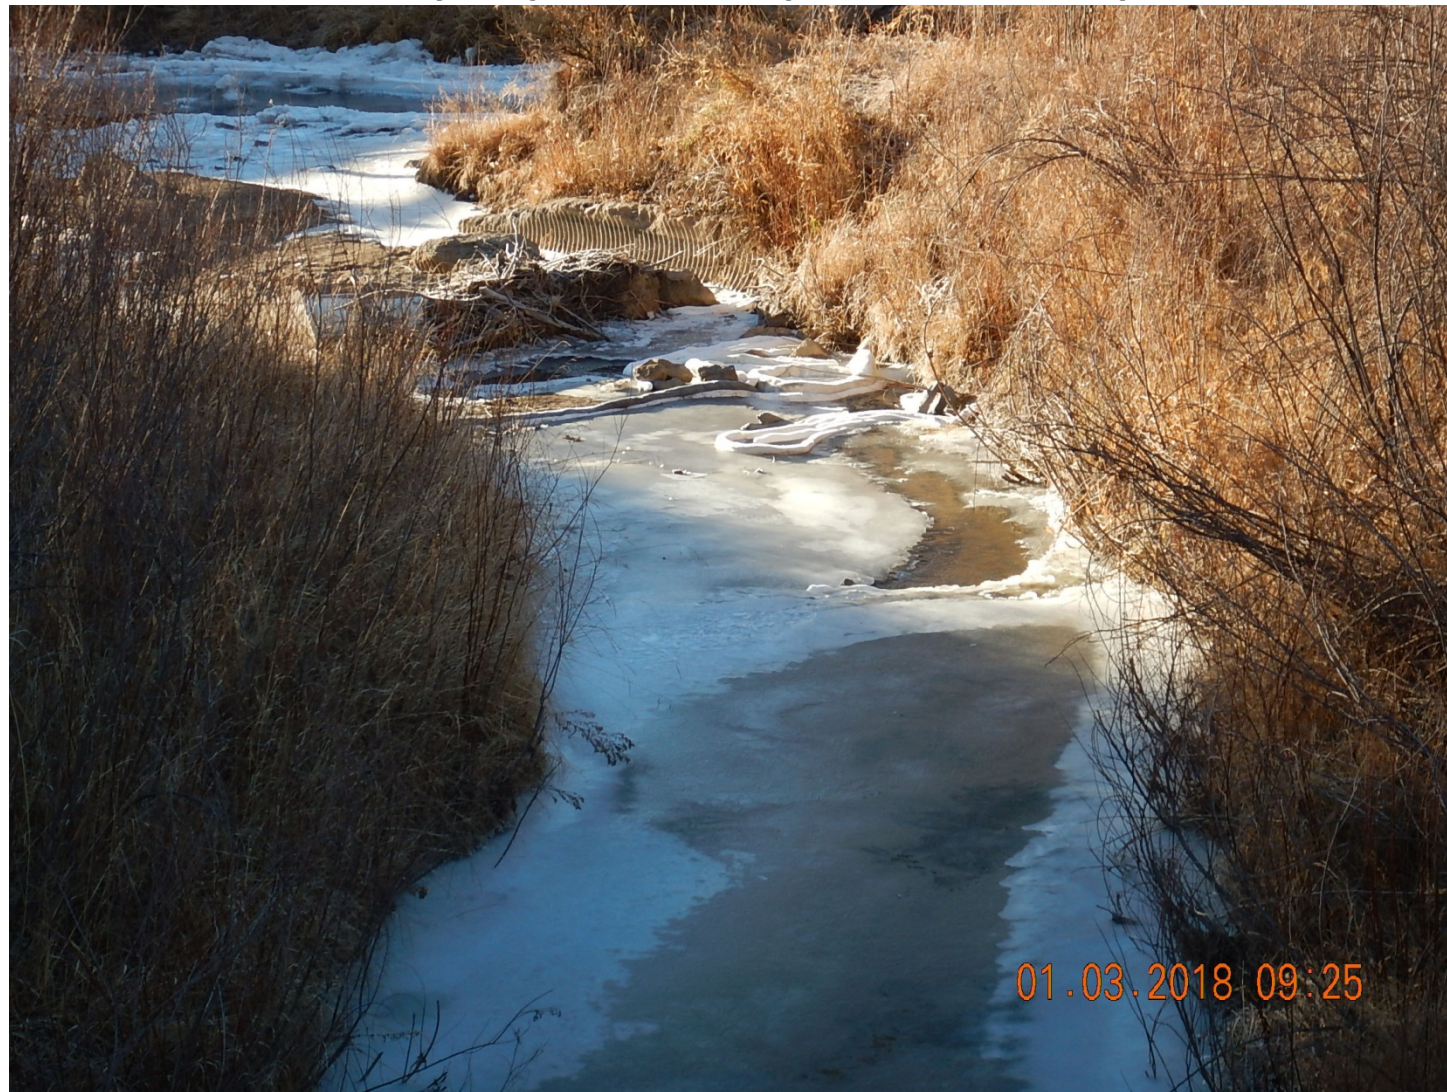
Looking from COGCC Sample #1 south (downstream) toward Purgatorie River. Purgatorie River visible in the upper left. Booms were placed in this location on 1/2/2018

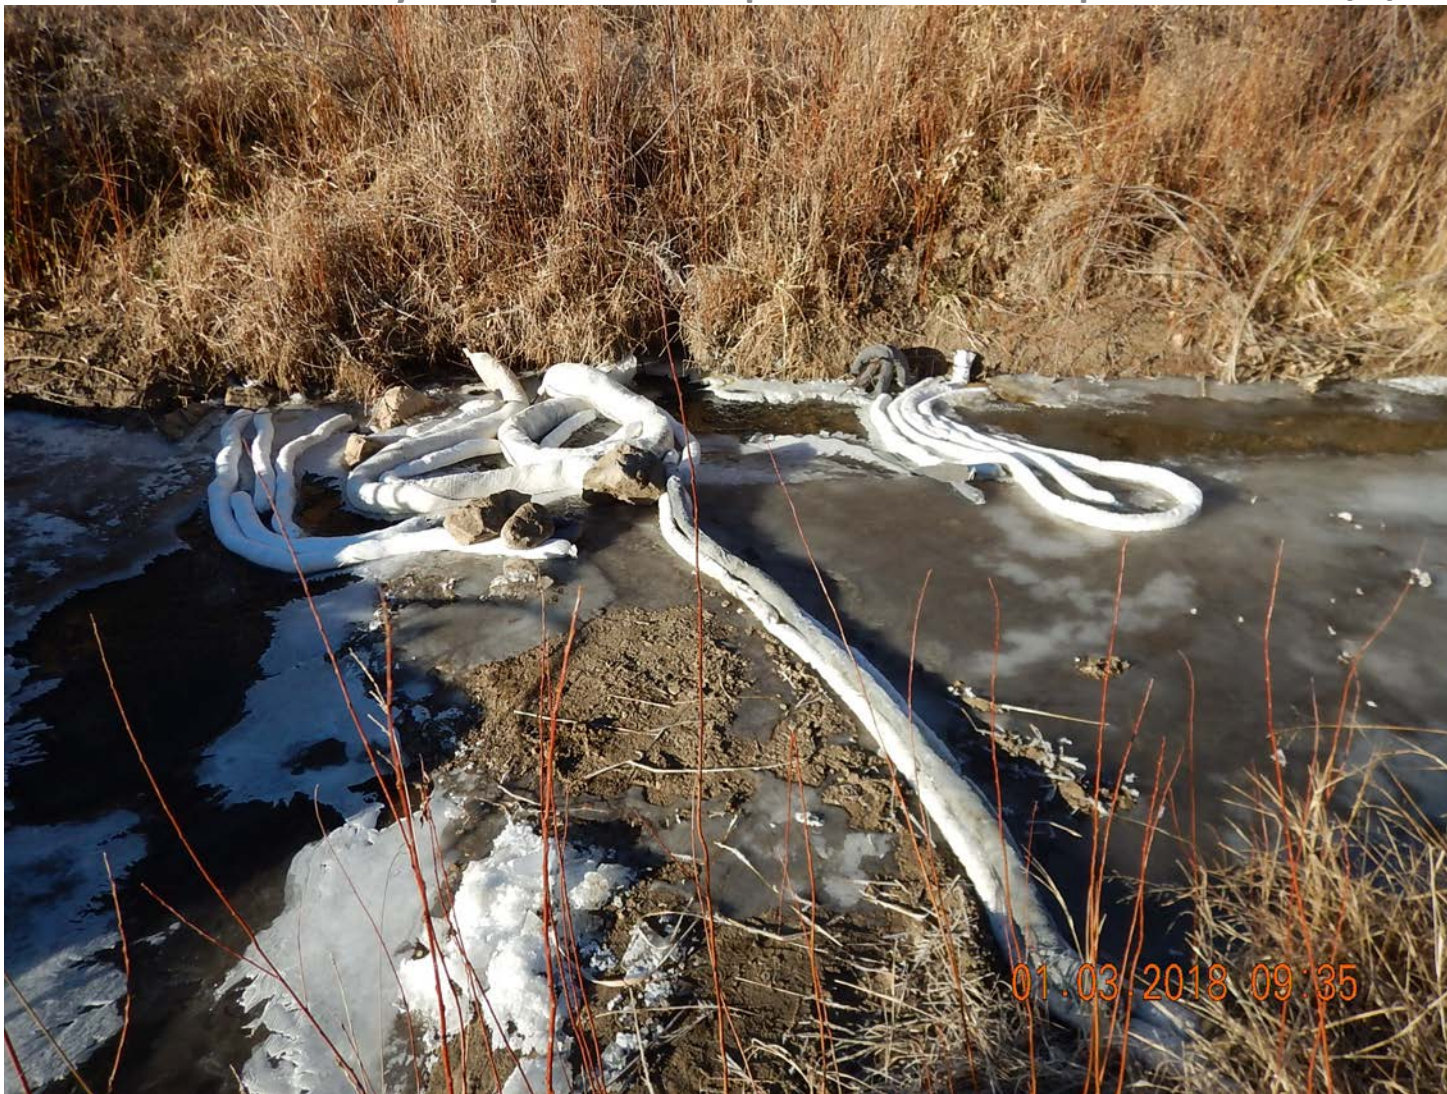
Close up of booms shown in previous picture.

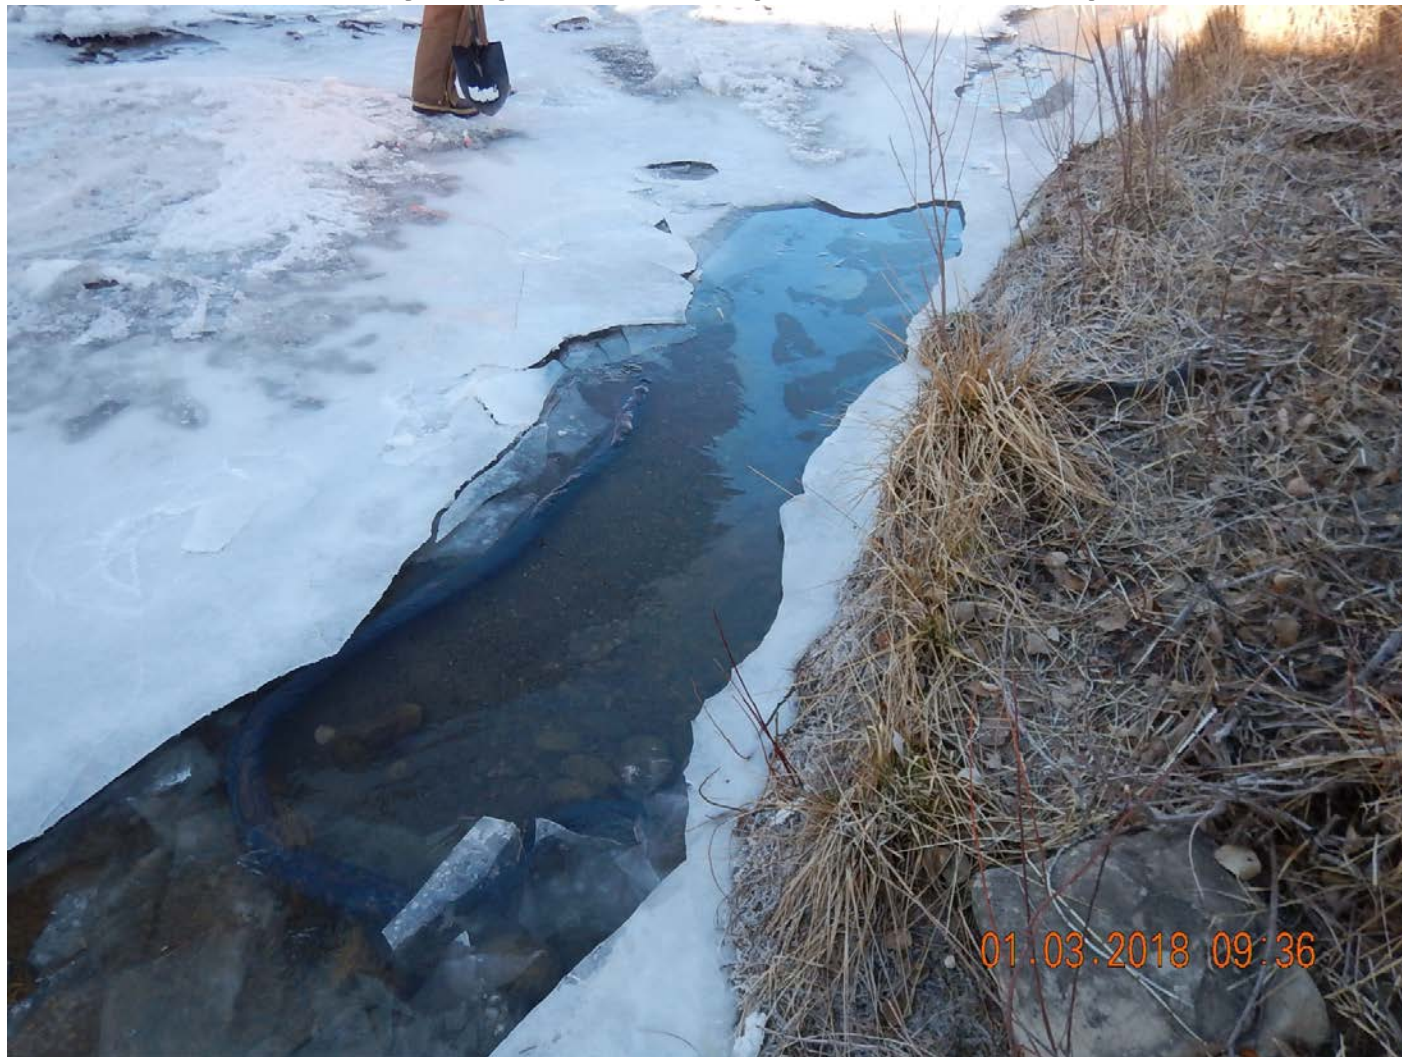
COGCC Sample #2. Surface water sample obtained from the Purgatorie River here. This location is where Wet Canyon flows into the Purgatorie. Saturated boom and thin oil sheen visible. Coordinates 37.131893, -104.847150

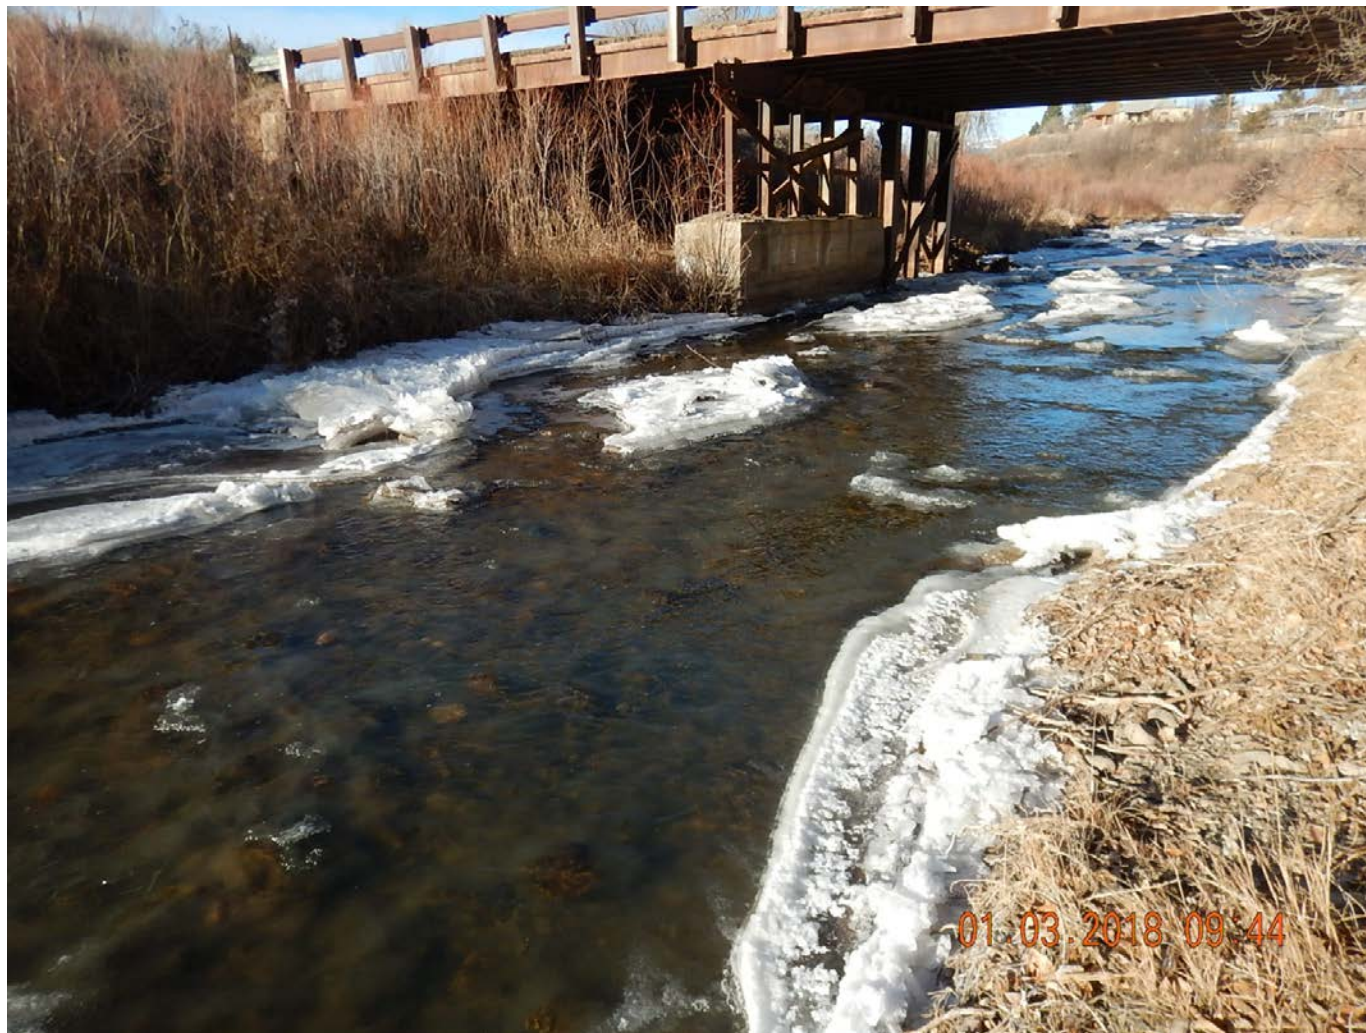
Purgatorie River just downstream from COGCC Sample #2. Looking west from coordinates 37.131747, -104.846793. No oil sheen visible from this location at the time of inspection. Cloudy areas seen are from ice forming on rocks.

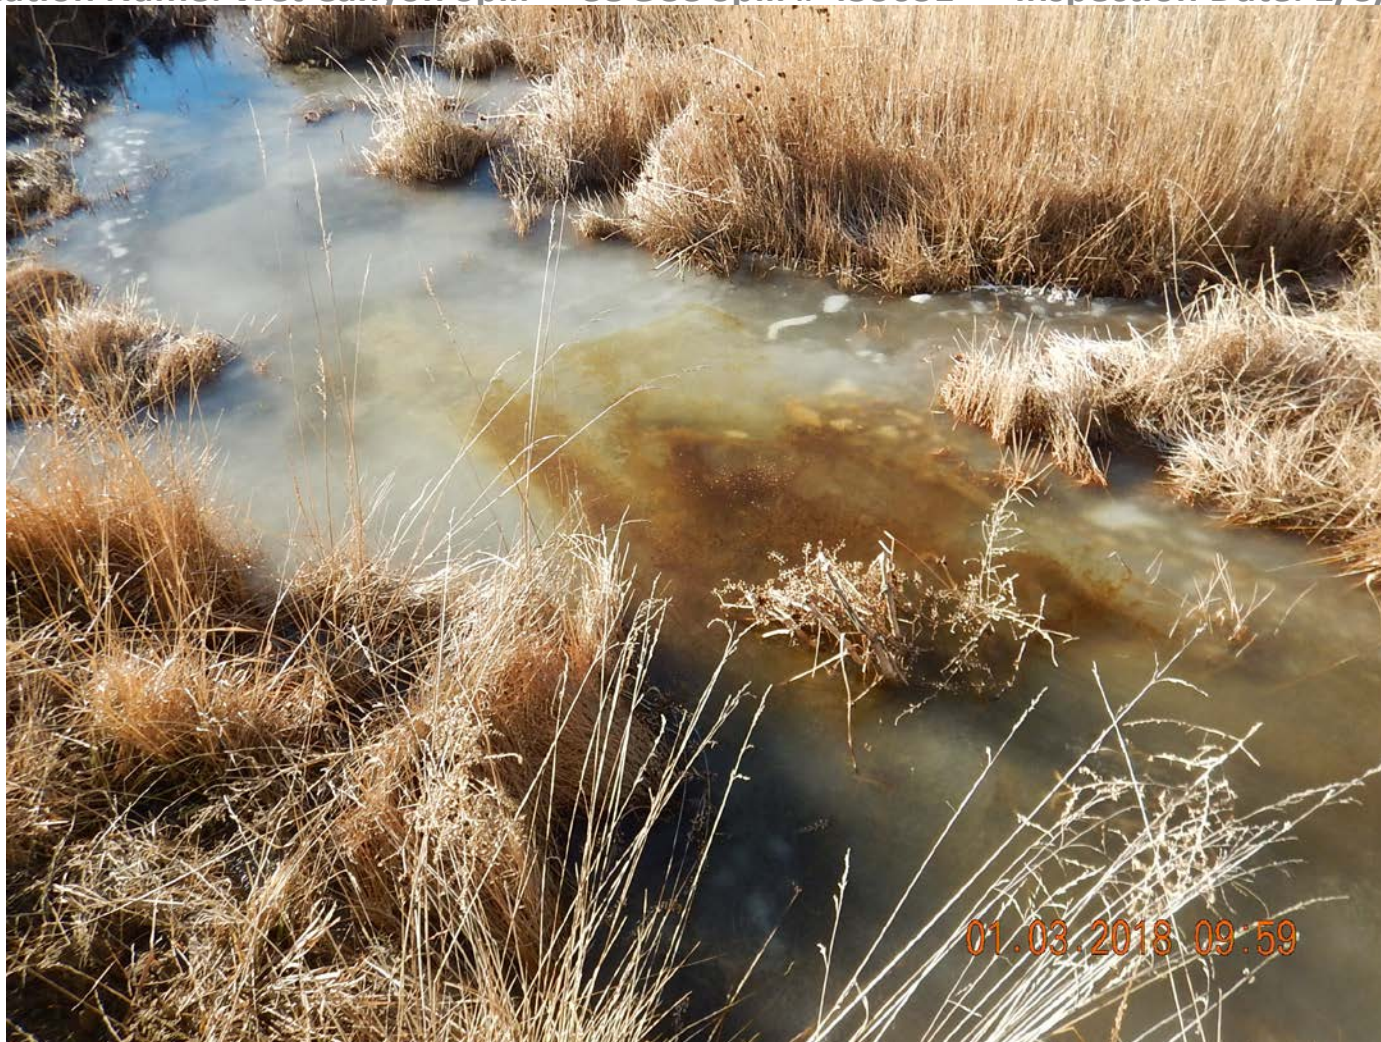
Wet Canyon COGCC Sample #2. Surface water sample obtained here. Coordinates: 37.146454, -104.860342.
Patches of oily slush/ice observed in Wet Canyon just below where spill flowed into Wet Canyon.

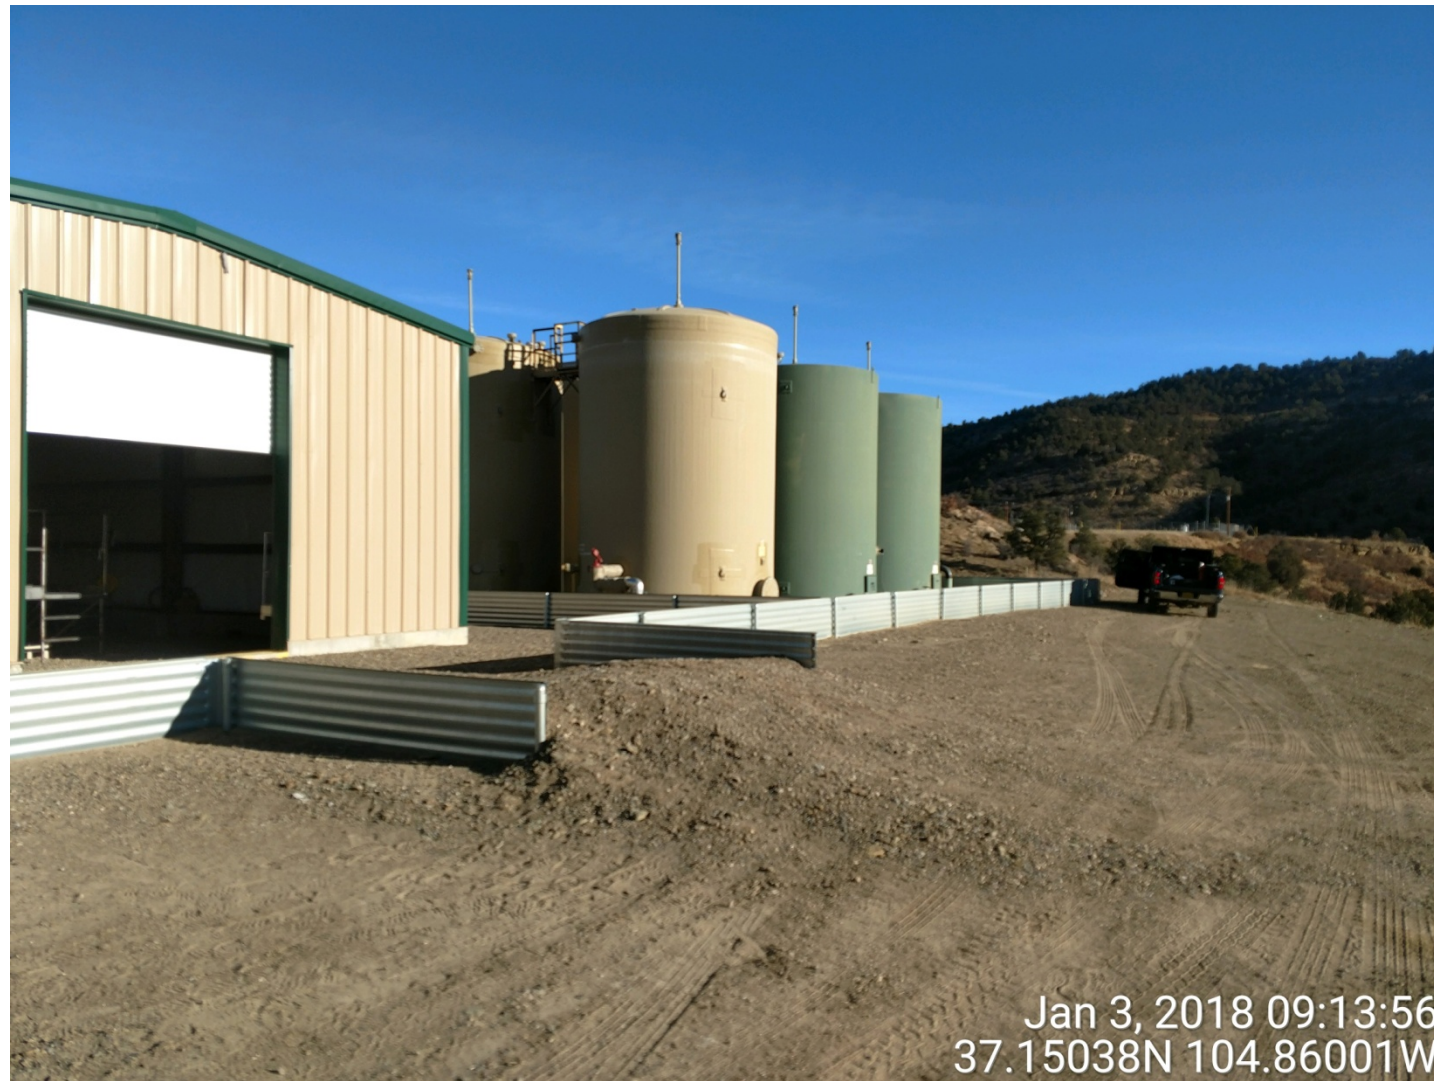
Jan 3, 2018 09:13:56
37.15038N 104.86001W

Tank battery where overflow occurred.

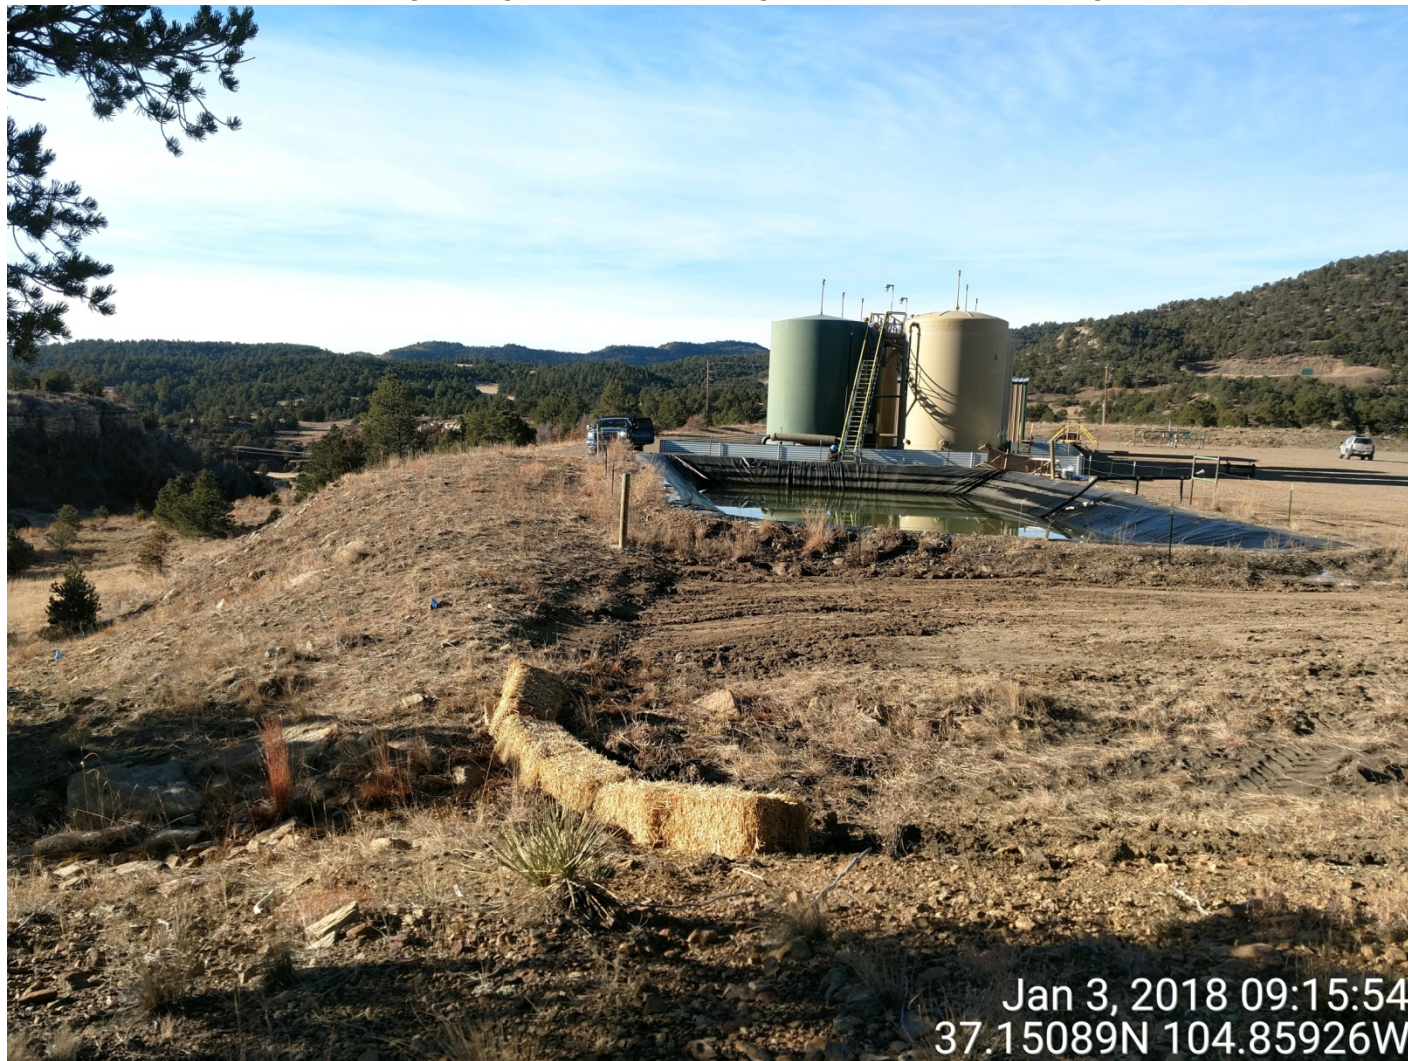
Jan 3, 2018 09:15:54
37.15089N 104.85926W

Spill occurred from tank overflow into emergency pit show. Spill flowed from pit toward hay bales pictured and into dry drainage.

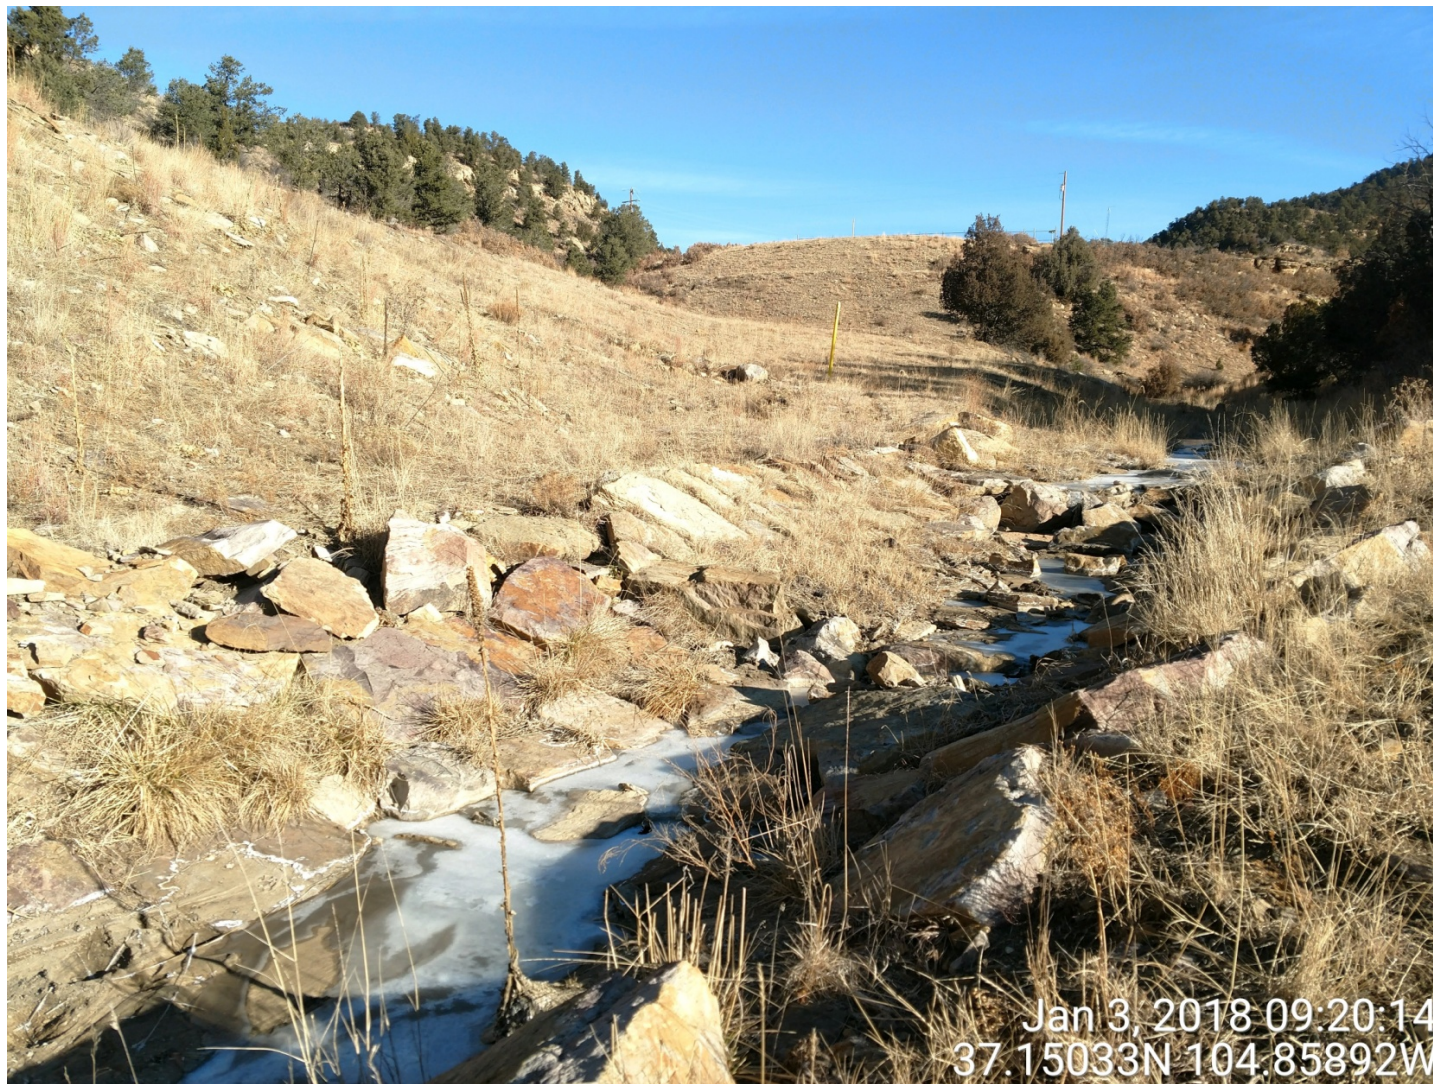
Jan 3, 2018 09:20:14
37.15033N 104.85892W

Looking downstream from pit into dry drainage where spill flowed. Ice shown is from spilled fluid.

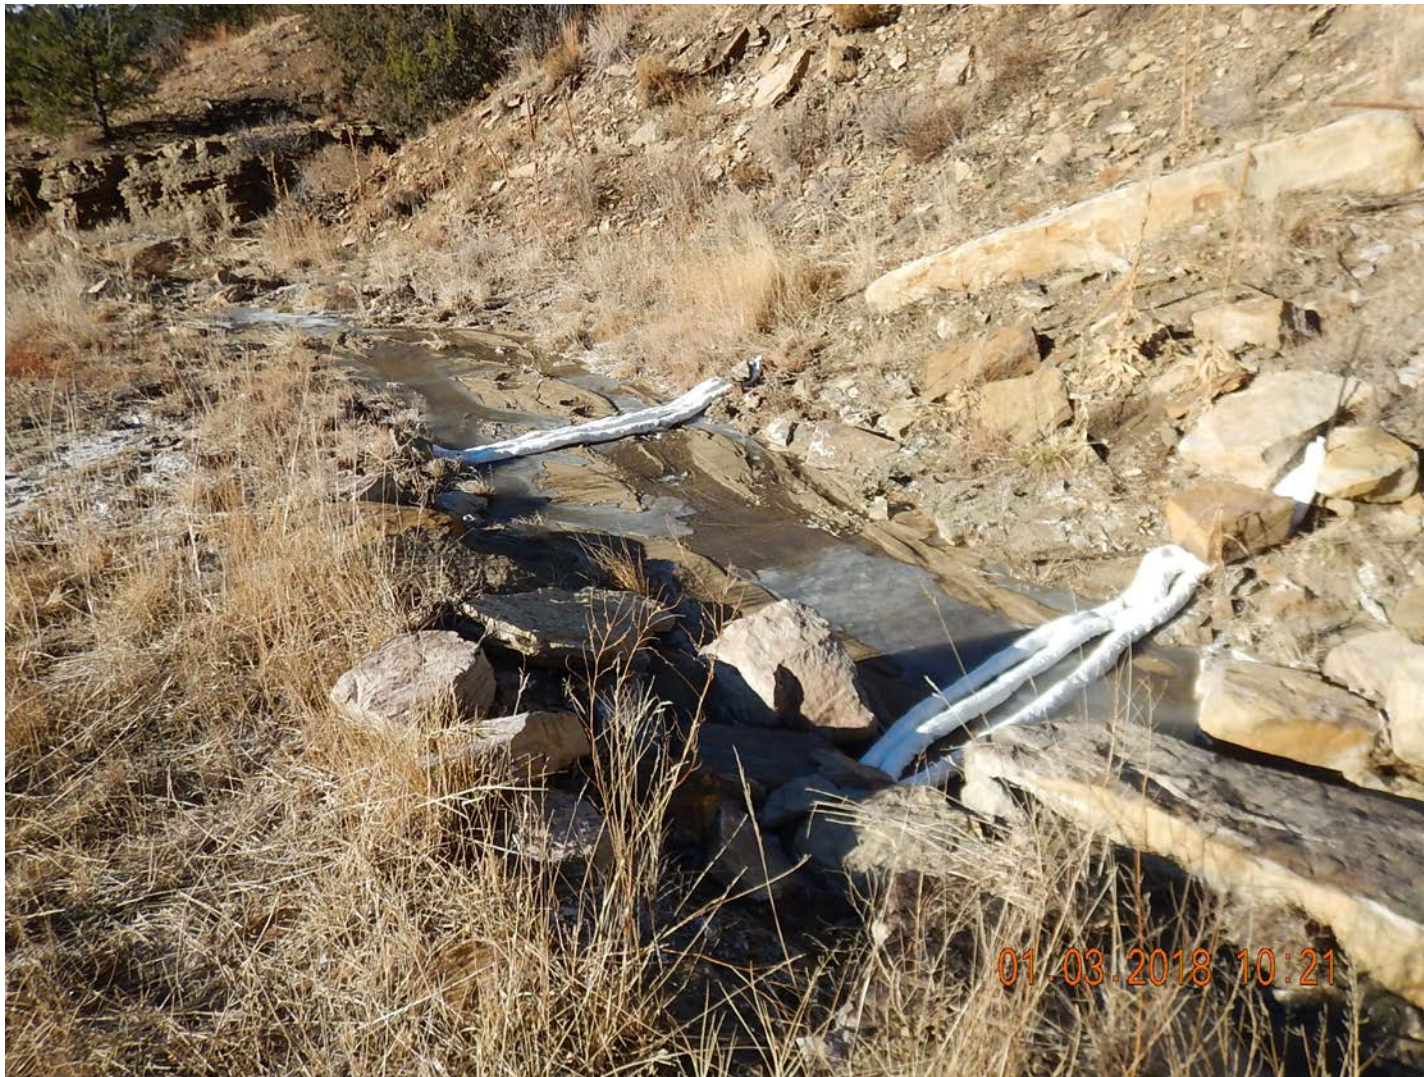
Looking down dry drainage where spill flowed. Ice shown is from spilled fluid.

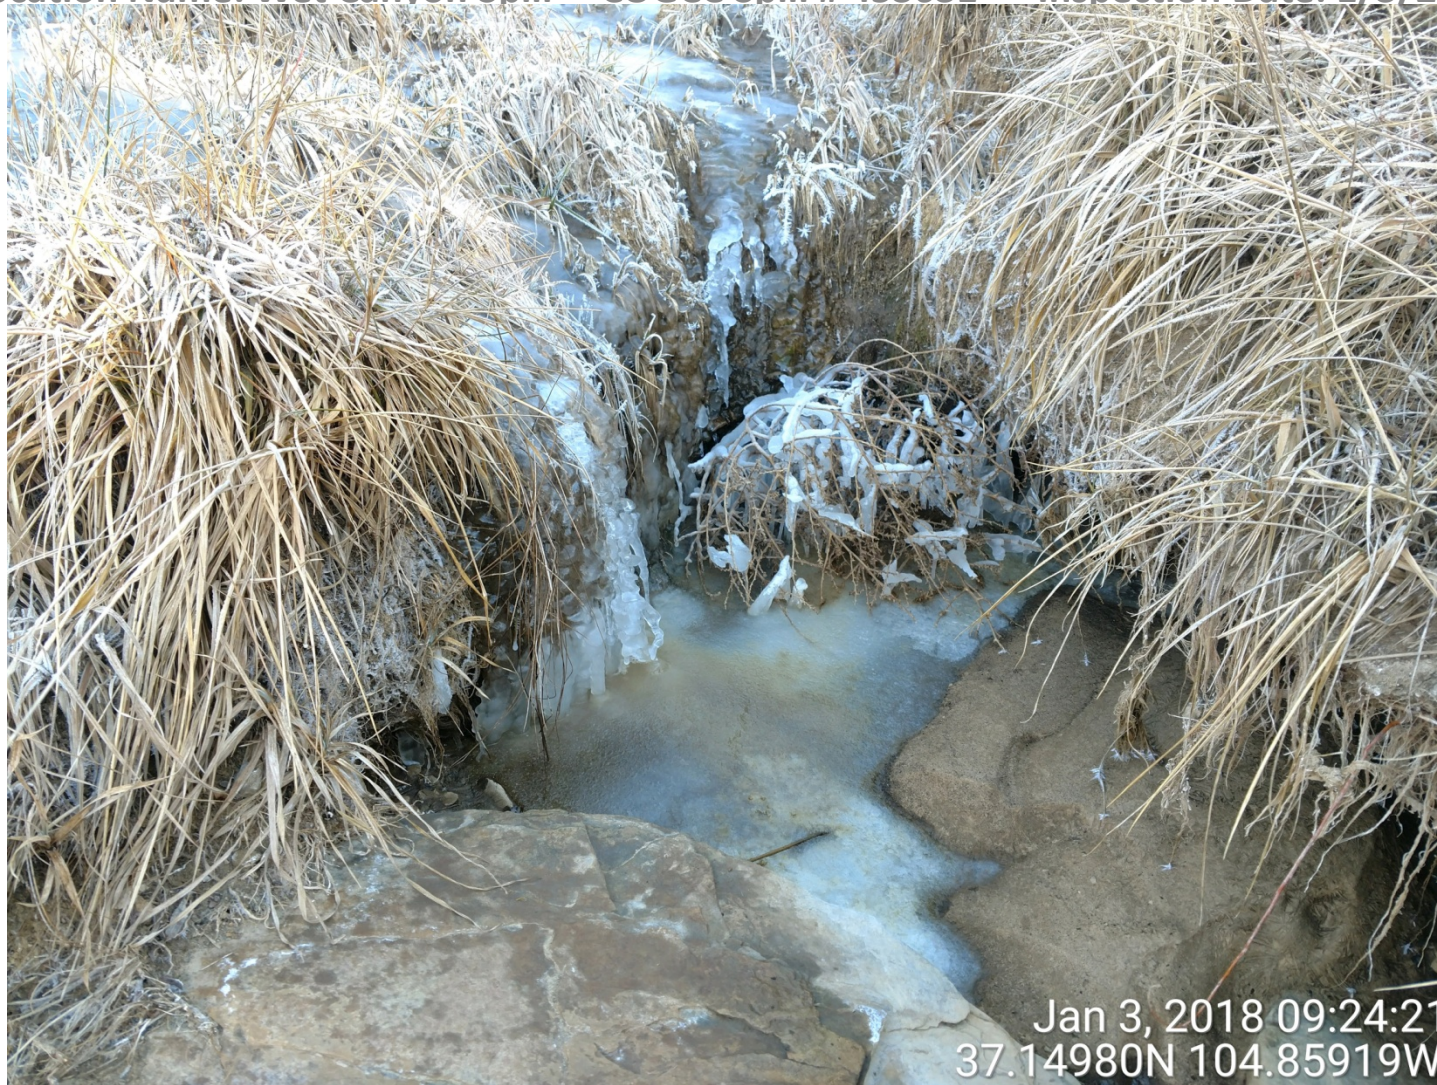
Jan 3, 2018 09:24:21
37.14980N 104.85919W

Patches of frozen spilled fluid observed in the dry drainage.

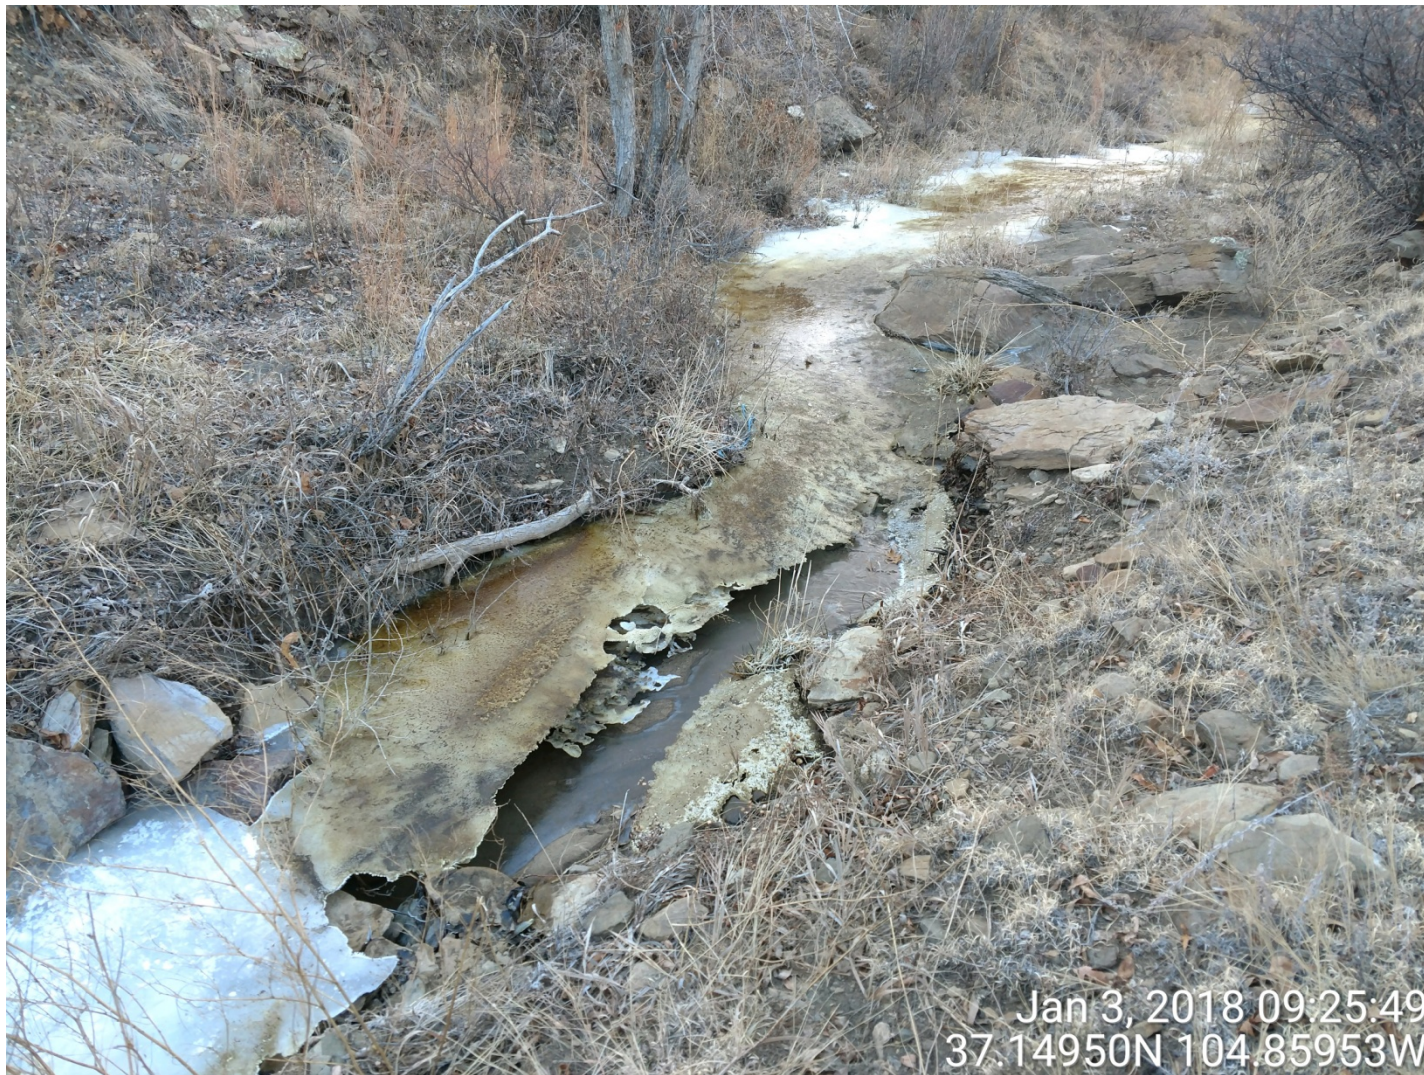
Jan 3, 2018 09:25:49
37.14950N 104.85953W

Patches of frozen spilled fluid observed in the dry drainage. Looking upstream.

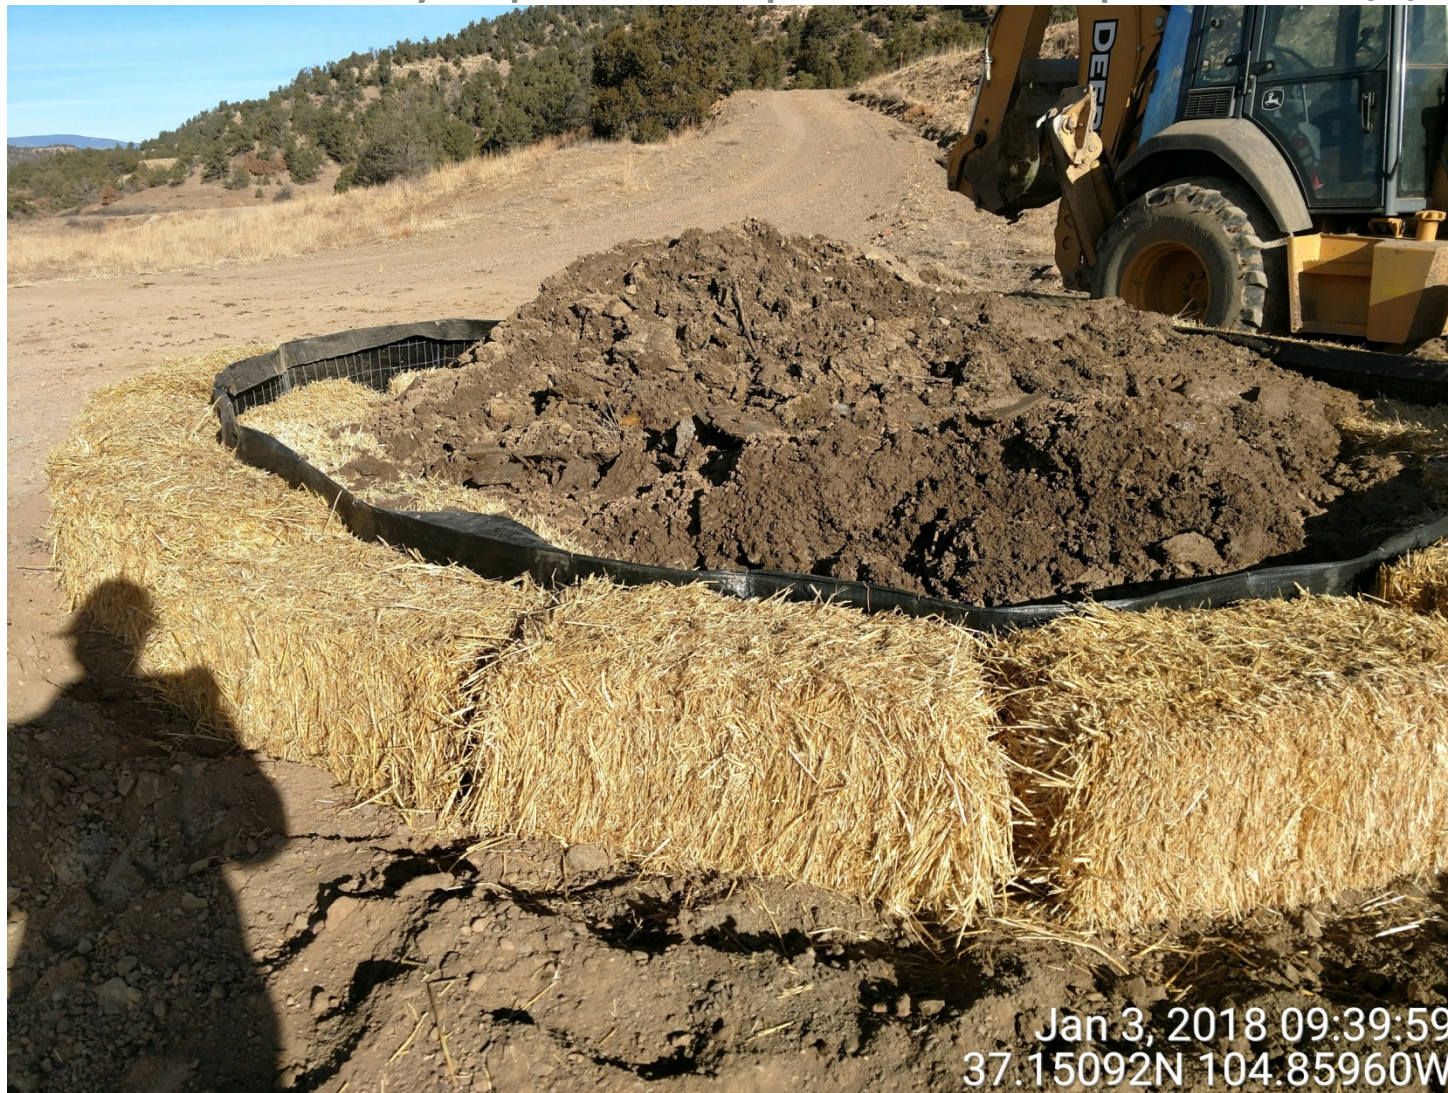
Impacted soil stored in secondary containment on well pad.
