Location Name: Wet Canyon Spill COGCC Spill # 453631

Inspection Date: 1/3/2018

COLORADO
Oil & Gas Conservation
Commission
Department of Natural Resources

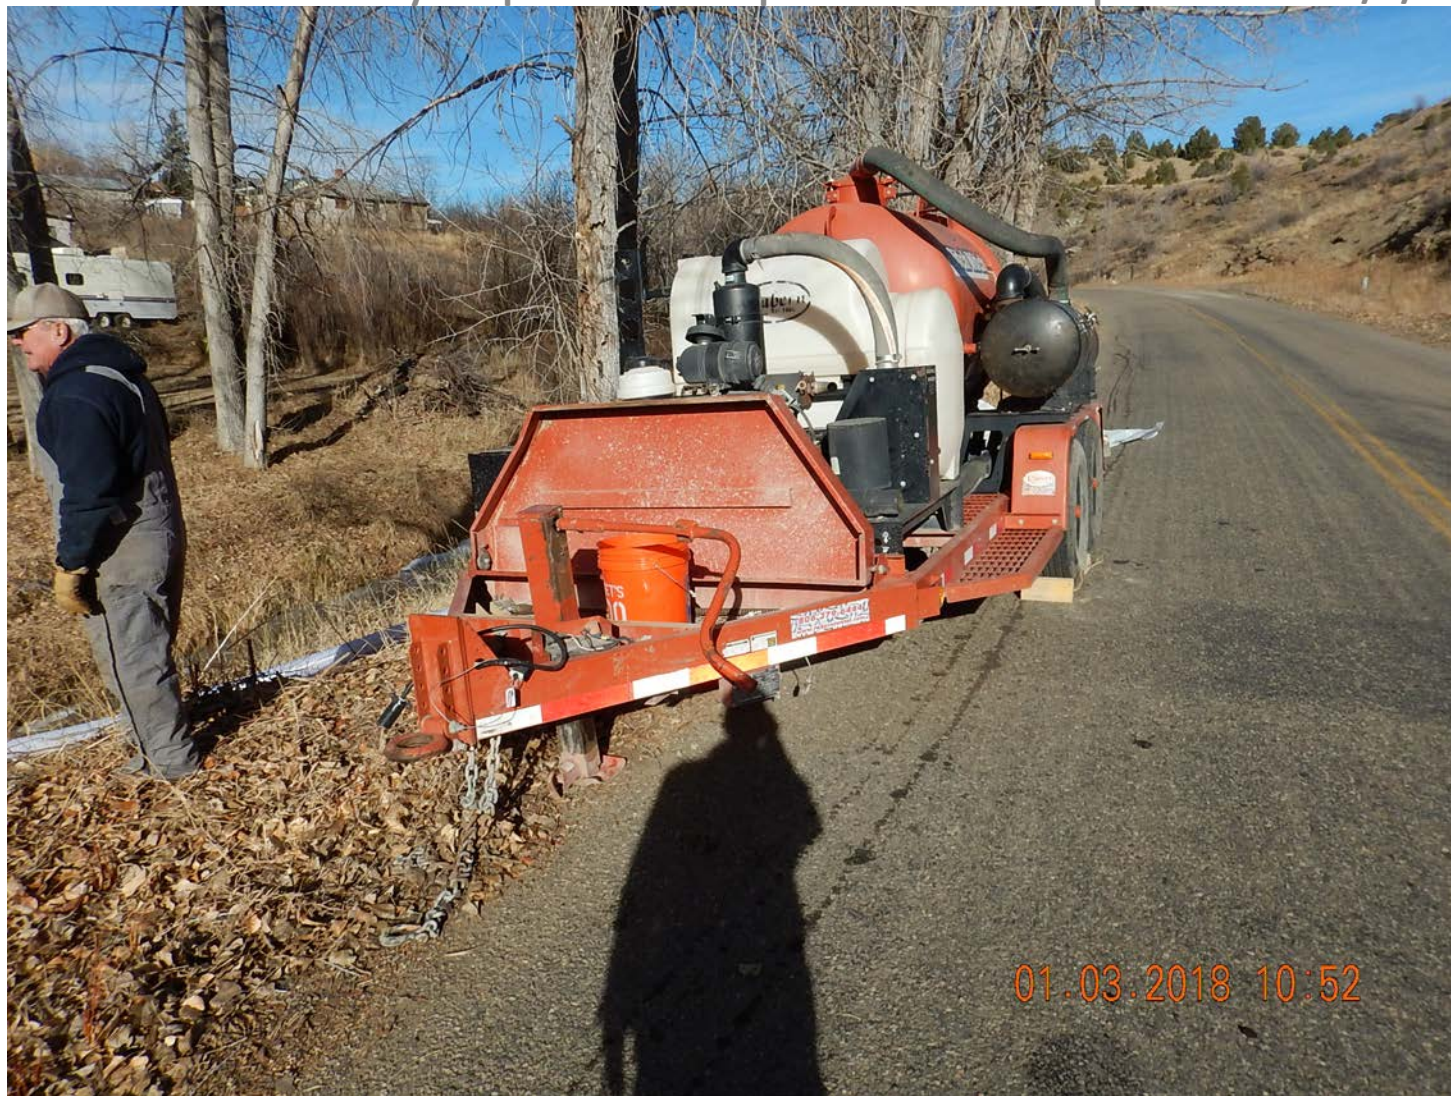
Vacuum trailer stationed at the base of Wet Canyon and was actively pumping impacted water from Wet Canyon. Located at COGCC Sample #1 location.

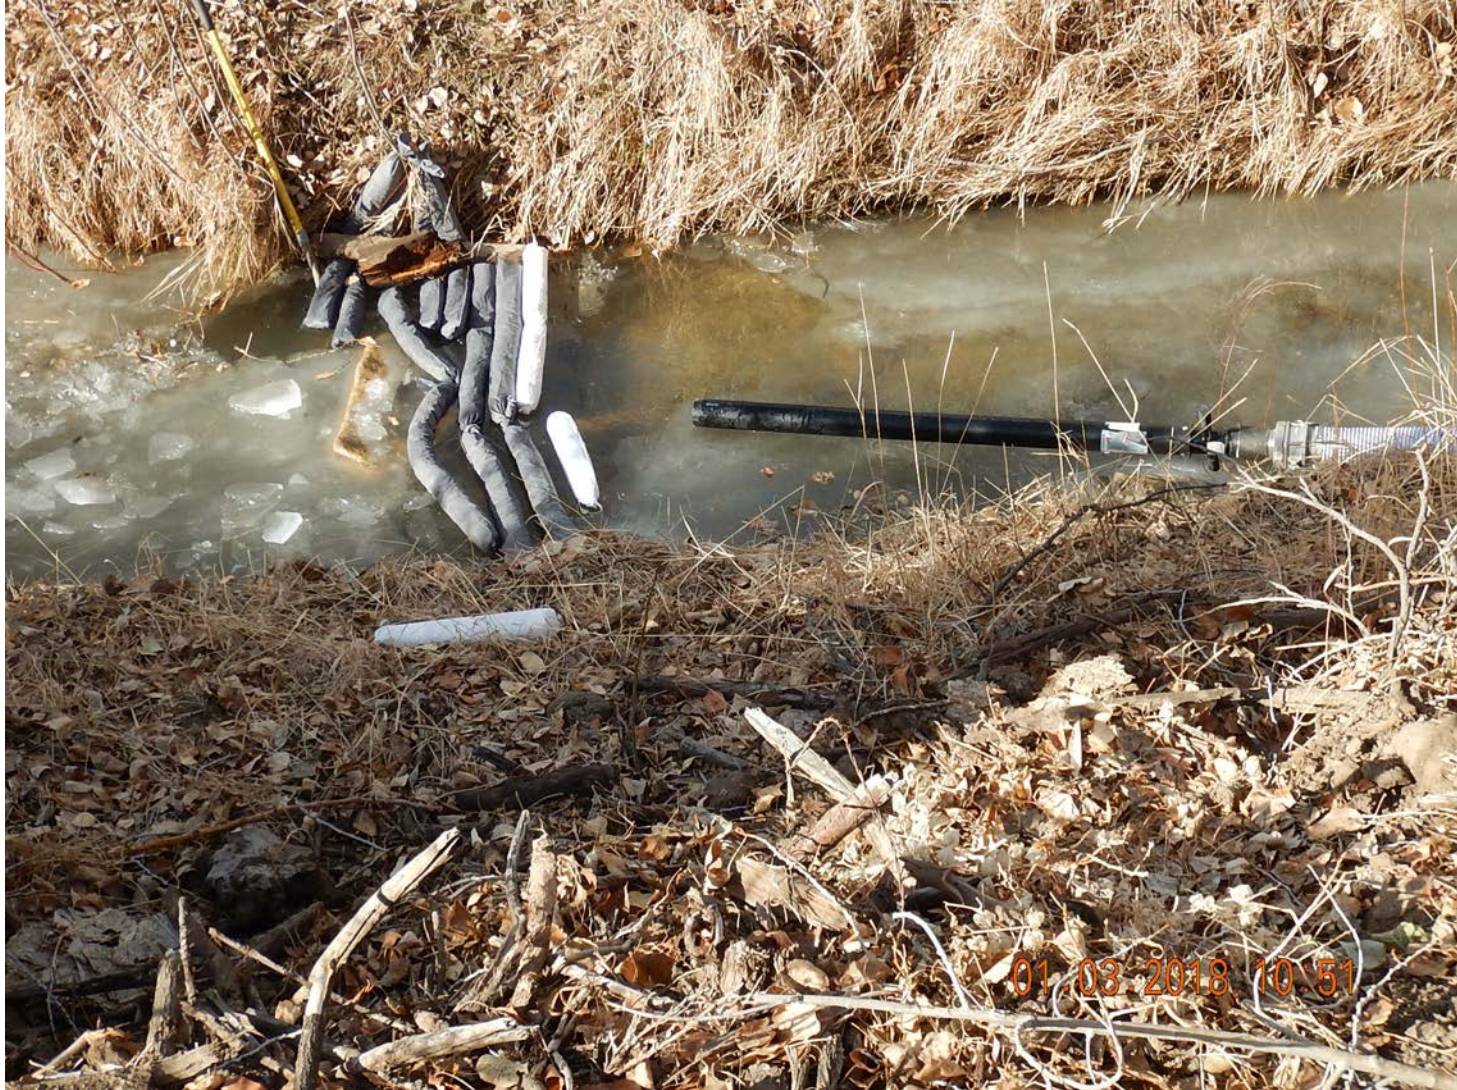
Vacuum truck extraction location. Located at COGCC Sample #1 location.
