Final Reclamation Inspection

Operator: CHESAPEAKE OPERATING LLC- 16660

API: 05-123-34591

Location Name: ROUSE FARMS 30-10-66 #1H

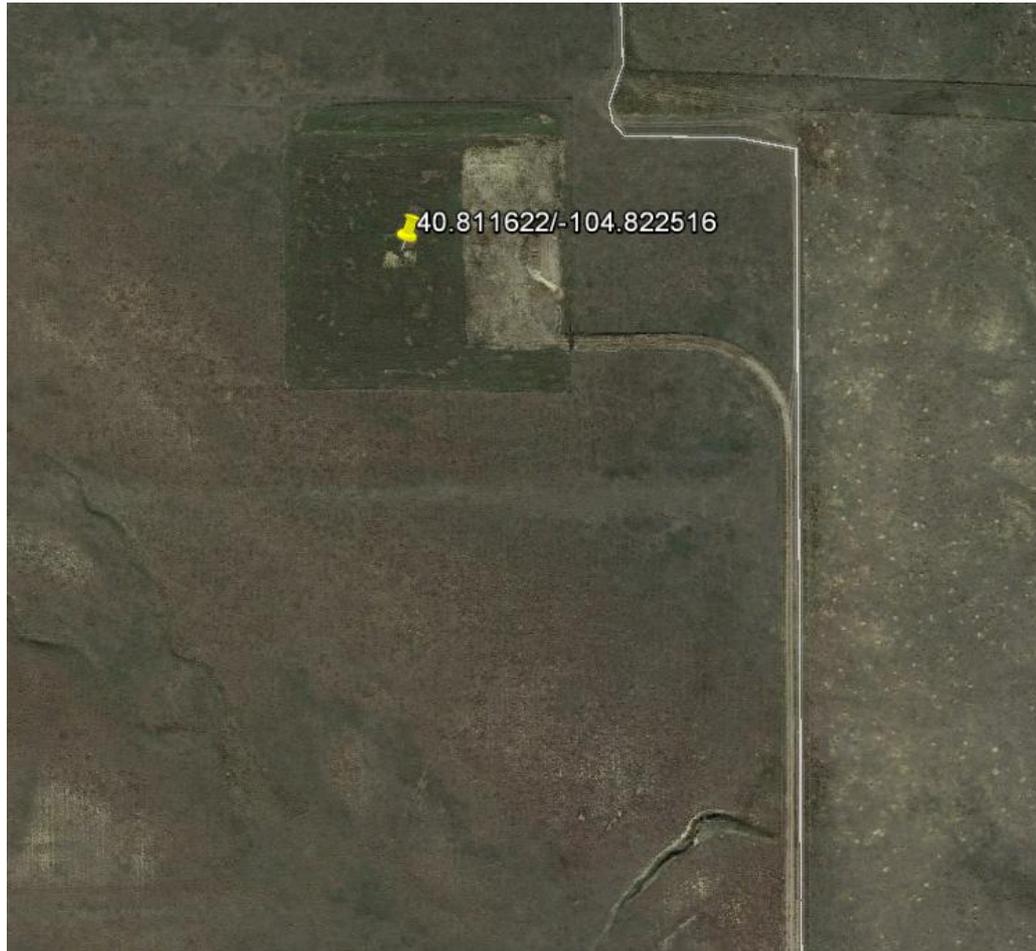
Google Earth imagery taken October 14, 2017. Photo illustrates the well pad location and access road. Access road has not been reclaimed per Rule 1004 standards- refer to the following photos for more detail.

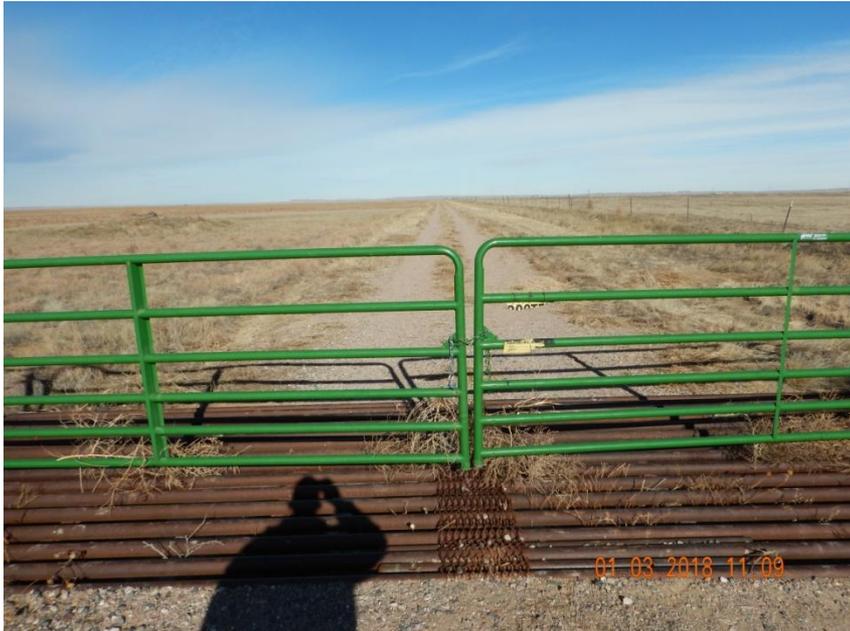
Photo 1. Photo taken from the entrance of the location, facing North. Operator has failed to reclaim the access road per Rule 1004. Cattle guard and gate remain at the entrance.

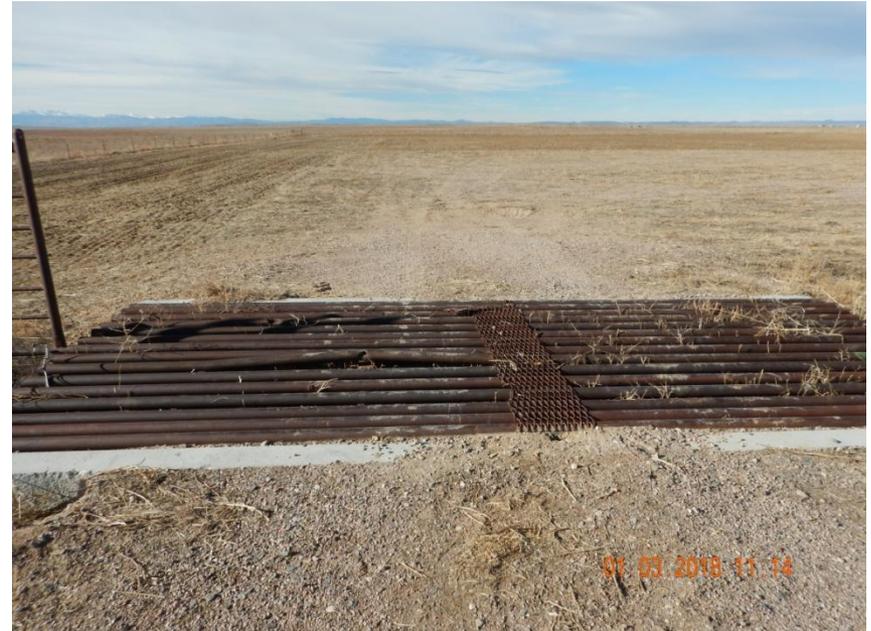
Photo 2. Photo taken from the entrance of the well location, facing West. Cattle guard remains at the entrance of the location.

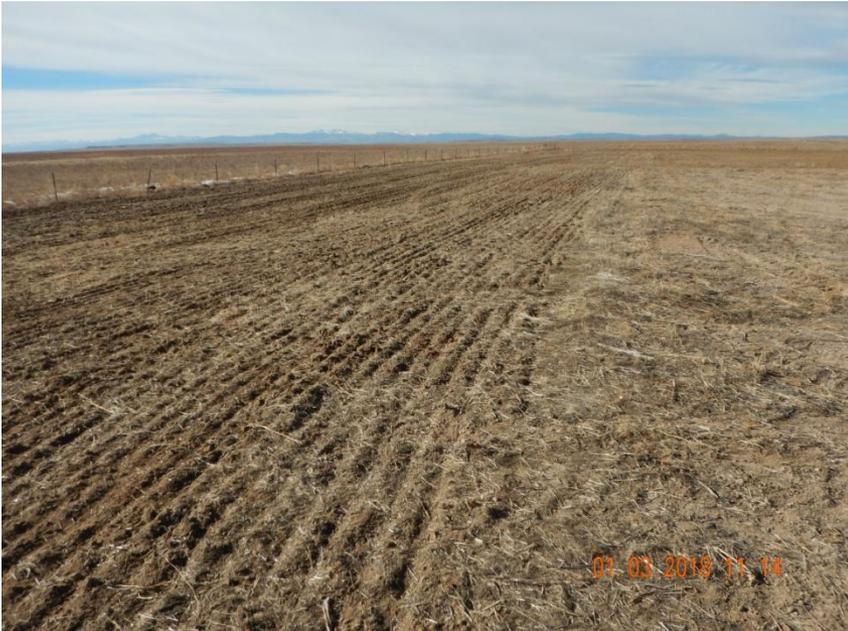
Photo 3. Photo taken from the southeast location, facing West. Appears the Operator has recently perform reclamation activities. Fence remains around the location and COGCC staff would recommend leaving the fence while vegetation establishes at location to keep cattle and other critters out during the reclamation process.

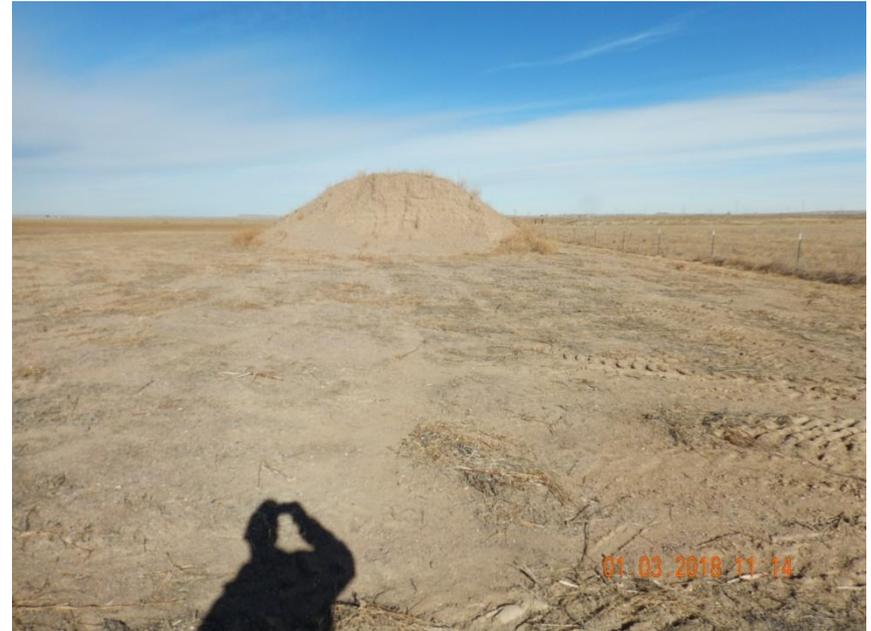
Photo 4. Photo taken from the southeast location, facing North. Appears a gravel stockpile has been left at location.

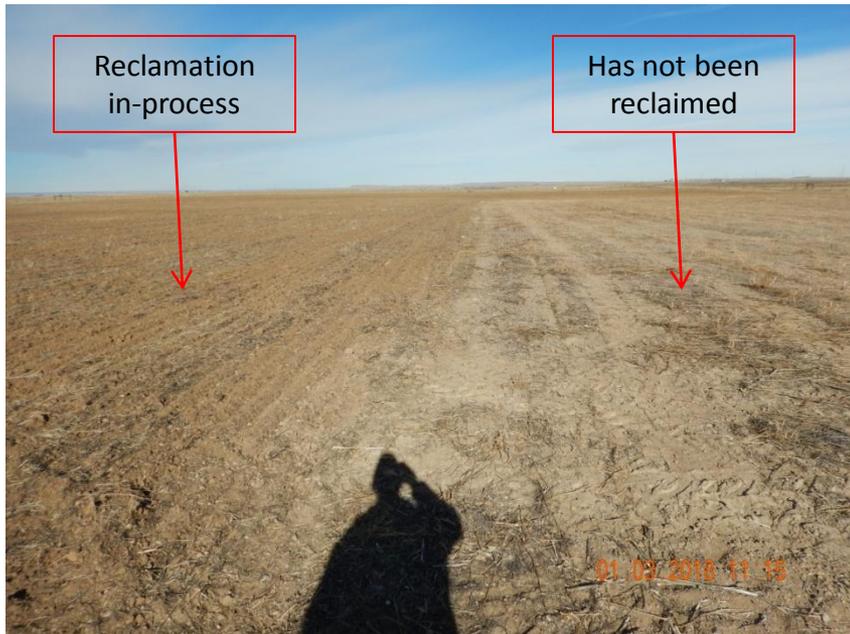
Photo 5. Photo taken from the southern location, facing North. Appears the Operator has recently perform reclamation activities but about 1/3 of the eastern location has not been reclaimed.

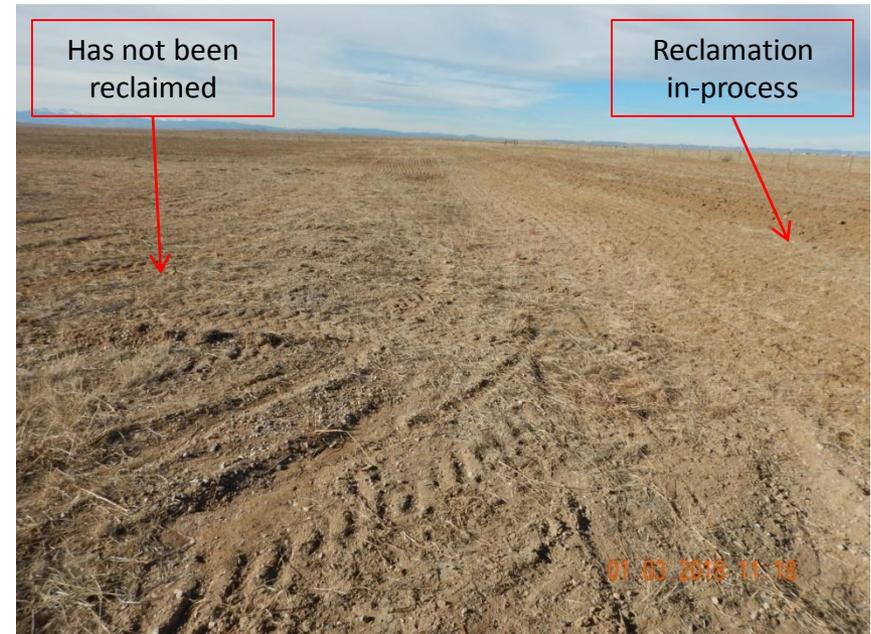
Photo 6. Photo taken from the northern location, facing West. See comments under Photo 5.
