Interim Reclamation Inspection

Operator: RED HAWK PETROLEUM LLC - #10503

Location ID: 431634

Inspection Photos
Location: Buchner #2-2H
Location ID: 431634

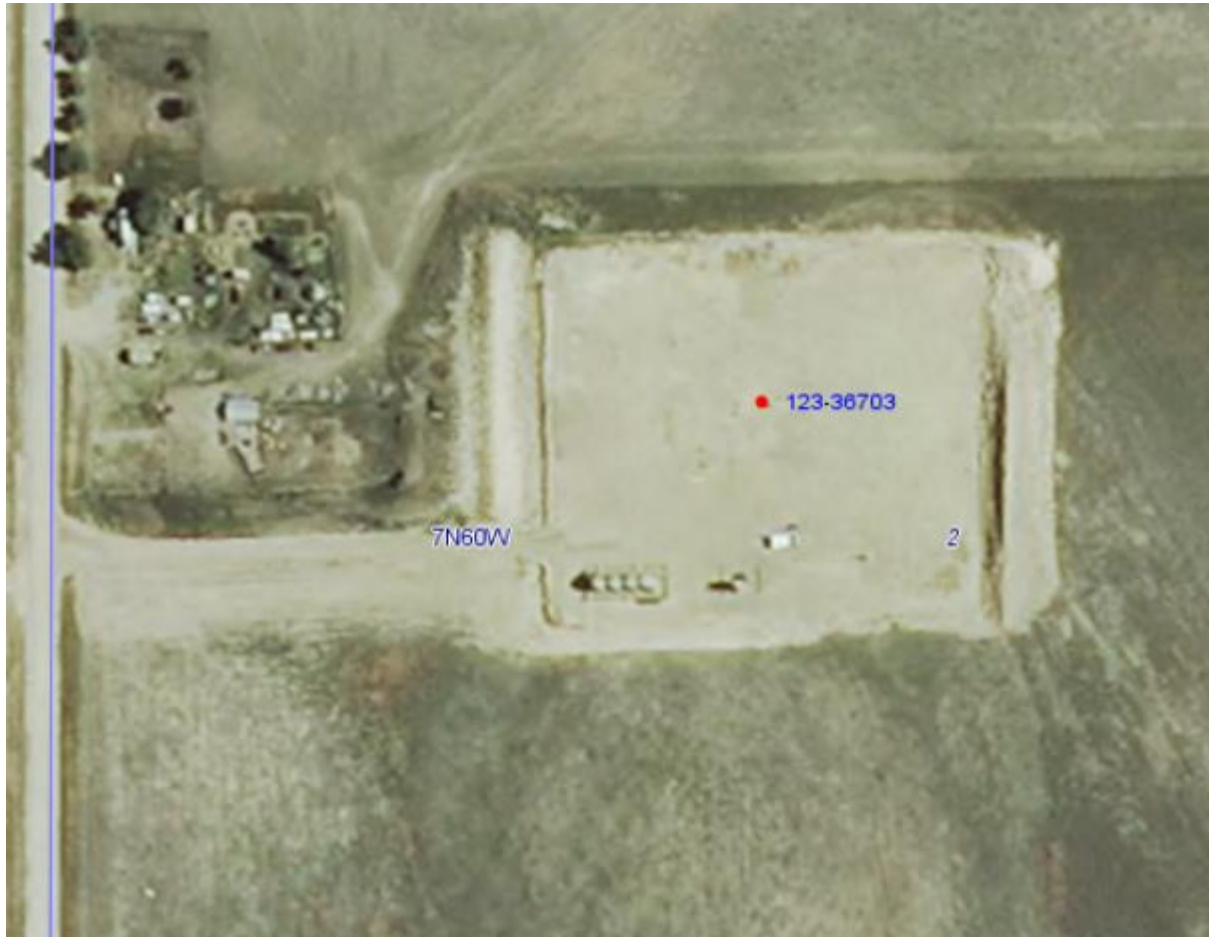
Photo 1. Aerial imagery taken from the COGCC GISOnline database from 2013 illustrating the Buchner location that was constructed.

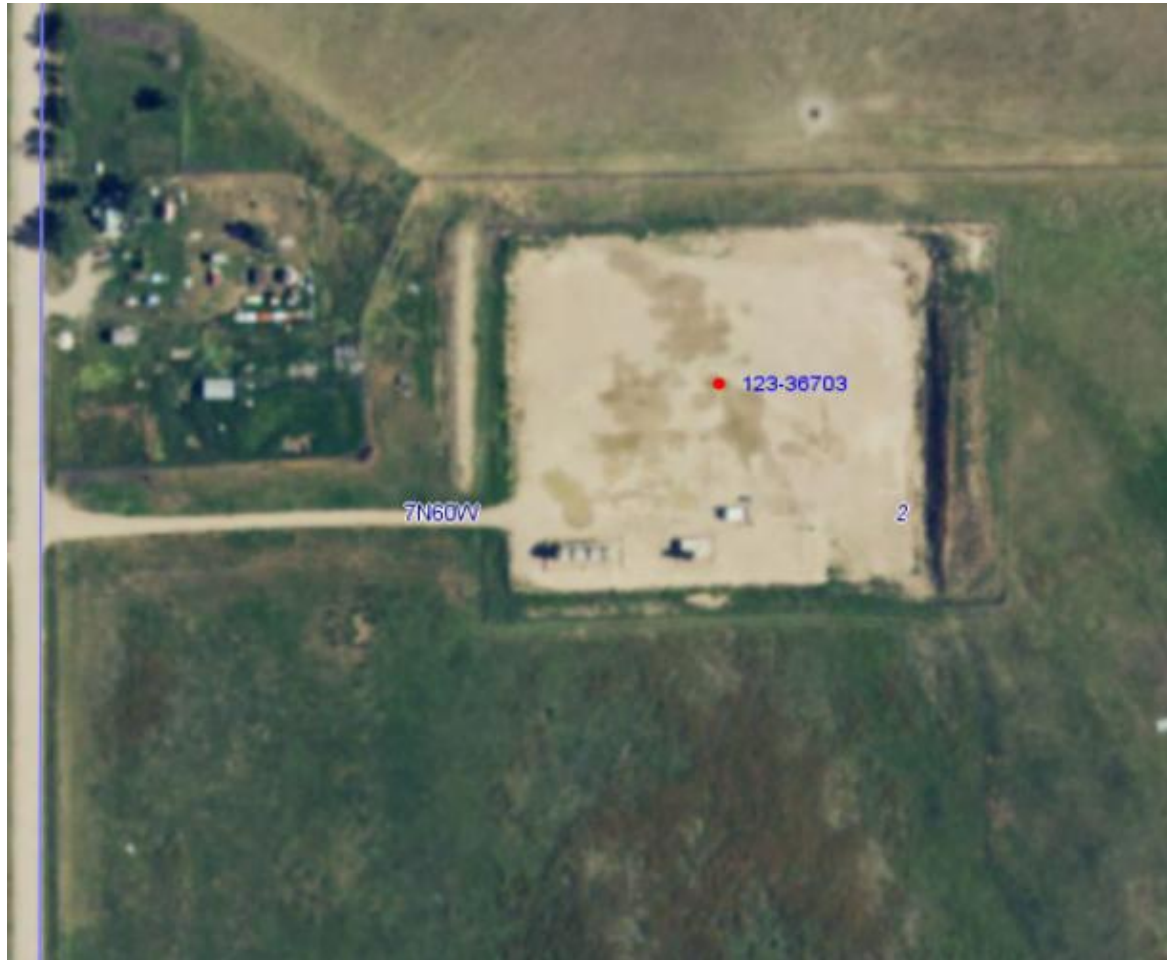
Photo 2. Aerial imagery taken from the COGCC GISOnline database from 2015 illustrating the Buchner location that was constructed in 2013. Operator has failed to perform interim reclamation per Rule 1003.b.

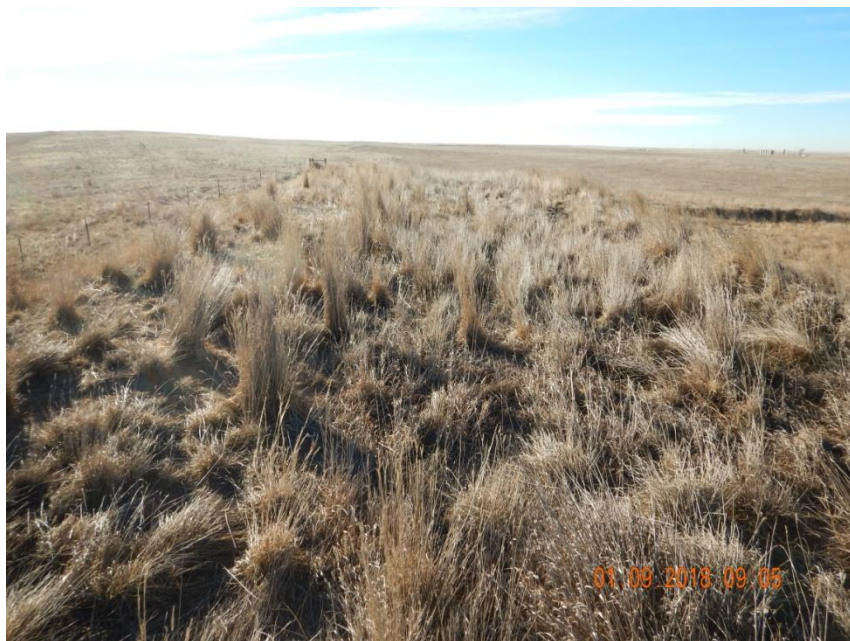
Photo 3. Photo taken from the eastern location on top of a stockpile, facing South. Soil stockpile appears to be stabilized and protected per Rule 1002.c.

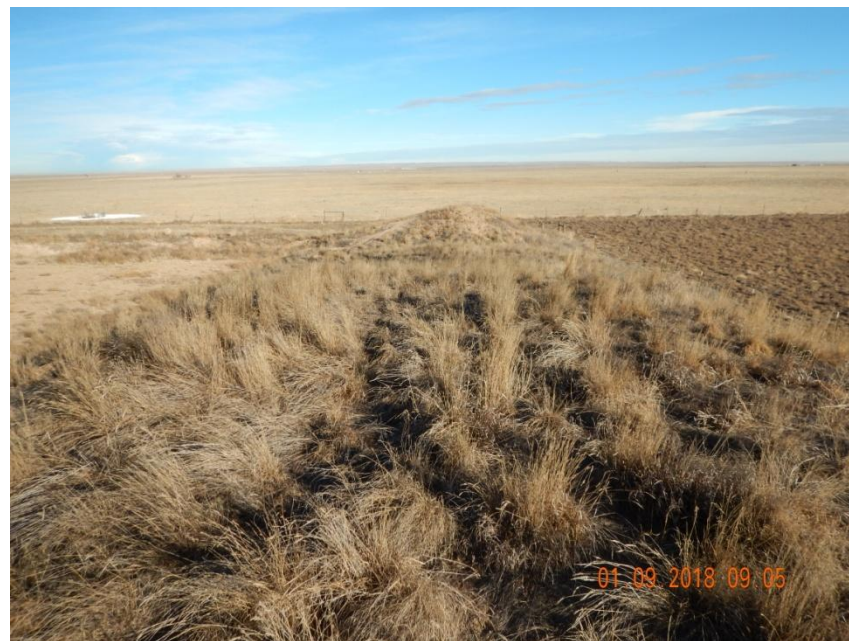
Photo 4. Photo taken from the eastern location on top of a stockpile, facing North. See comments under Photo 3.

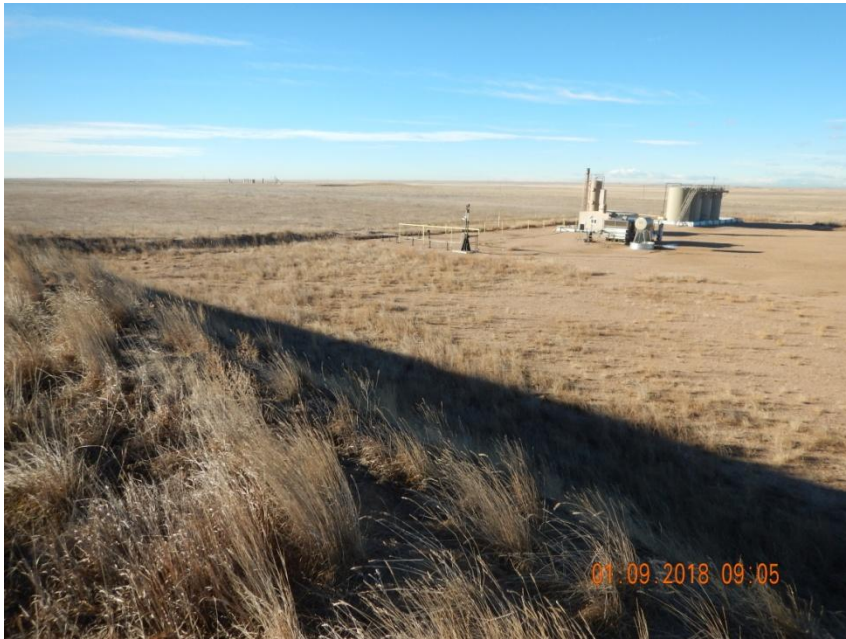
Photo 5. Photo taken from the eastern location on top of a stockpile, facing Southwest. Operator has failed to perform interim reclamation per Rule 1003.b. to reduce disturbance areas only reasonably needed for production operations.

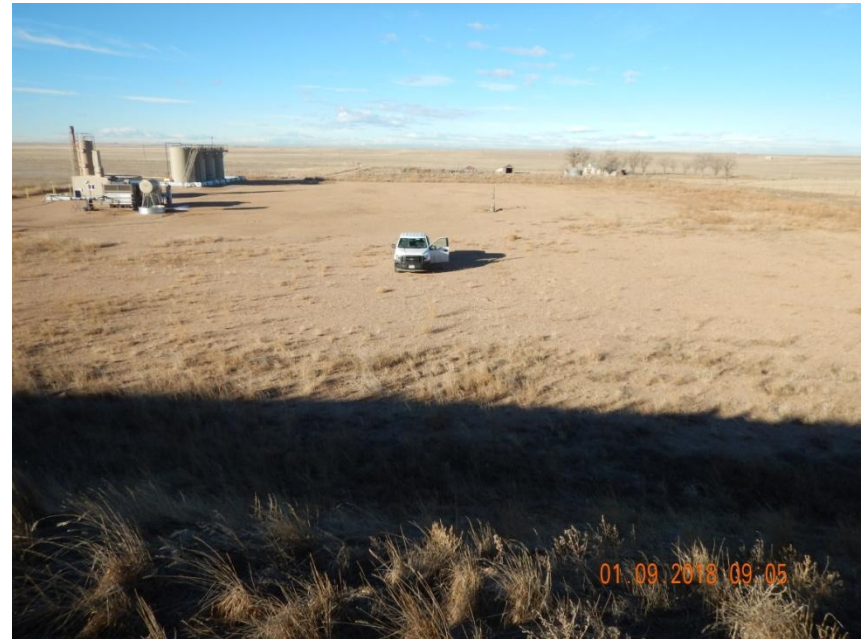
Photo 6. Photo taken from the eastern location on top of a stockpile, facing West. See comments under Photo 5.

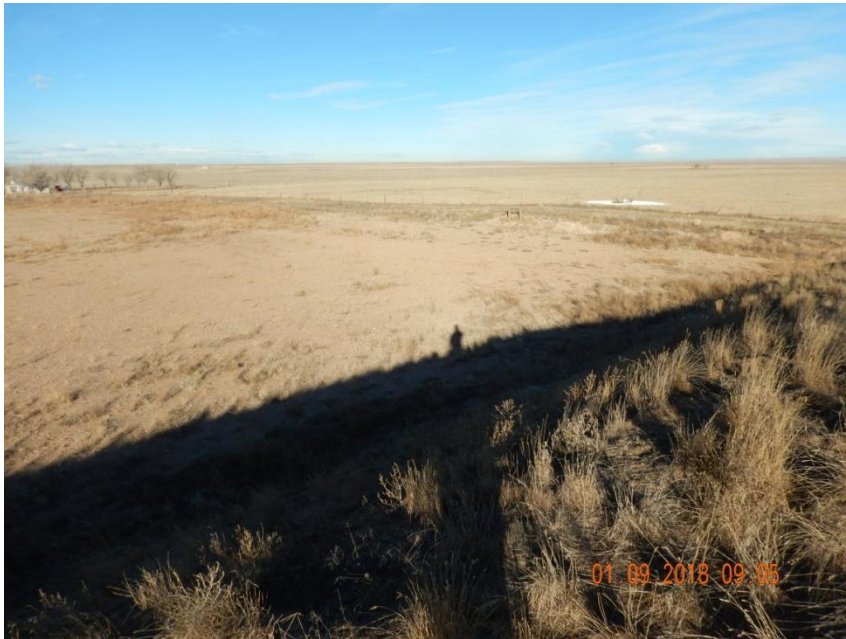
Photo 7. Photo taken from the eastern location on top of a stockpile, facing Northwest. See comments under Photo 5.

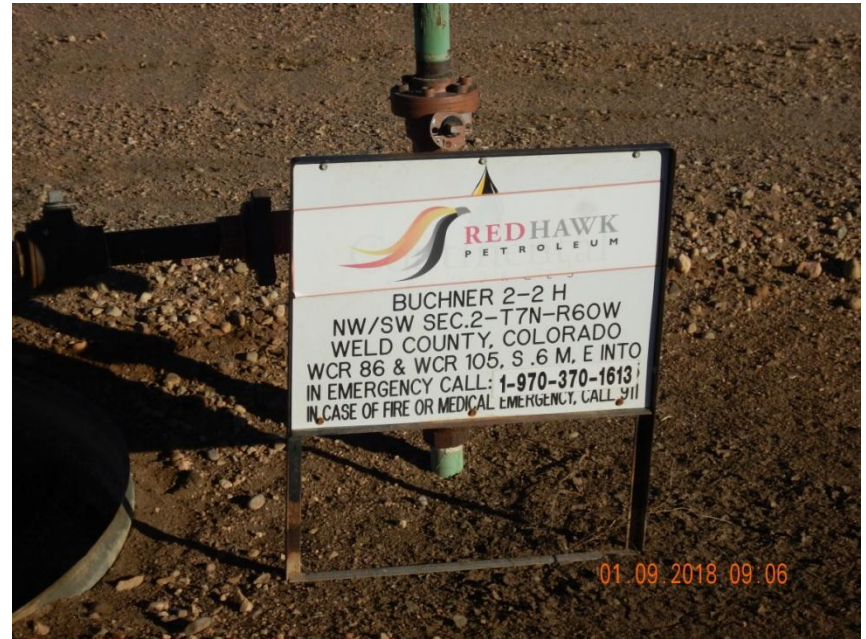
Photo 8. Photo taken of the well sign at location.
