# Inspection Photos

Operator: NOBLE ENERGY INC - 100322

Location ID: 329551

Inspection Doc. Number: 682503076

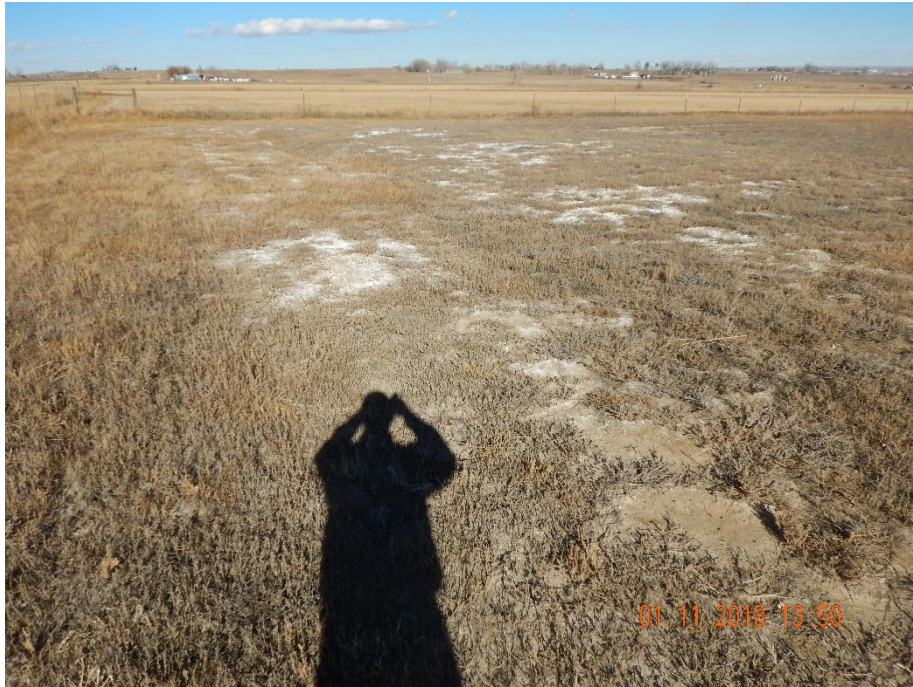
**Photo 1:** Photo taken from the south end of the well location, facing north. Photo shows vegetation over the well location has not achieved a uniform cover, and does not appear to be progressing towards an 80% desirable perennial cover to that of the reference. Vegetation observed on well predominantly undesirable weedy plant species. Photo also shows no reclamation activities appear to have been conducted per the corrective actions.

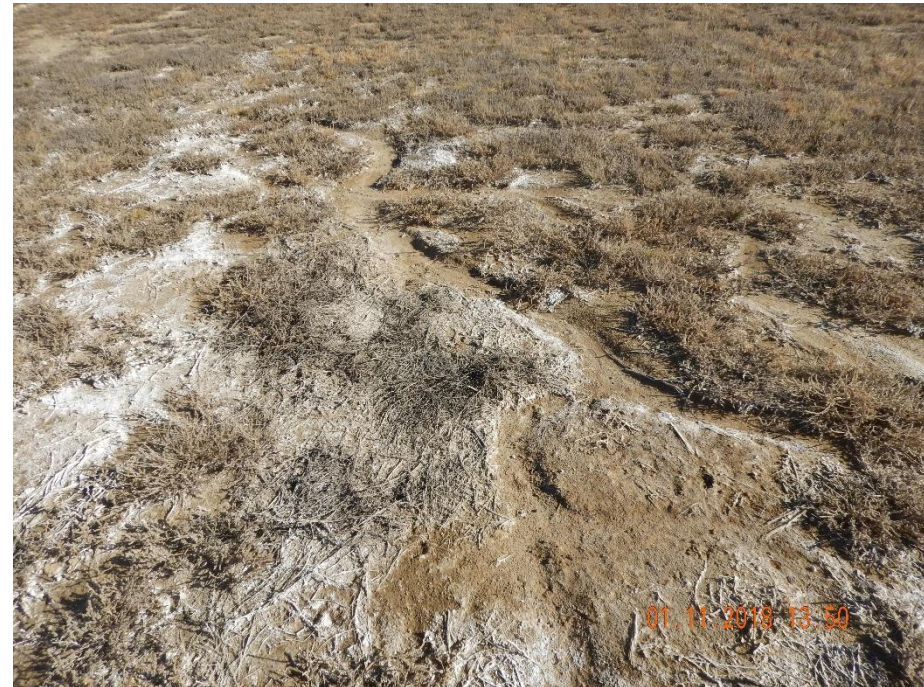
**Photo 2:** Photo taken from the well location, facing east. Photo shows water movement patterns and erosion degradation beginning to form. Site does not appear to be stabilized. Photo also shows no reclamation activities appear to have been conducted per the corrective action.

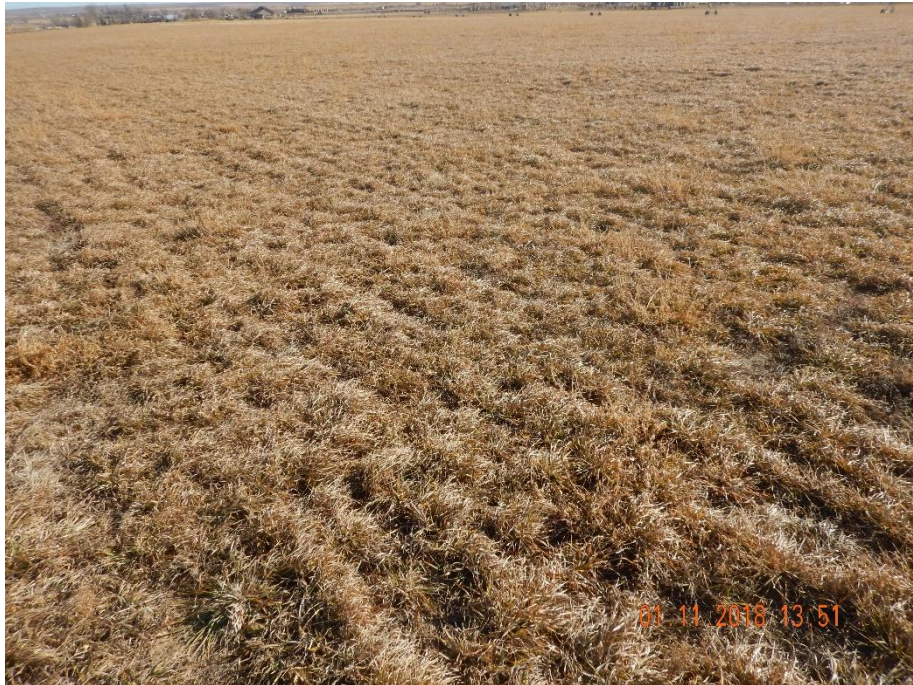
**Photo 3:** Photo taken from the adjacent reference area. Reference area is an irrigated hay meadow composed predominantly of perennial grass.

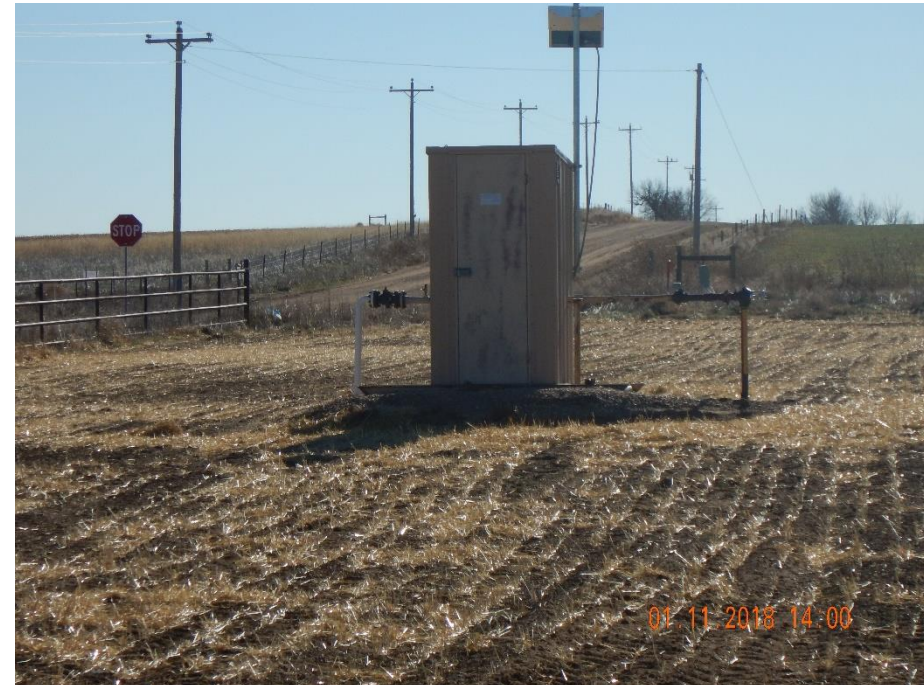
**Photo 4:** Photo taken from former battery location. Photo shows meter shed equipment has not been removed per corrective actions.
