# Inspection Photos

API: 05-067-09913

Operator: CATAMOUNT ENERGY PARTNERS LLC

Inspection Number: 6806024650

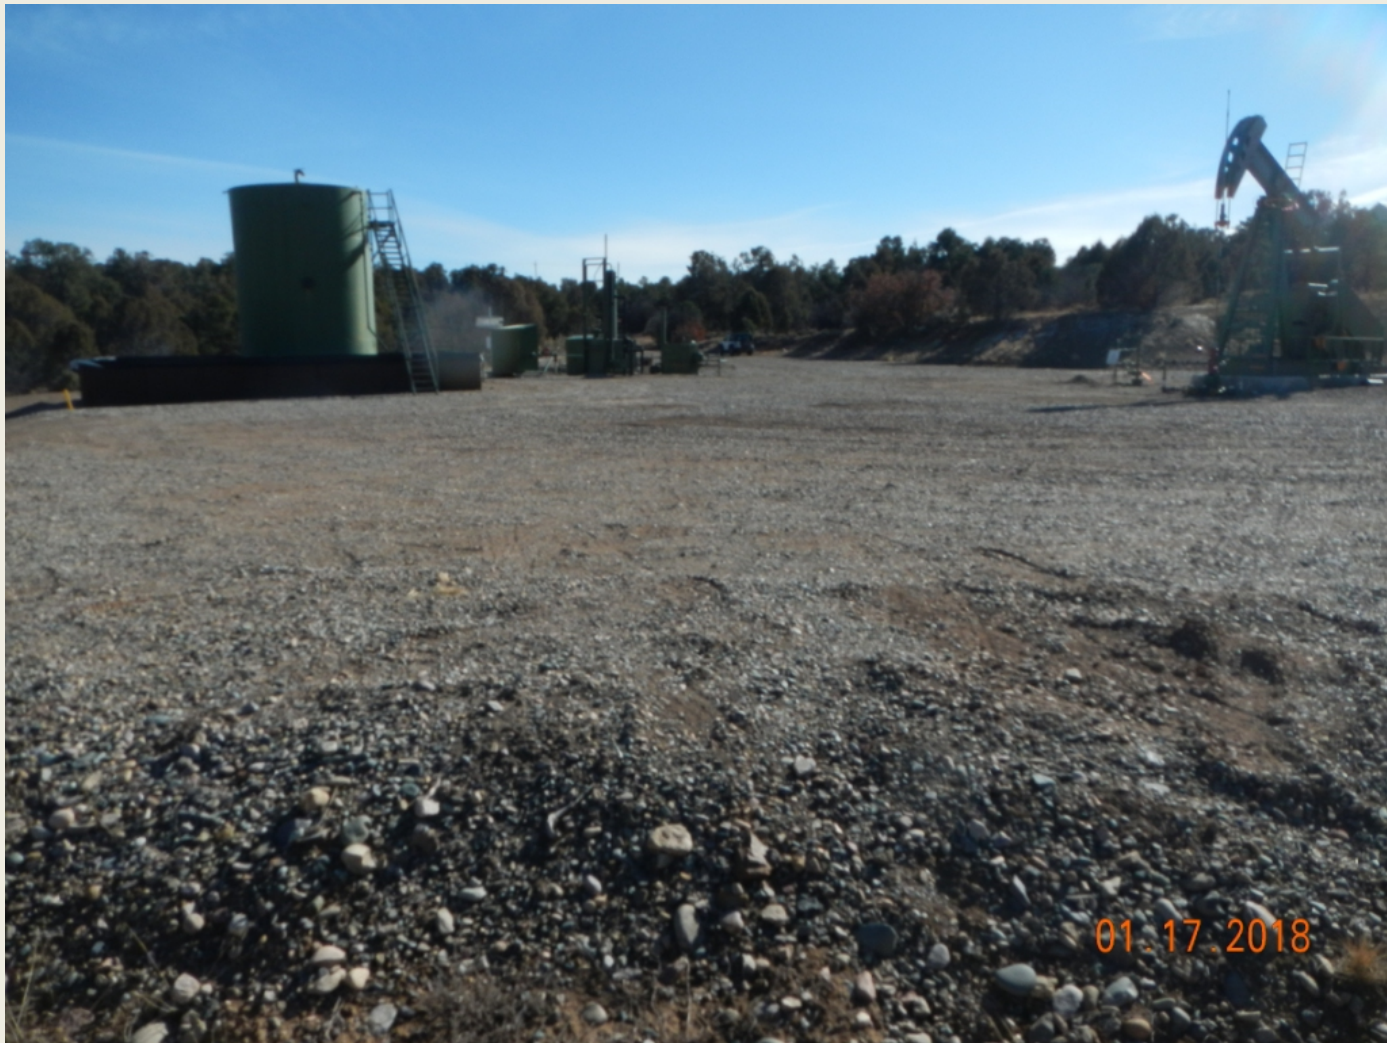
**Photo 1. View of the project area from the northern corner facing center.**

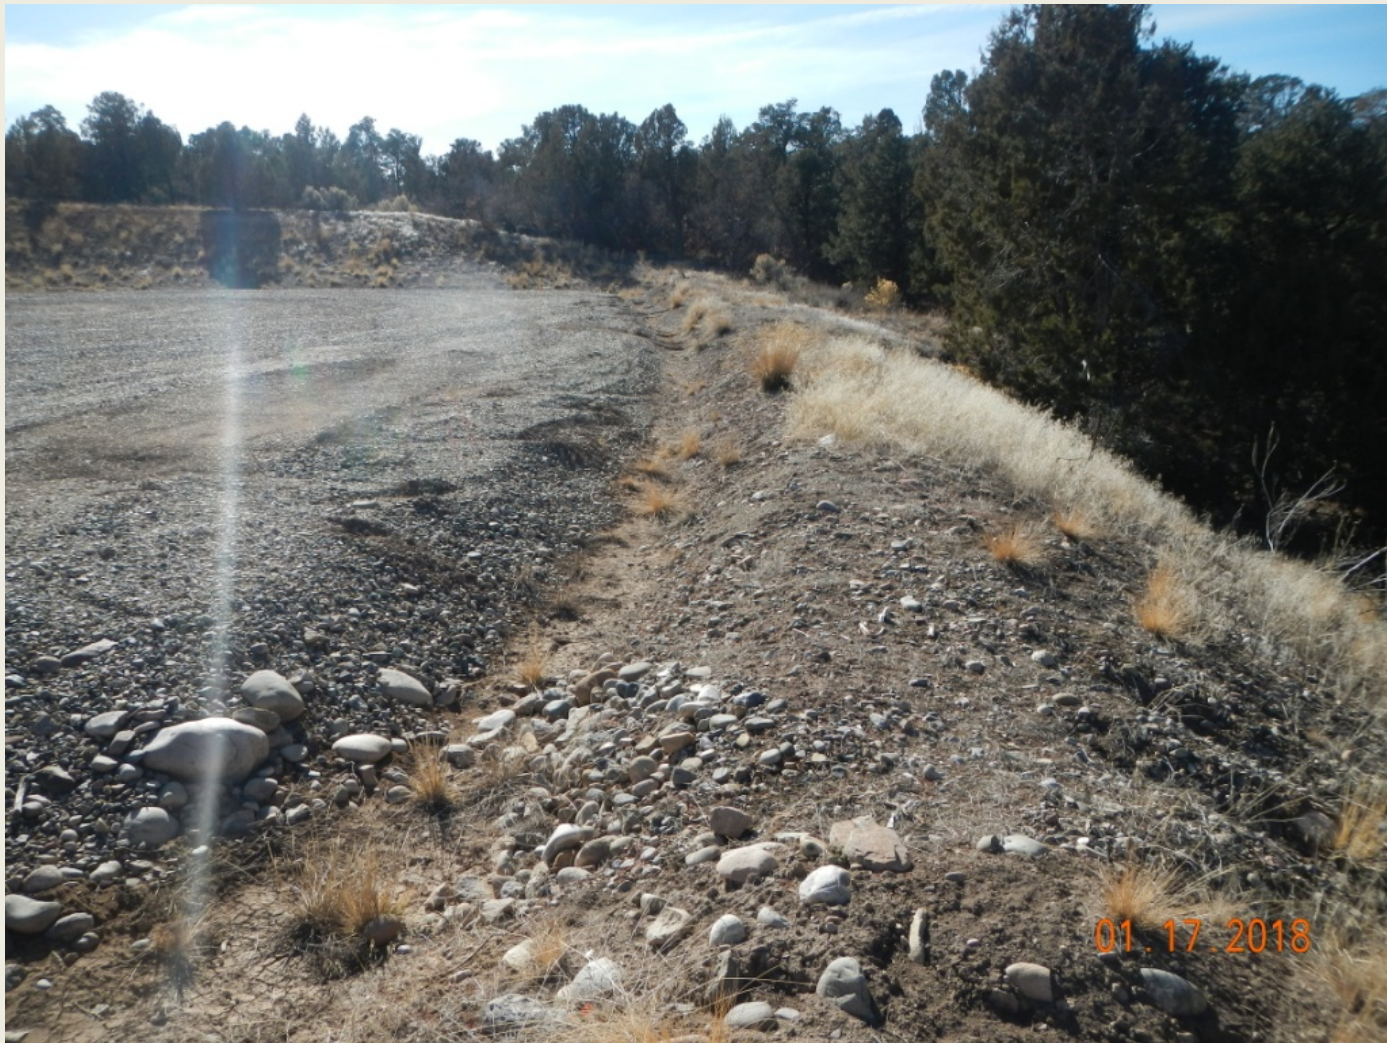
**Photo 2. View of the western portion of the project area from the northern corner facing southwestward.**

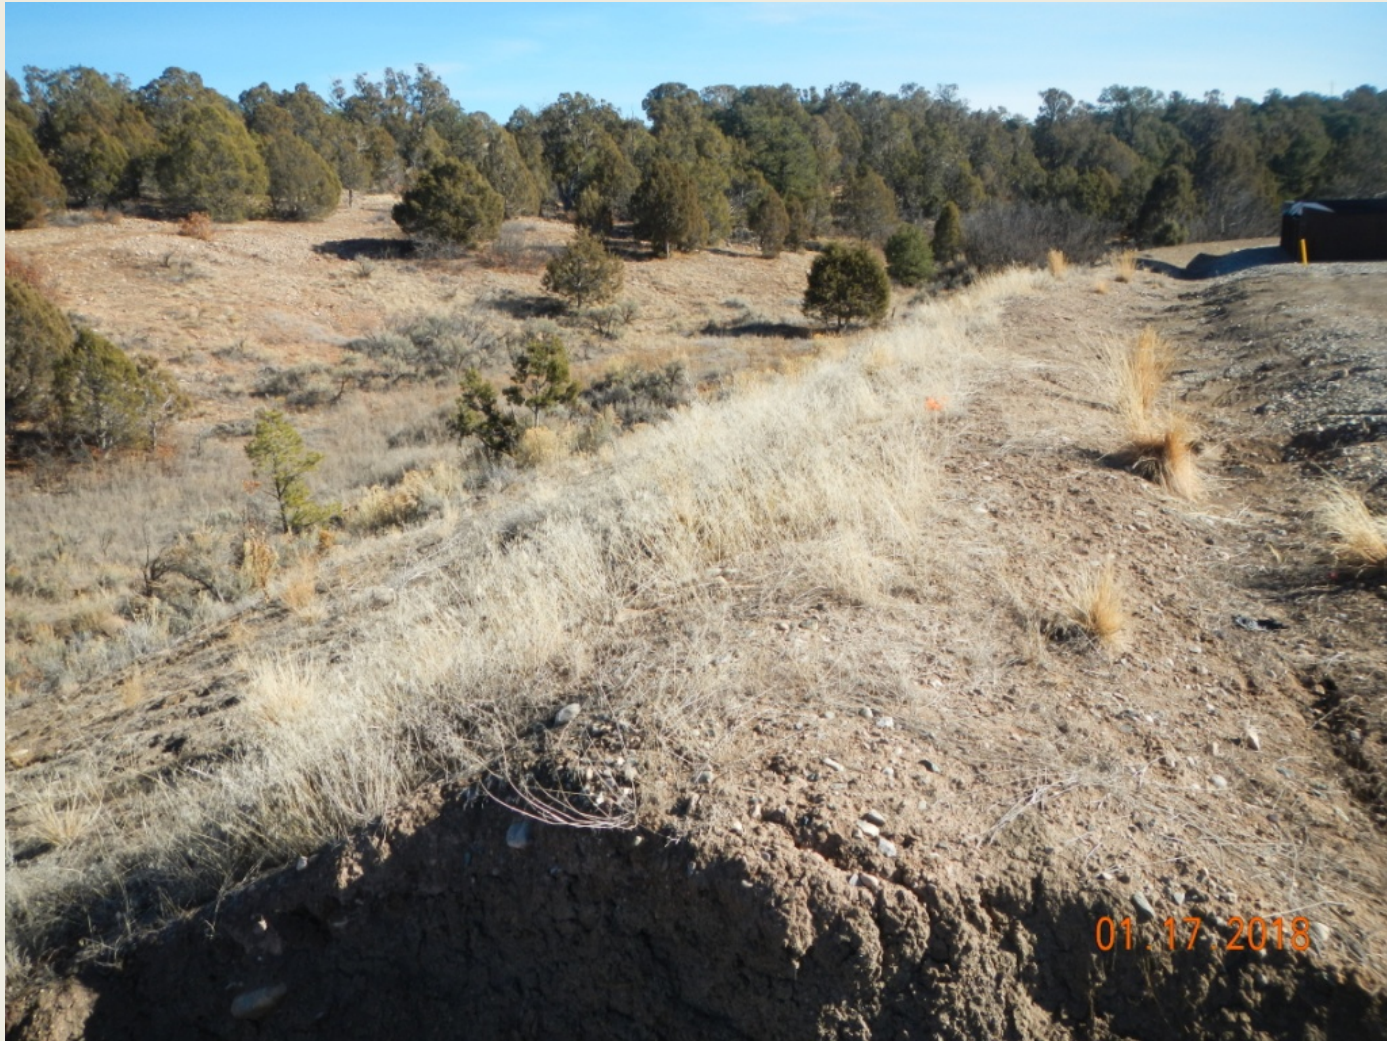
**Photo 3. View of the northeastern portion of the project area from northern corner facing southeastward.**

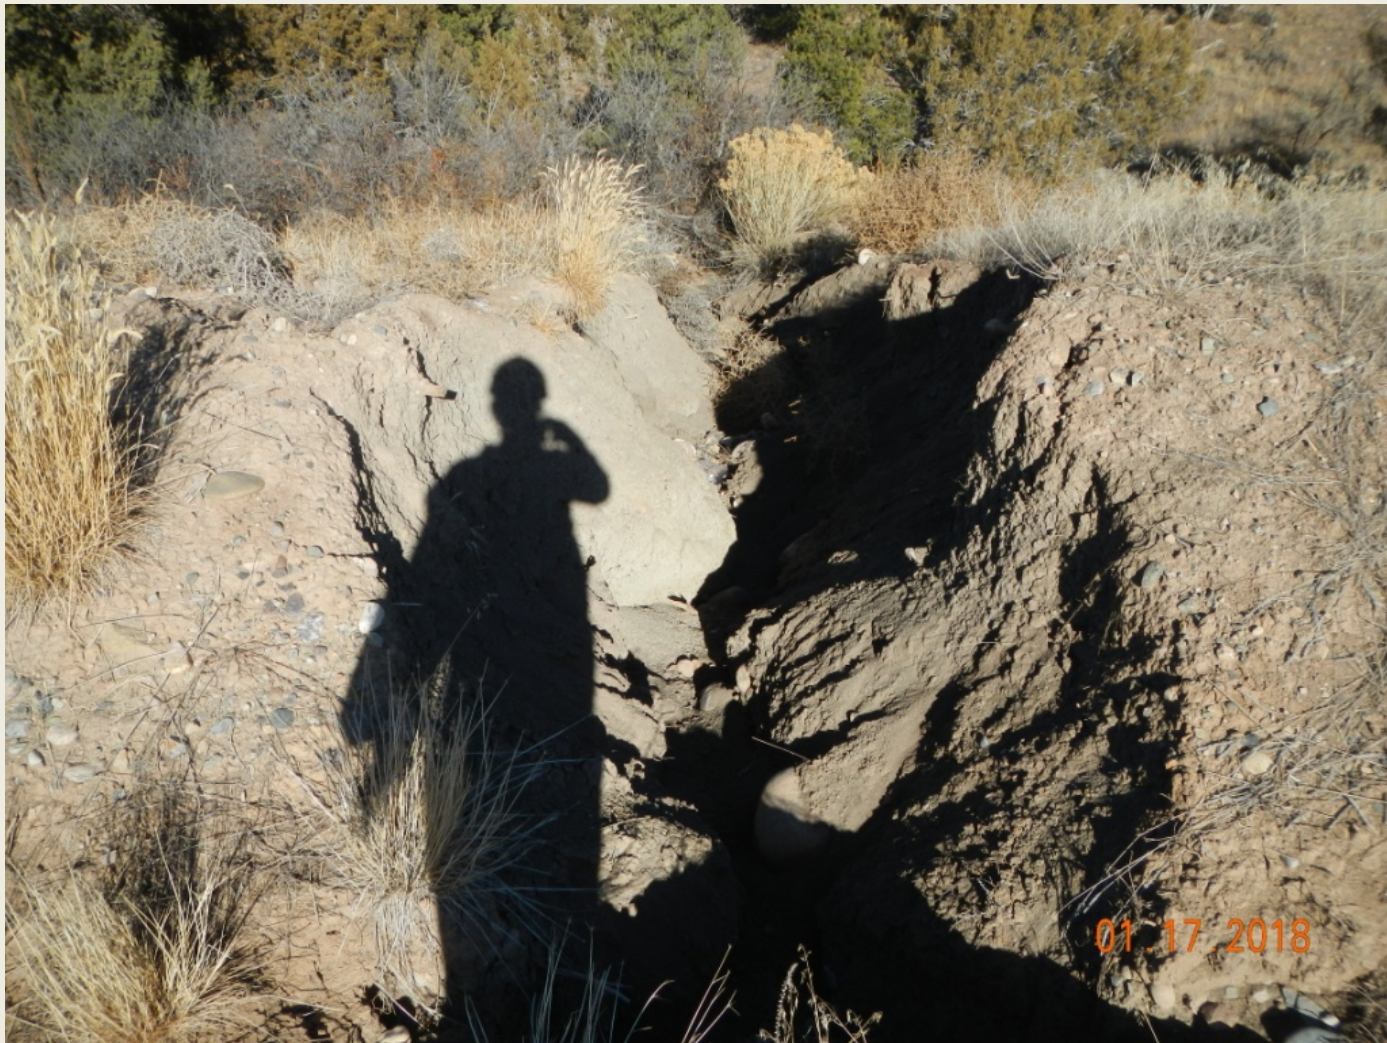
**Photo 4. View of an erosional channel approximately 5.5 feet wide and deep in the northern portion of the project area. Stabilization measures are needed here.**

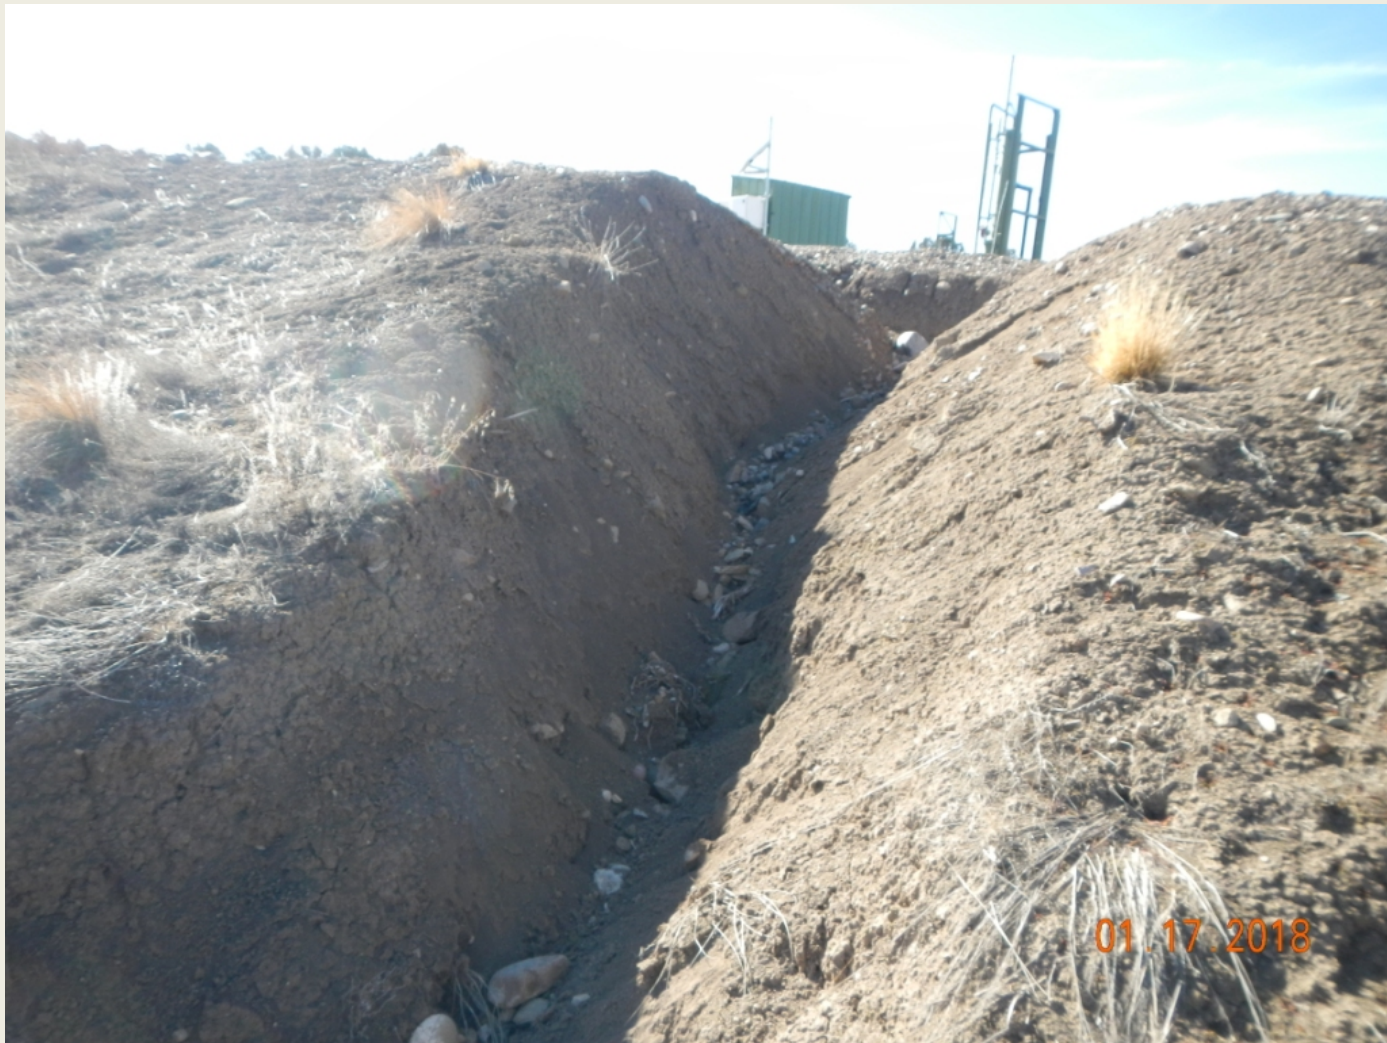
**Photo 5. View of another erosional channel approximately 5 feet wide and deep in the eastern portion of the project area. Stabilization measures are needed here.**

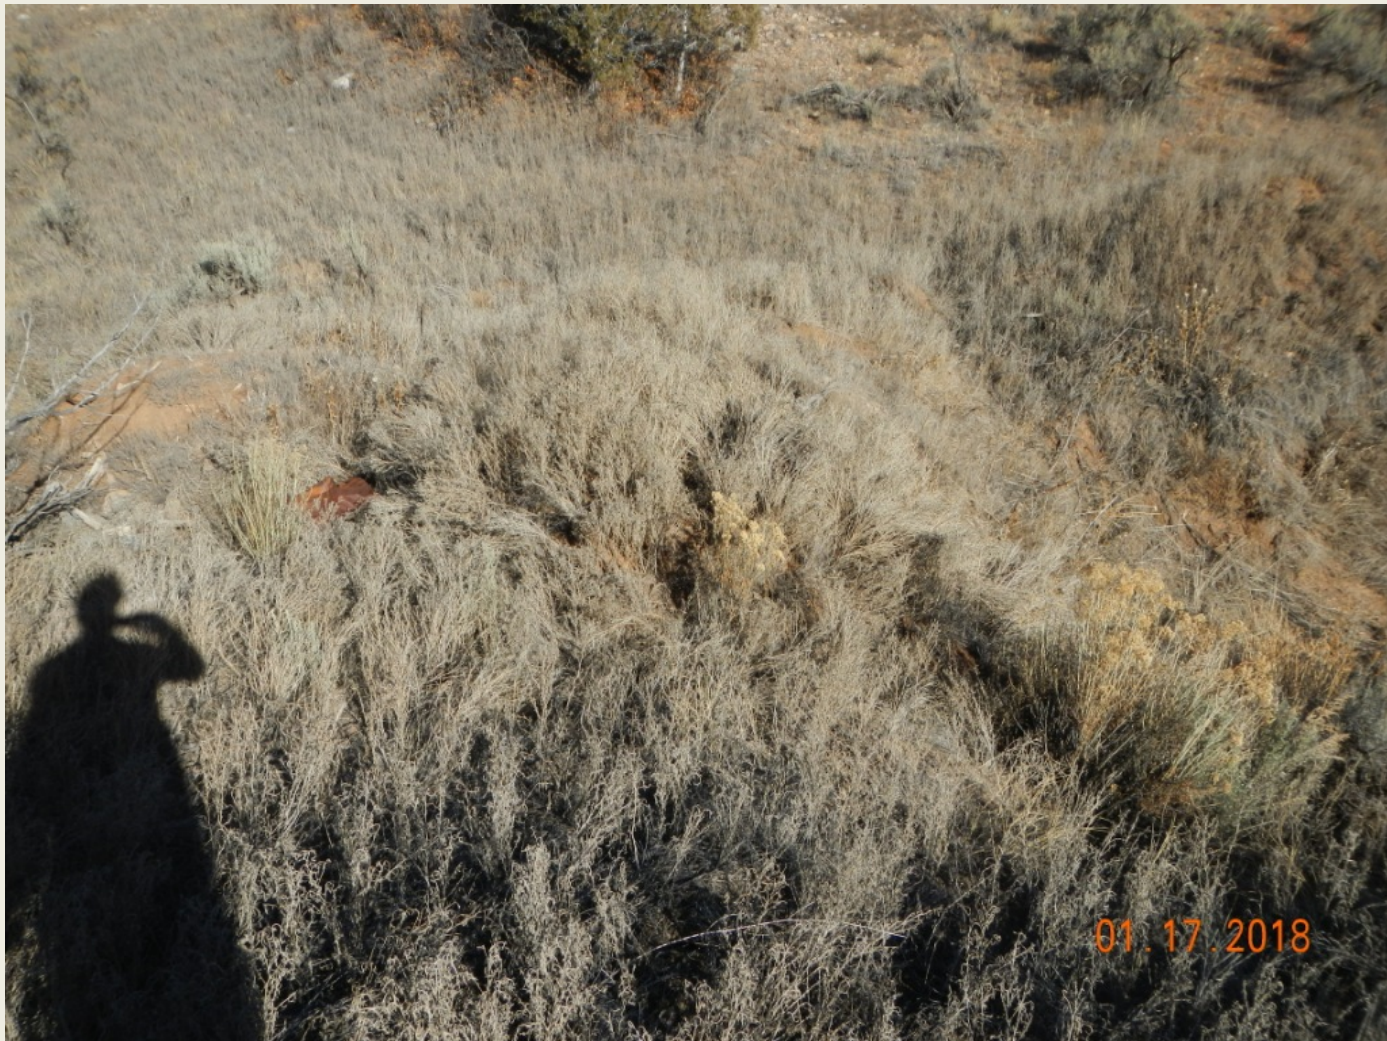
**Photo 6. View of Russian knapweed (*Acroptilon repens*) infestation along the northeastern edge of the project area.**
