Construction and Stormwater Inspection

Operator: BAYSWATER EXPLORATION AND PRODUCTION LLC - #10261

Location ID: 453331

Inspection Photos
Location Name: G & D Hanks /27-N Pad
Location ID: 453331

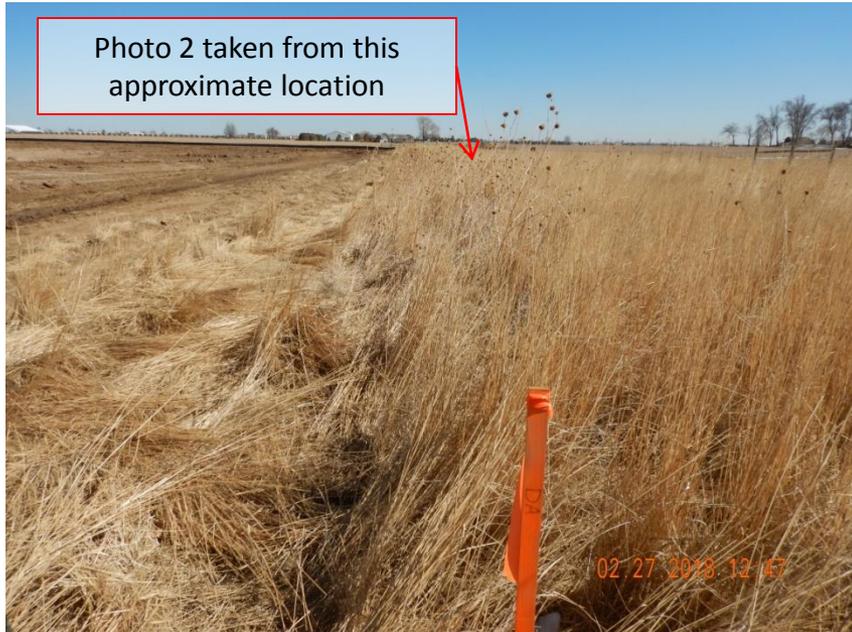
Photo 1. Photo taken from the southeastern location, facing East. Operator has a Disturbance Area staked along portions of the southern location. Staff did not observe other stakes/markers to delineate for the mapped wetland shown on the Hydrology Map (Doc. #401436127).

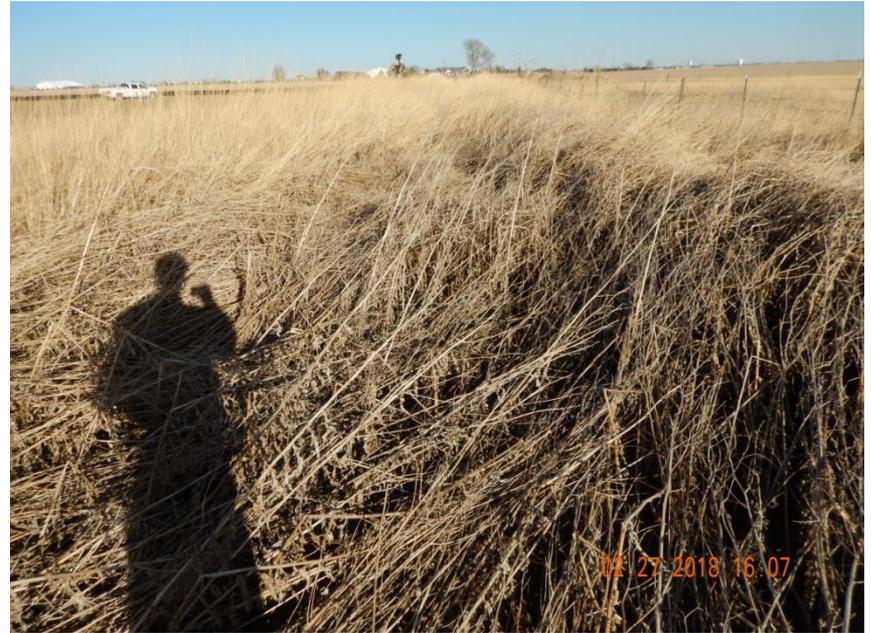
Photo 2. Photo taken just south of the location, facing East. Canada thistle (*Cirsium arvense*), a Facultative Upland species which can occur in wetlands, was observed along portions of the mapped wetland area. Staff did not appear to observe other wetland vegetation; however, this is not the growing season for wetland vegetation, making it difficult to identify plant species.

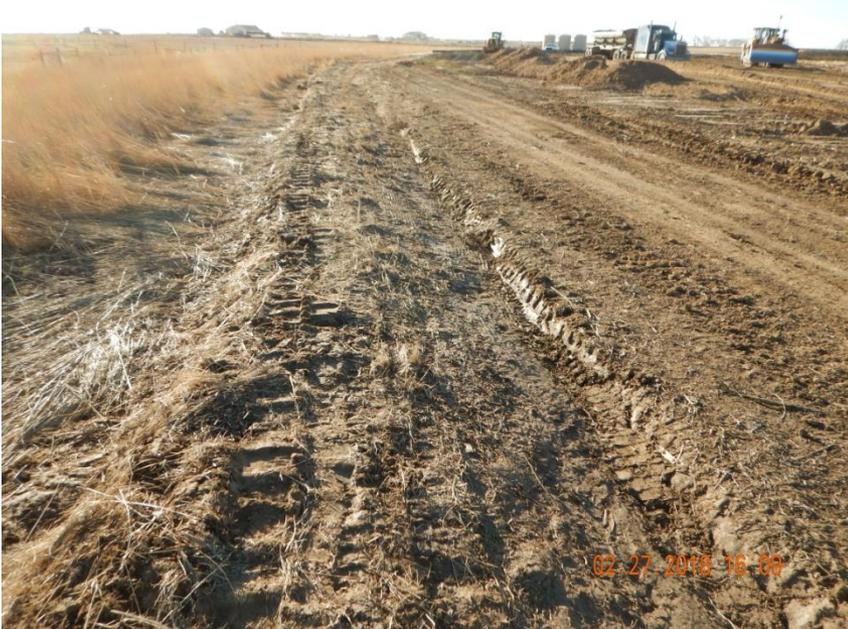
Photo 3. Photo taken from the southern location, facing West. Appears the Operator has further stabilized the berm BMP with equipment tracking. Operator was in-process of installing a silt fence BMP around the entire location during this inspection.

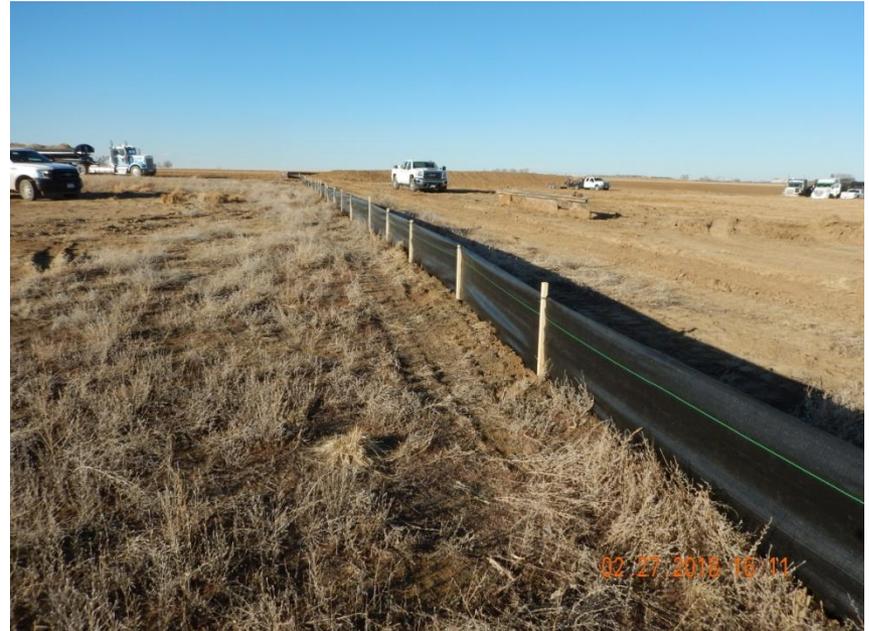
Photo 4. Photo taken from the southwestern location, facing North. Photo illustrates the Operator has installed a silt fence BMP around the western location.

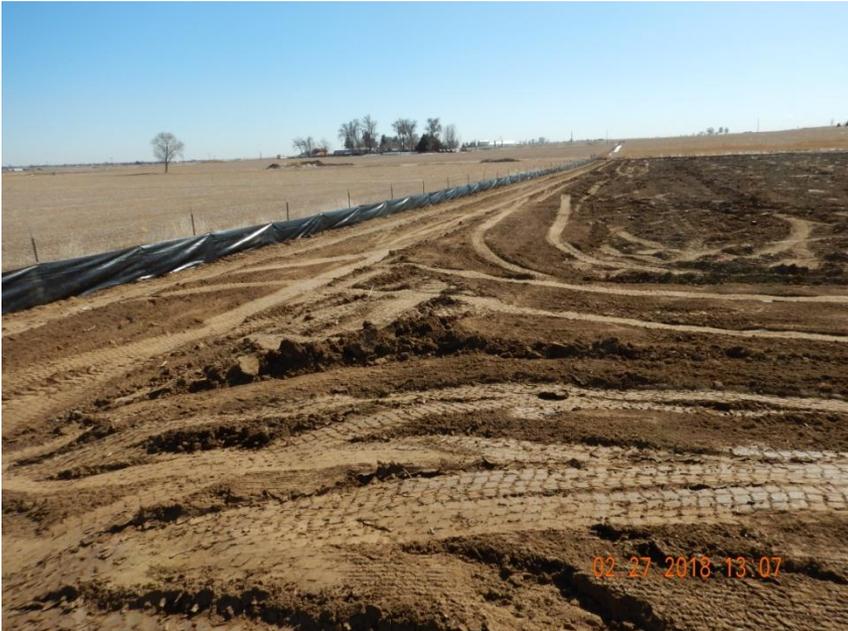
Photo 5. Photo taken from the northeastern location, facing South. See comments under Photo 4.

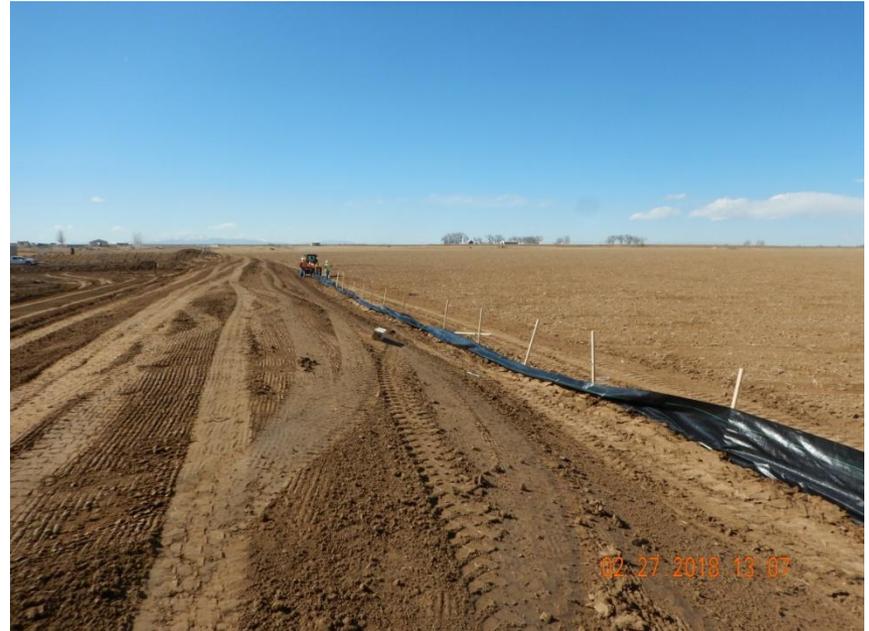
Photo 6. Photo taken from the northeastern location, facing West. See comments under Photo 3.

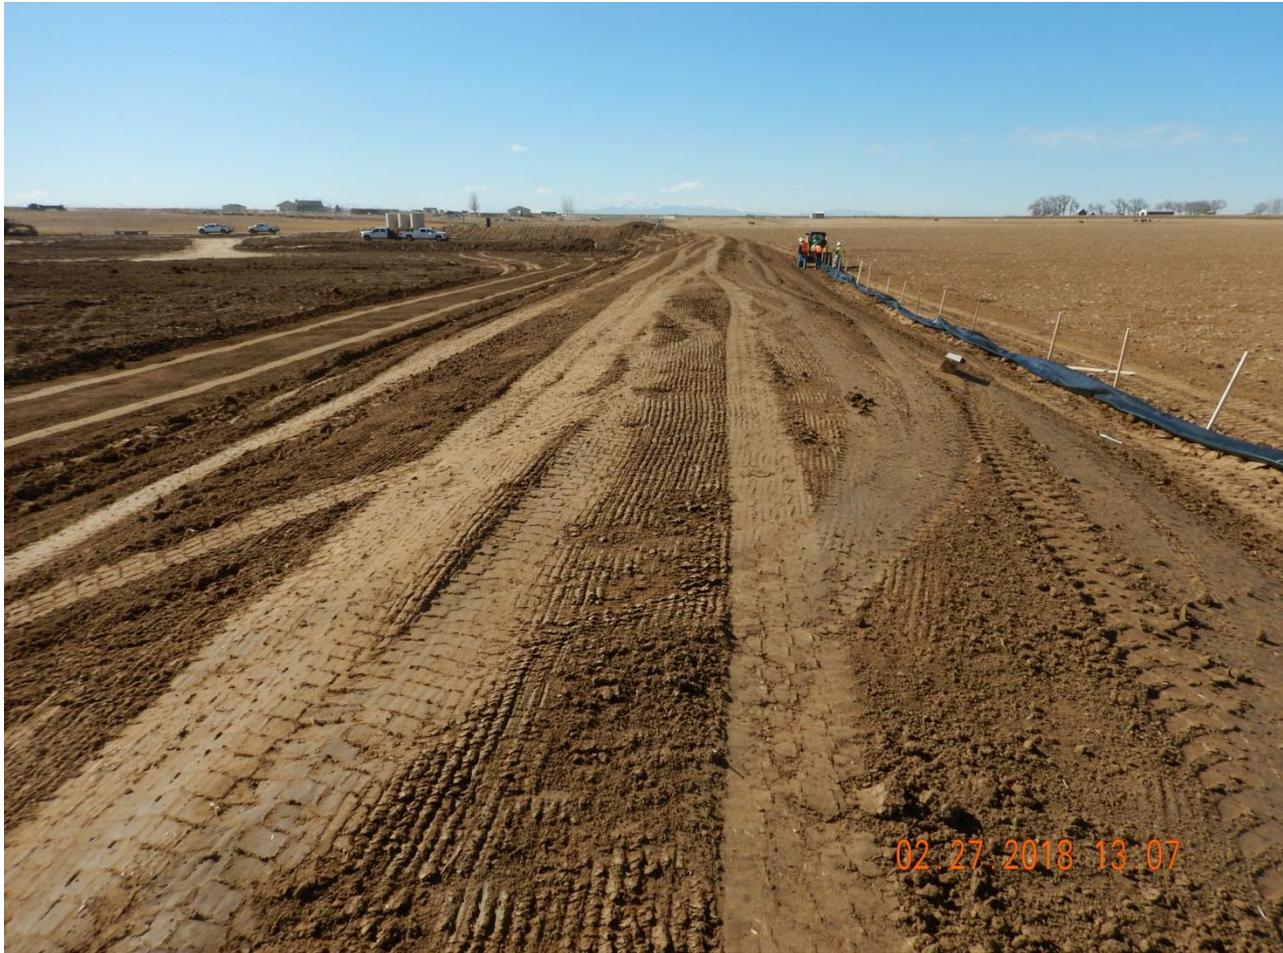
Photo 7. Photo taken from the northeastern location, facing West. Photo illustrates the topsoil stockpile that has been salvaged and stored along the northern and a portion of the western location.

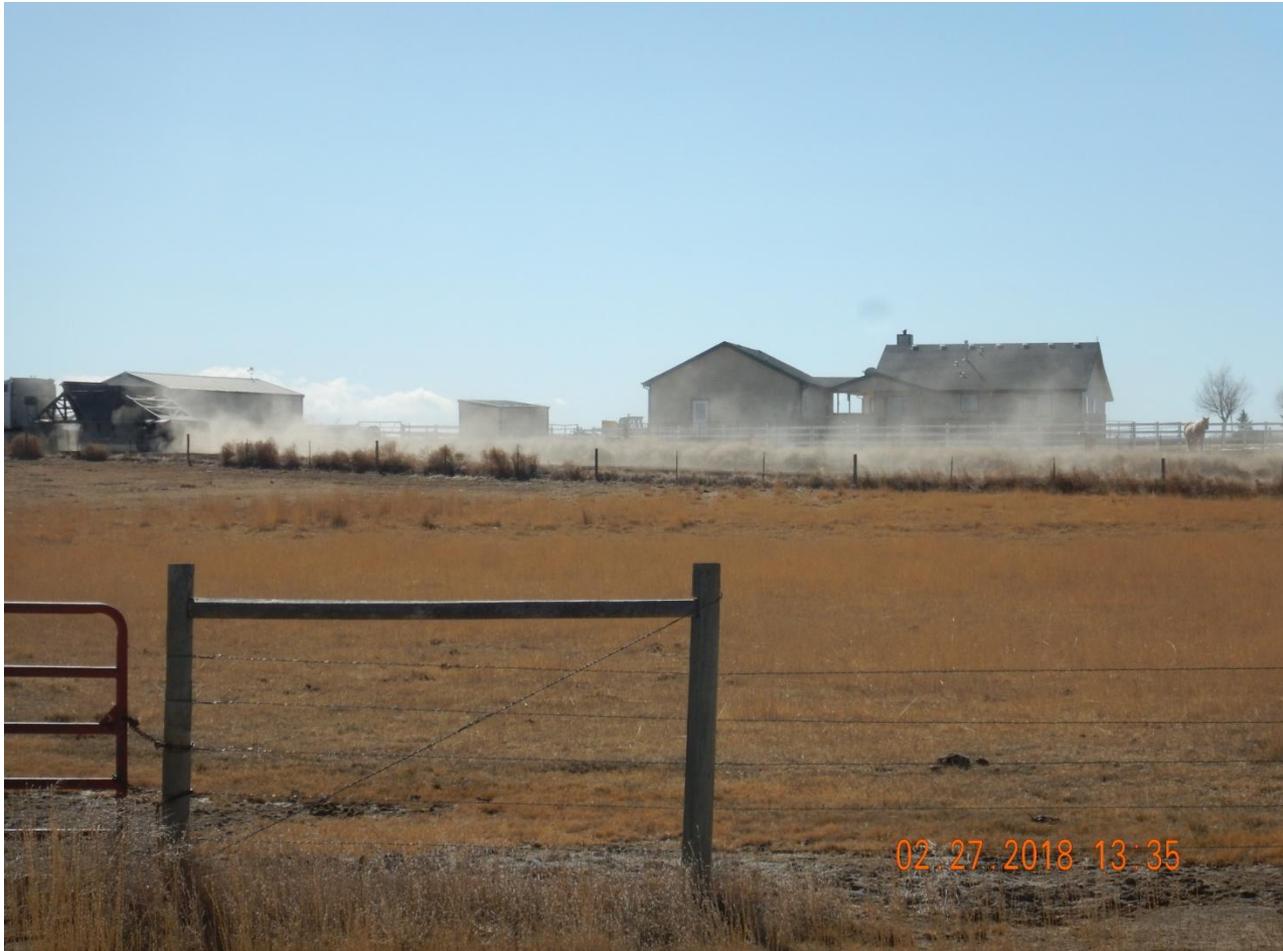
Photo 8. Photo illustrates fugitive dust along the main access road. Operator needs to comply with Rule 805.c.
