# Inspection Photos

API: 05-067-08216

Operator: BP AMERICA PRODUCTION COMPANY

Inspection Number: 680602504

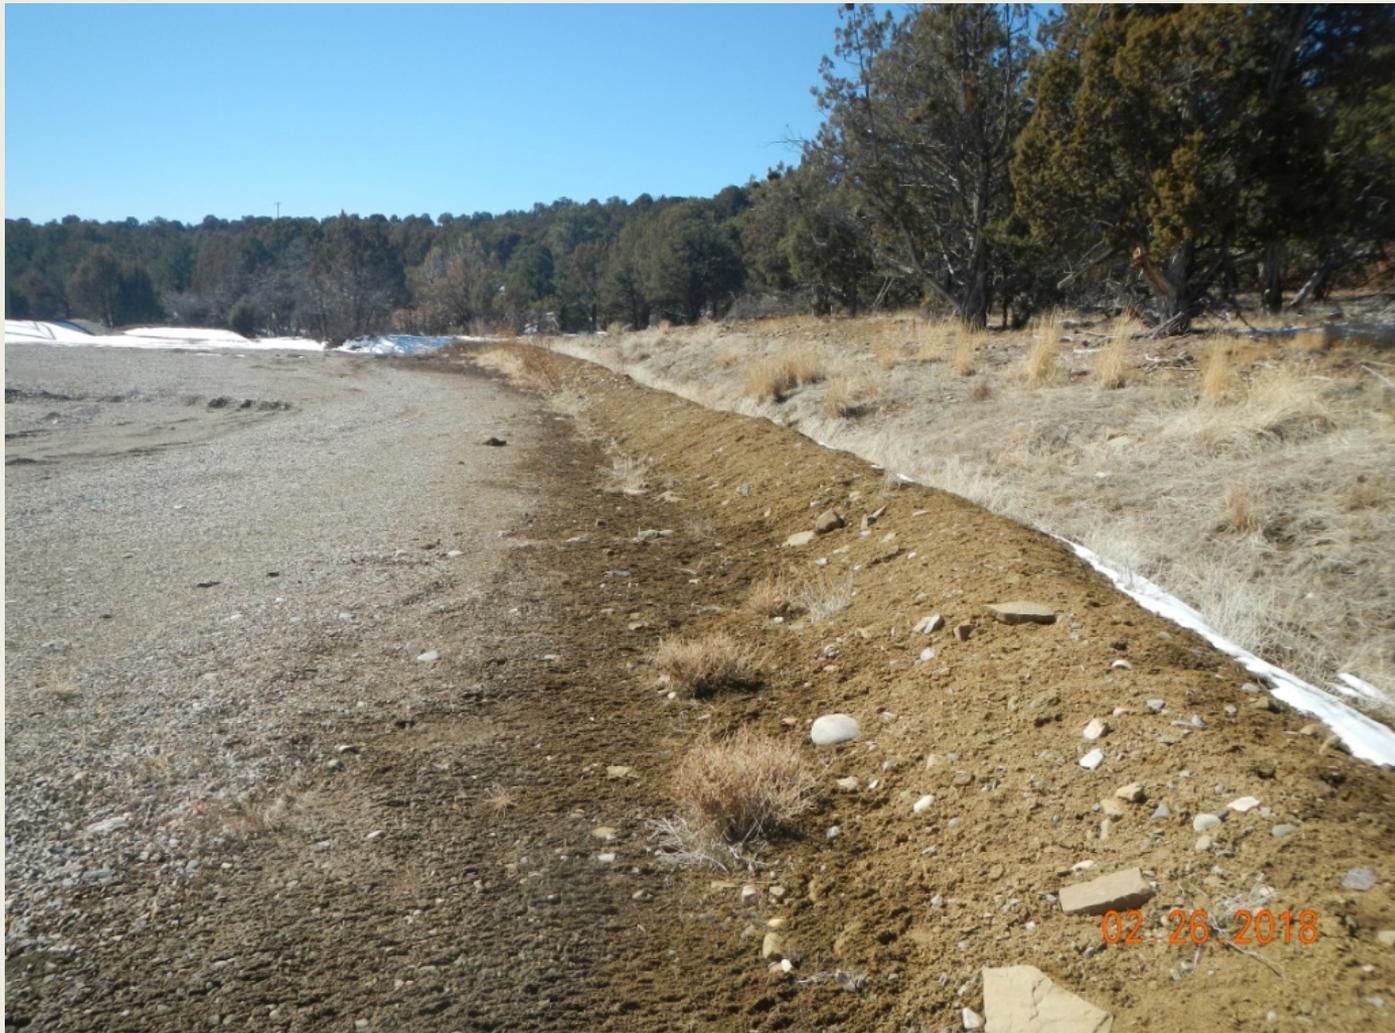
**Photo 2. View of the northern portion of the project area from the northeastern corner facing westward. Revegetation is progressing with grasses such as western wheatgrass (*Pascopyrum smithii*) and intermediate wheatgrass (*Thinopyron intermedium*).**

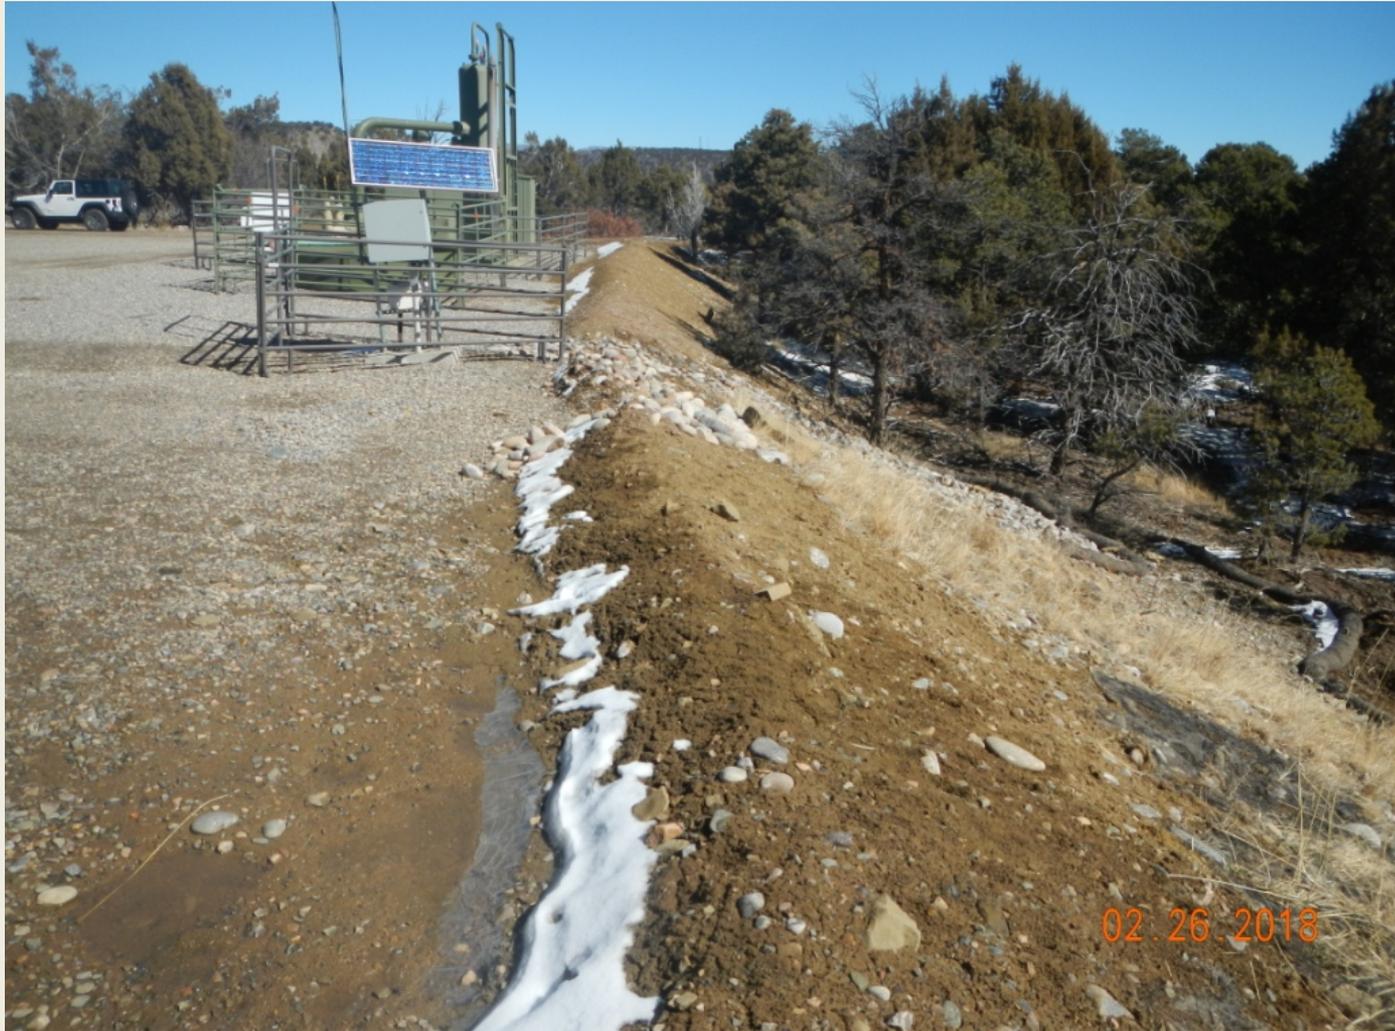
**Photo 3. View of the southern portion of the project area from the southwestern corner facing eastward. Poor revegetation on berms and fill slopes. These should be seeded in spring 2018.**

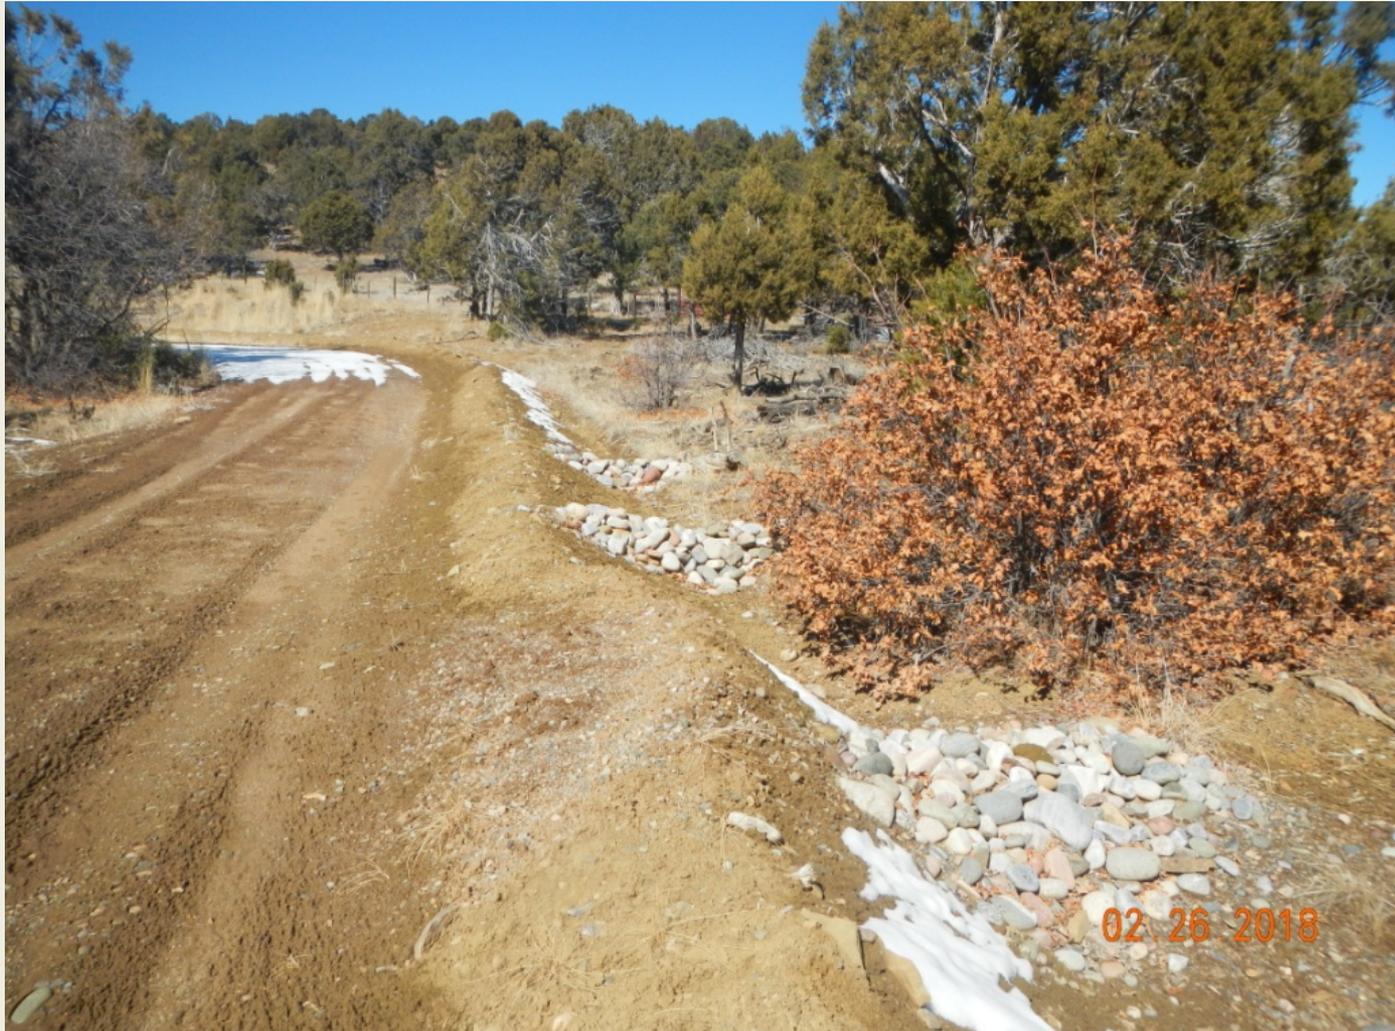
**Photo 4. View of stormwater controls in the eastern portion of the project area facing northward. Appear to be functioning at this time .**

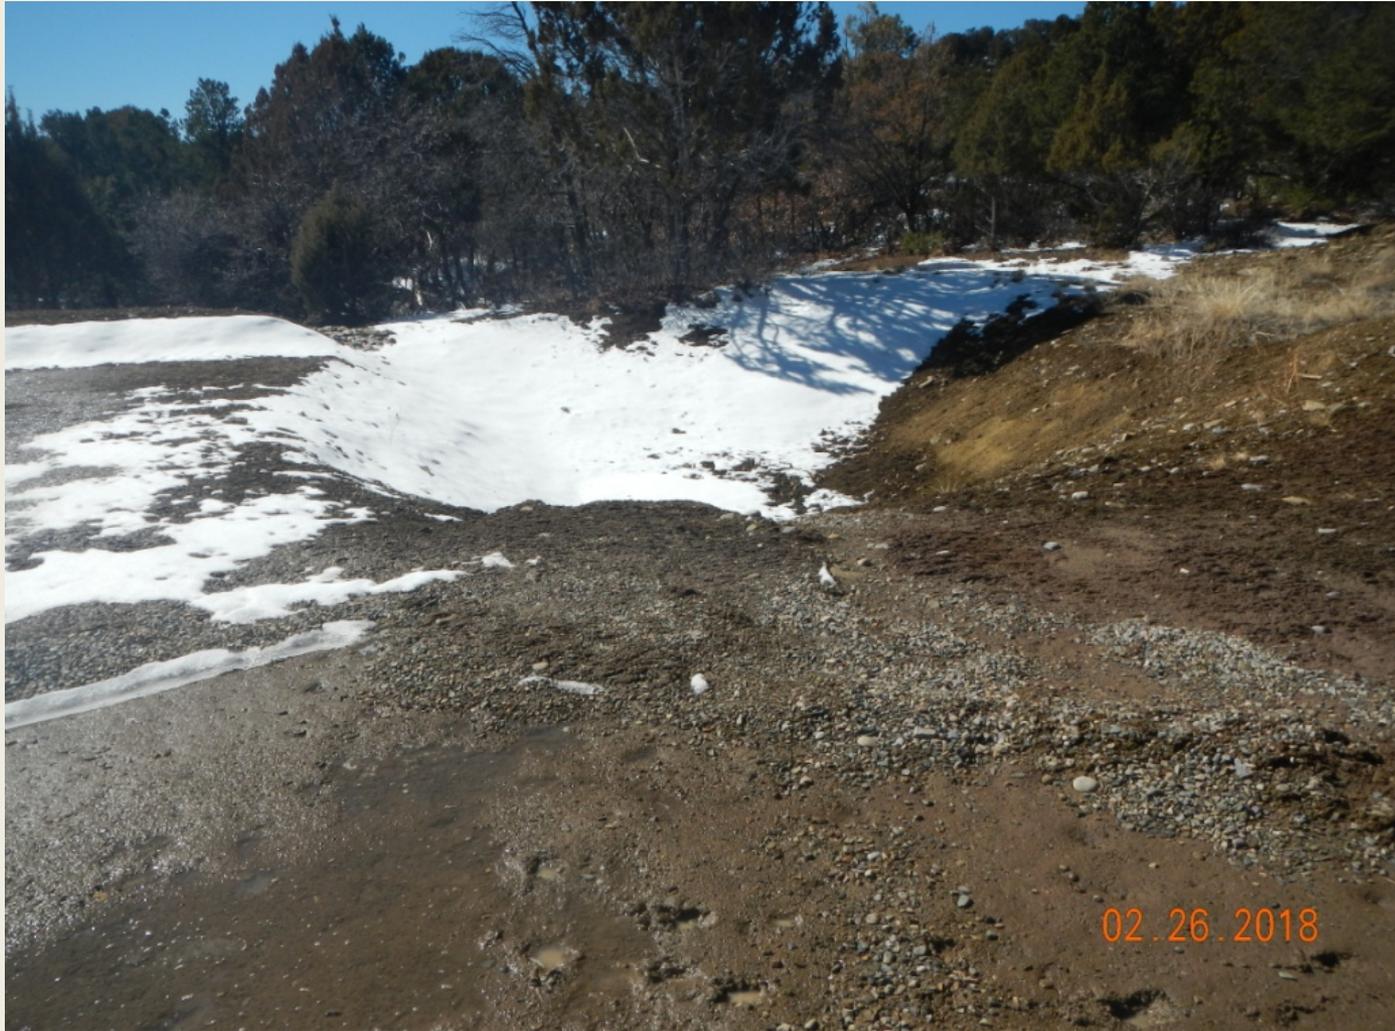
**Photo 5. View of silt trap in the northwestern portion of the project area, appears to functioning at this time.**
