Interim Reclamation Inspection

Operator: CRESTONE PEAK RESOURCES OPERATING LLC- #10633

Location ID: 305447

Inspection Photos
Location Name: Woolley-Sosa-Becky
Location ID: 305447

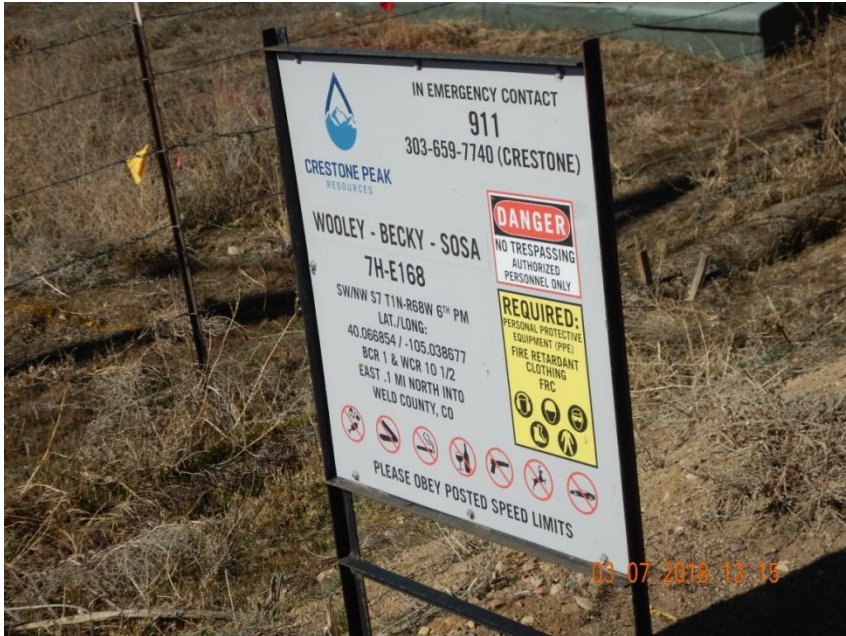
Photo 1. Photo taken from the entrance of the facility/well location. Sign appears to be in compliance with applicable rules and regulations.

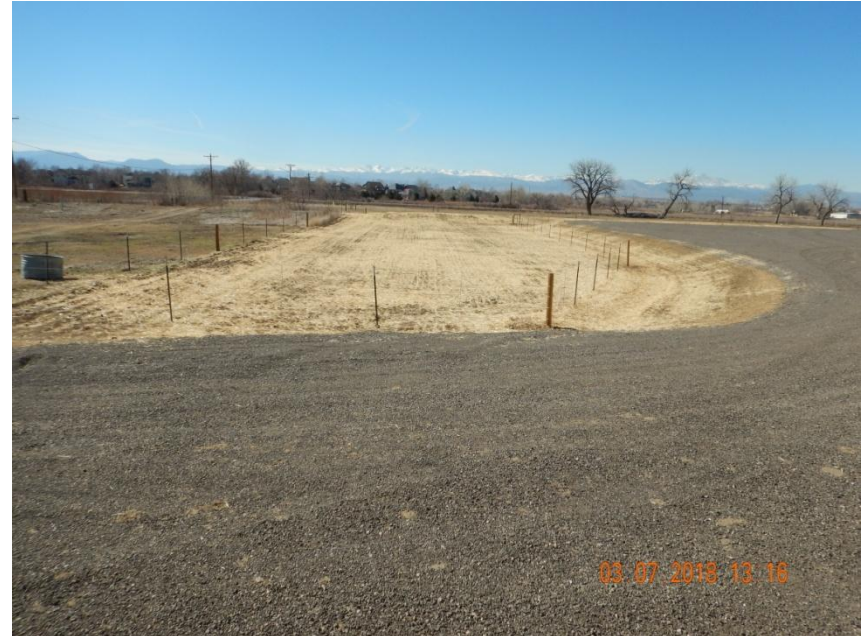
Photo 2. Photo taken from the entrance of the facility/well location, facing West. Appears the Operator has reduced areas only reasonably needed for production operations per Rule 1003.

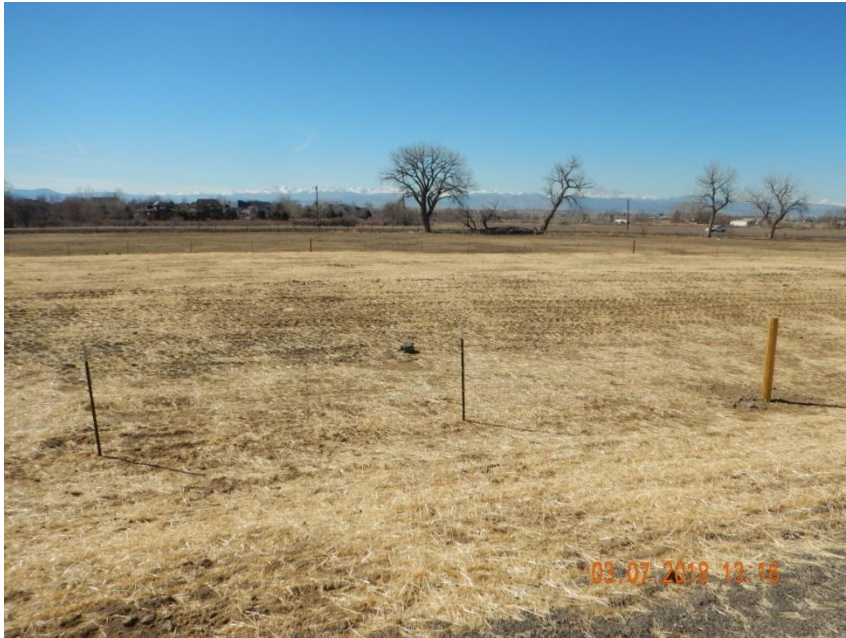
Photo 3. Photo taken from the western facility/well location, facing West. See comments under Photo 2.

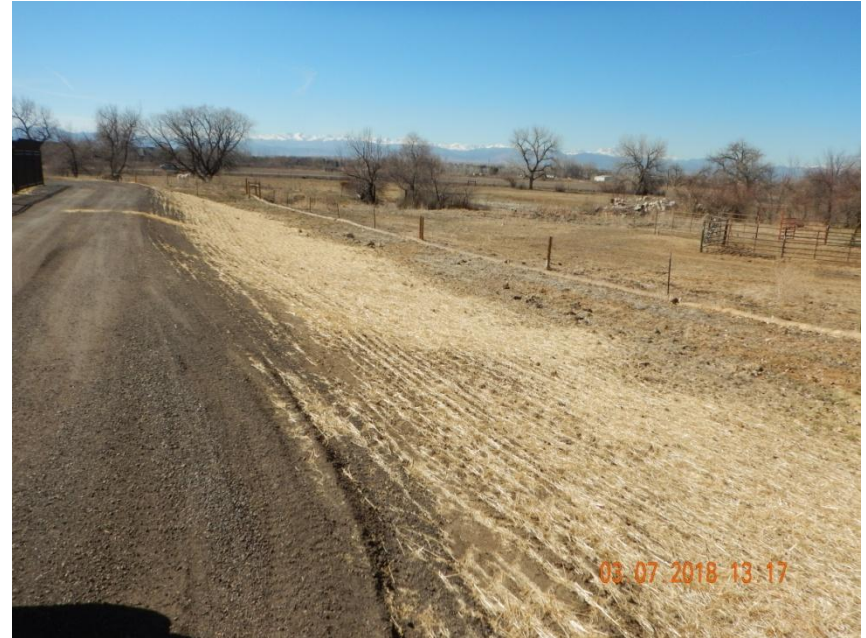
Photo 4. Photo taken from the northeastern facility/well location, facing West. See comments under Photo 2.

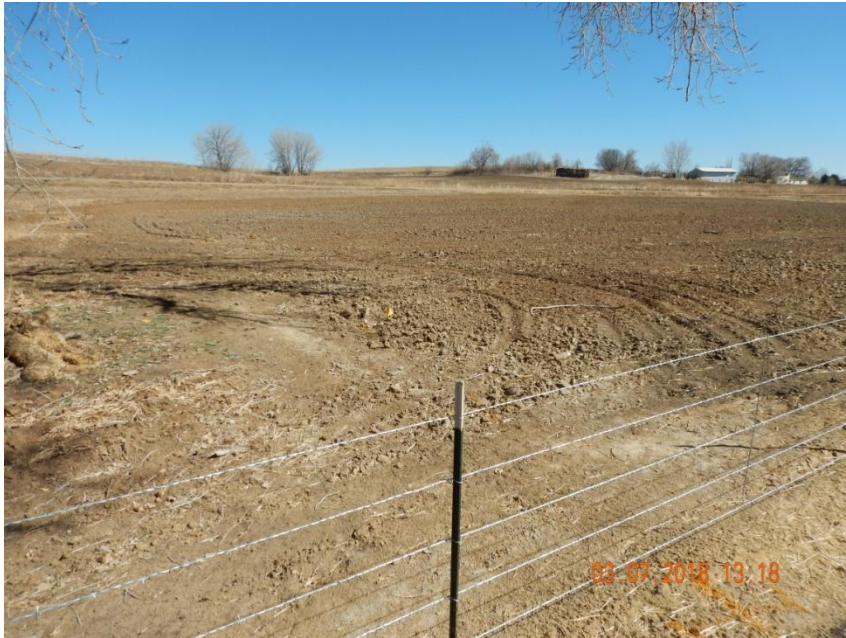
Photo 5. Photo taken from the northeastern facility/well location, facing East. Appears the Operator has performed a seedbed prep along the cropland area. Staff would recommend the Operator ensure erosion controls are implemented throughout all disturbance areas, as these areas would be susceptible to wind and water erosion.

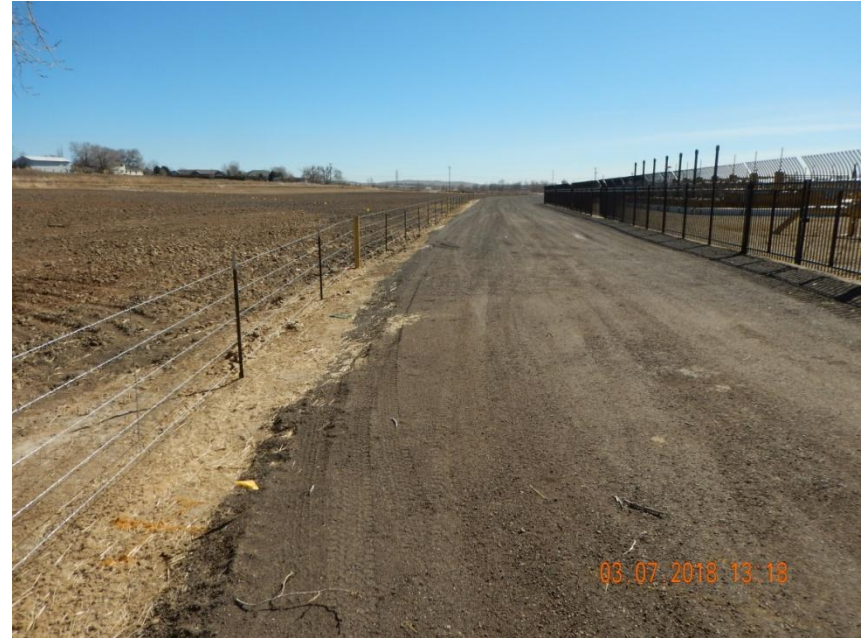
Photo 6. Photo taken from the northeastern facility/well location, facing South. See comments under Photo 2.
