Inspection Photos

API# 071-06409

Operator: Timber Creek

Inspection Number: 680102744

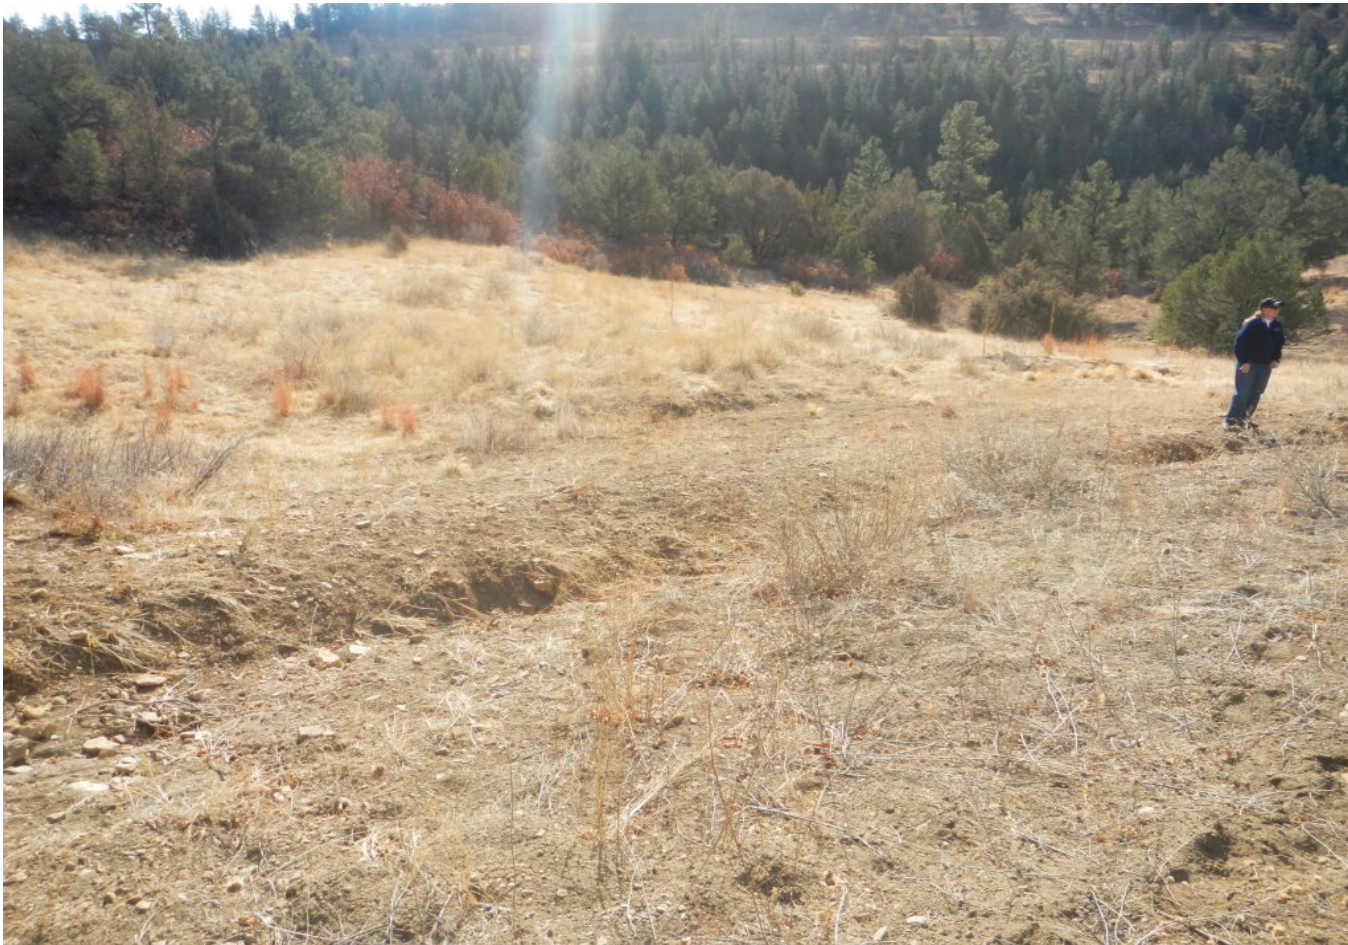
Photo#1:

Overview of Location to Southeast, showing slope along Northwest side of the location which does not have adequate vegetation establishment.

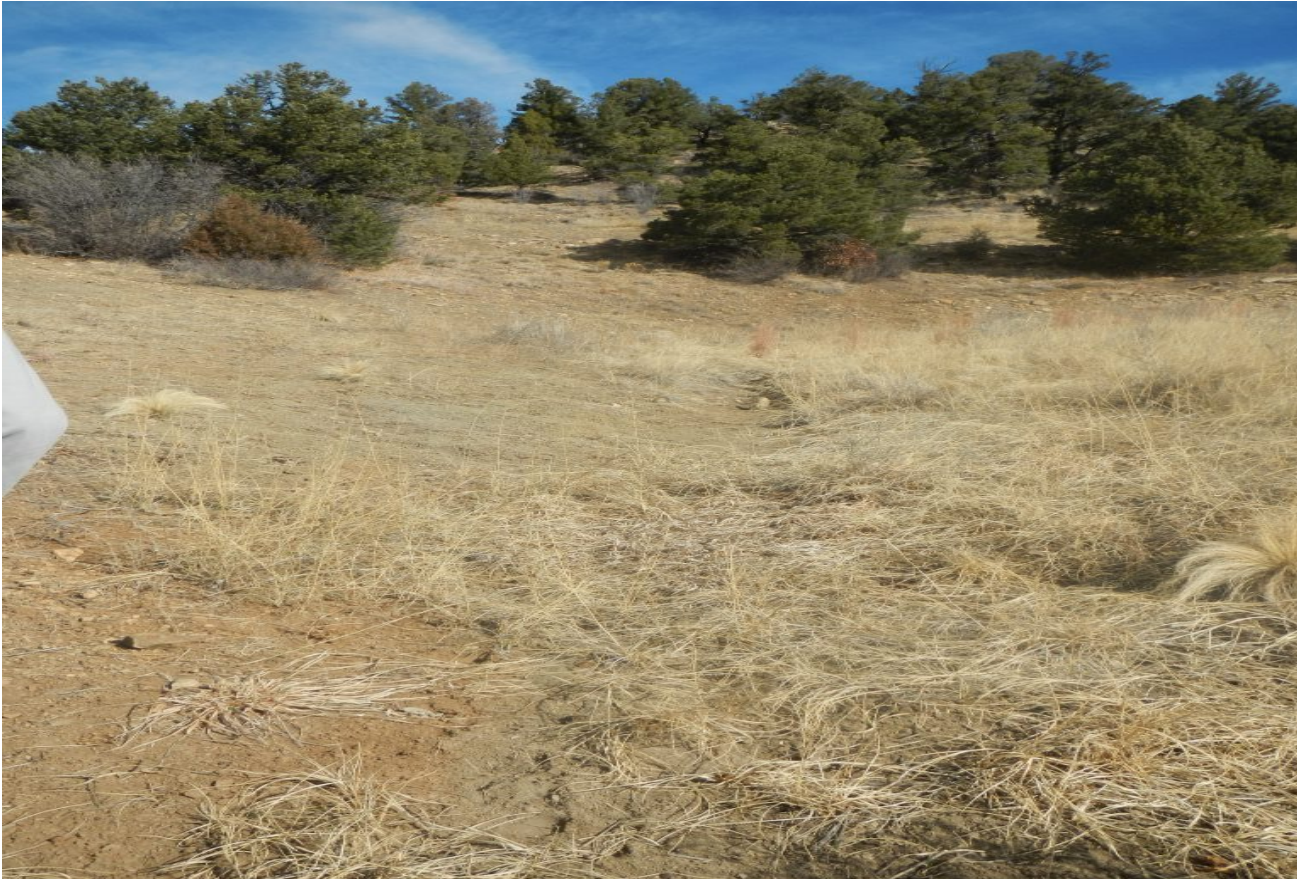
Photo#2:

View along NW Slope which does not have adequate vegetation establishment.

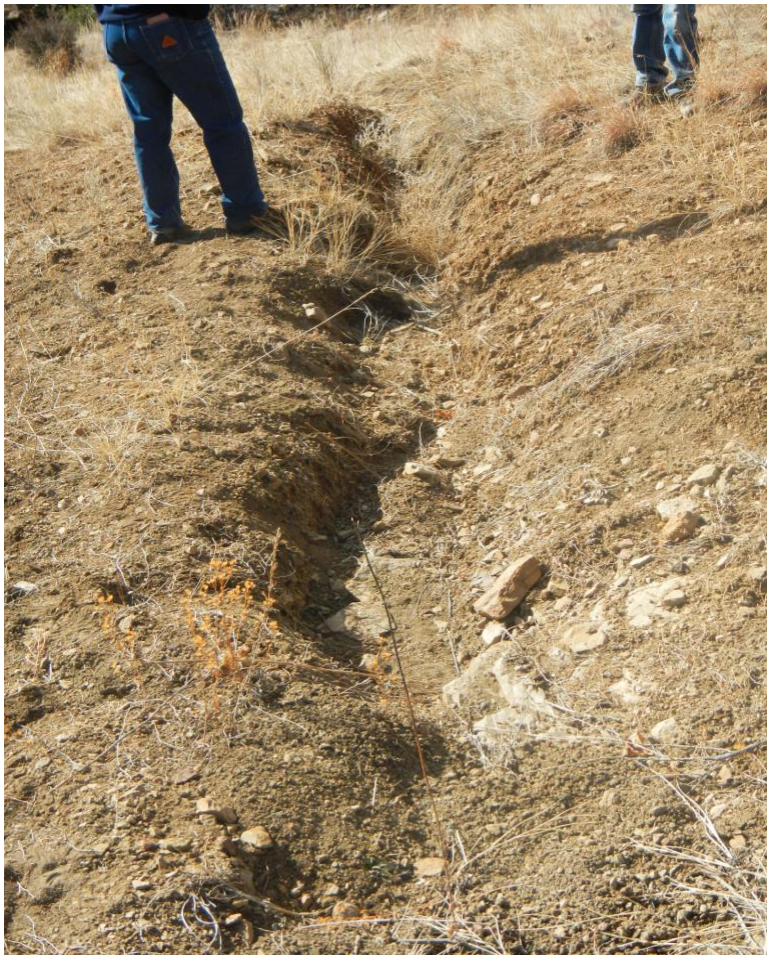
Photo#3:

Ditch that conveys stormwater from lease road through failed vegetation area of location is eroding & needs to be stabilized.

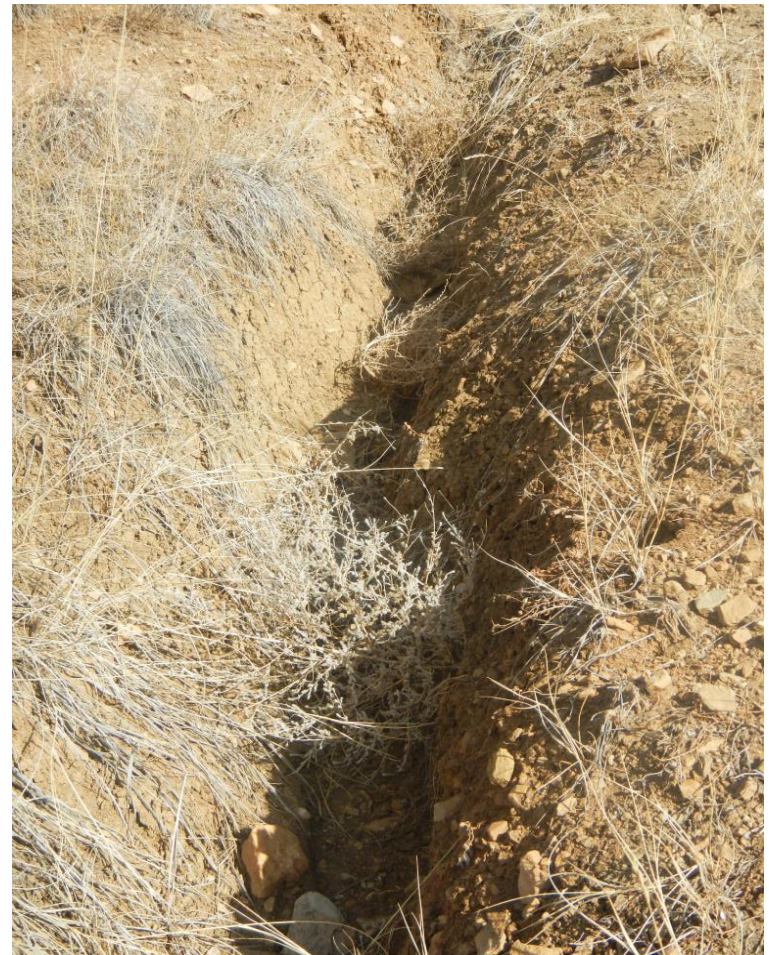
Photo#4:

Refer to Photo#3 description
